Cripple Wall Small-Component Test Program: Dry Specimens

**A Report for the “Quantifying the Performance of
Retrofit of Cripple Walls and Sill Anchorage in Single-
Family Wood-Frame Buildings” Project**

PEER Report 2020/17

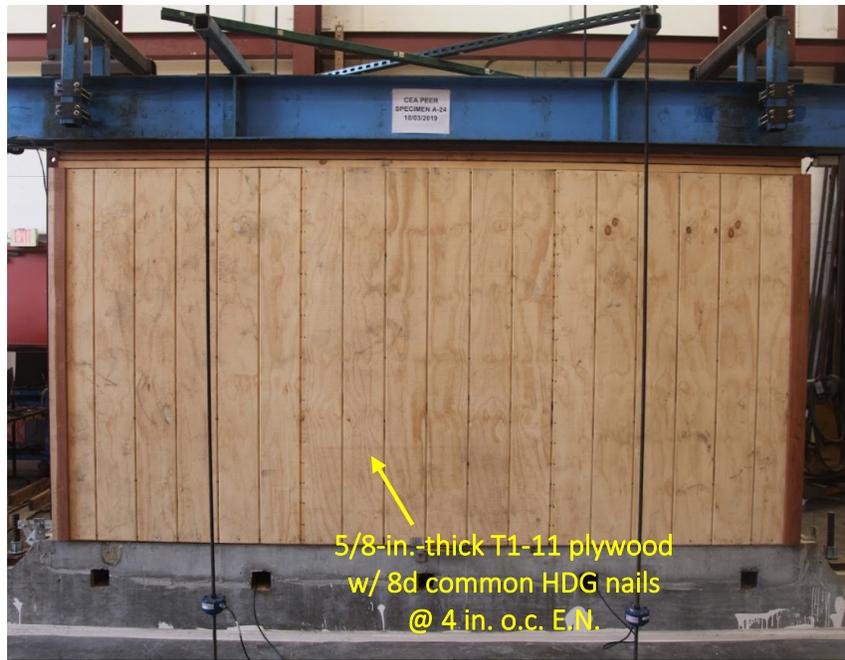
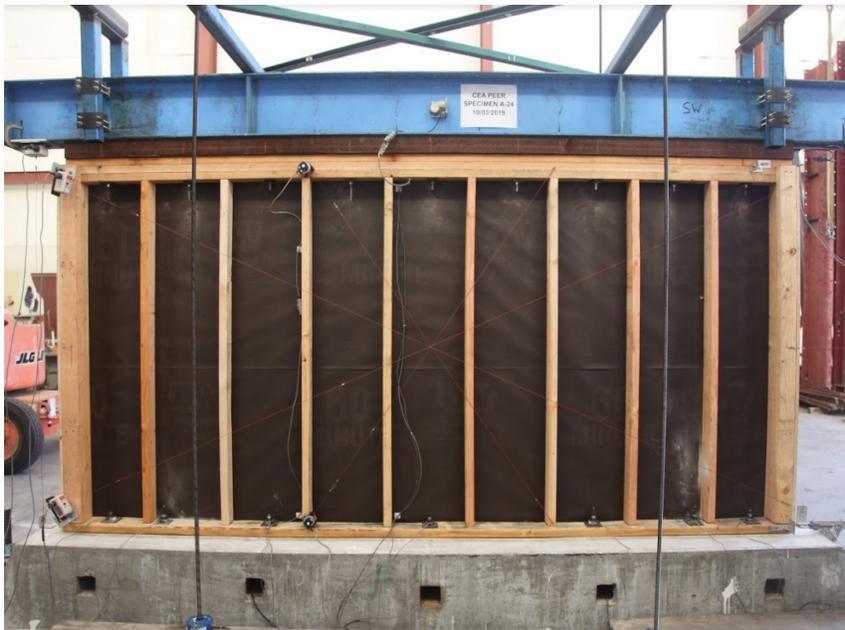
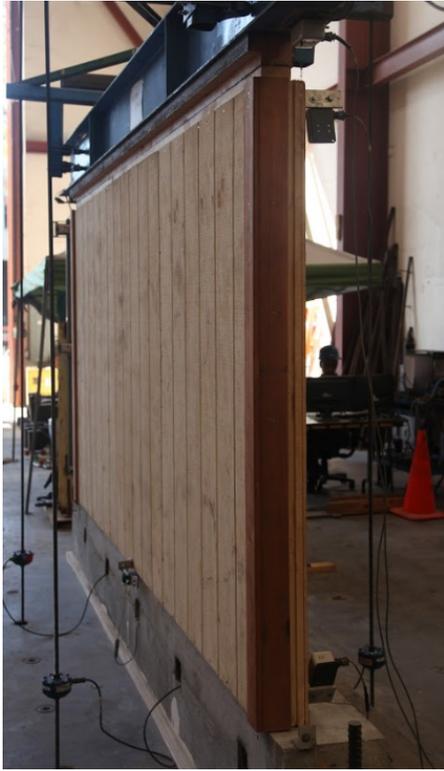
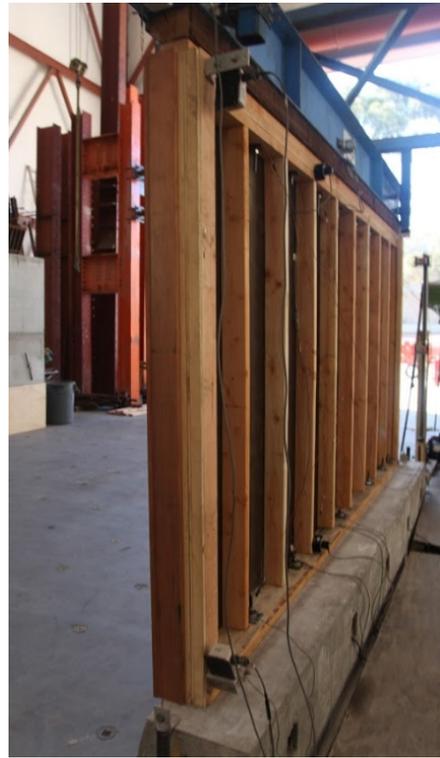
Figure 4.19 Specimen A-24 pre-test photographs of the retrofitted 6-ft-tall cripple wall finished with T1-11 wood structural panels: (a) exterior elevation; (b) interior elevation; (c) north-end exterior of wall corner view; and (d) north-end interior of wall corner view.

The photographs in Figure 4.19 show the initial state of Specimen A-24 prior to testing. Specimen A-23 is a retrofitted 6-ft-tall cripple wall with 5/8-in.-thick T1-11 wood structural panels. With the added retrofit, no plywood was attached to the interior of the cripple wall. Instead, the edge nailing spacing was reduced from 8 in. on center to 4 in. on center. In addition, an additional row of nails was attached to the underlying panel at the panel overlaps. These nails were also spaced at 4 in. on

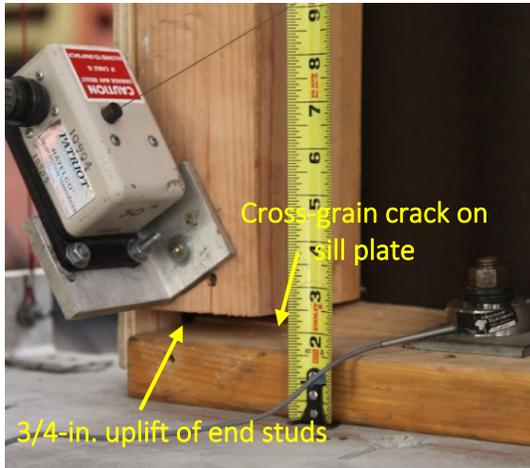
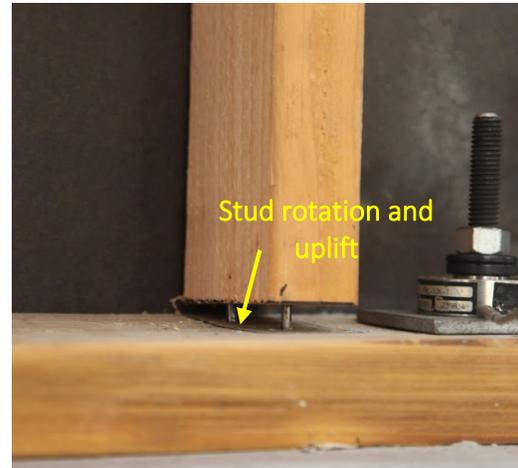
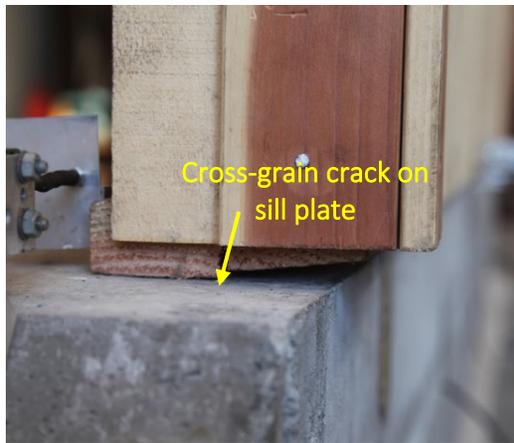
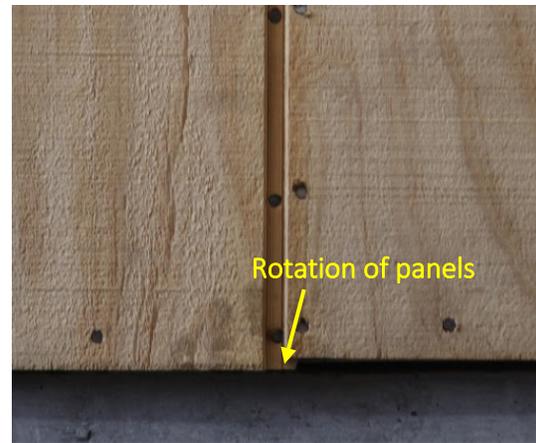
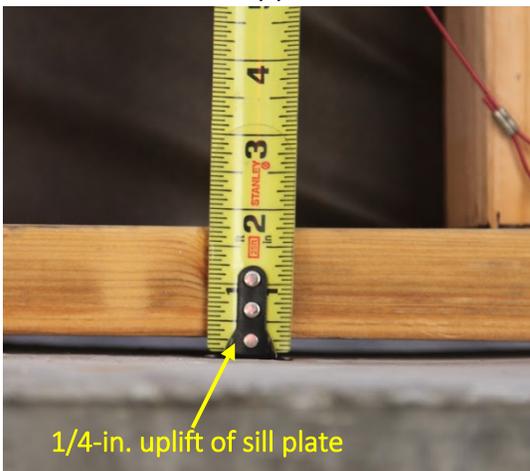
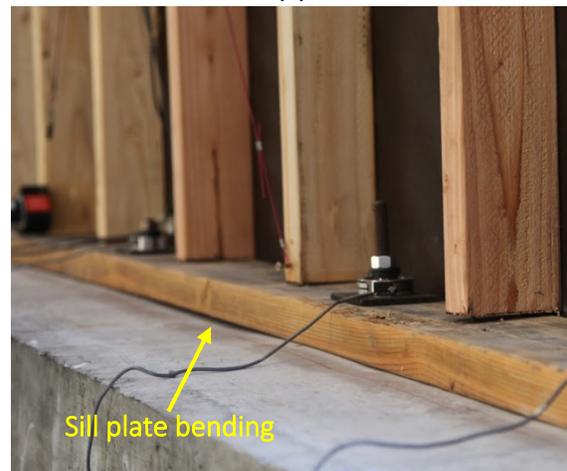
Figure 4.20 Specimen A-24 damage state details at -1.4% drift ratio level @ $\Delta = -1.008$ in. unless otherwise noted: (a) bottom of north-end of interior of wall corner view at +1.4% drift; (b) bottom of interior of wall view; (c) bottom of south-end of wall corner view; (d) bottom of middle exterior of wall view (south and middle panels); (e) bottom of middle interior of wall view; and (f) bottom of interior of wall view.

Figure 4.20 shows details of the damage at the -1.4% drift. At this point, the sill plate has a cross-grain split on both ends of the wall which can be seen in Figure 4.20(a) and (c). There is uplift of the not only the corner studs but also the interior studs. The studs are also rotated as shown in Figure 4.20(b). Through the middle of the cripple wall, the sill plate is bending, and there is a 1/4 in. gap between the sill plate and the foundation in the middle of the sill plate span; see Figure 4.20(e). Figure 4.20(f) shows the bending of the sill plate in the middle of its span along with the uplift and rotation of the studs in the middle of the cripple wall. Slight rotation of the panel has started to occur, and the nails have begun to rotate; see Figure 4.20(d).

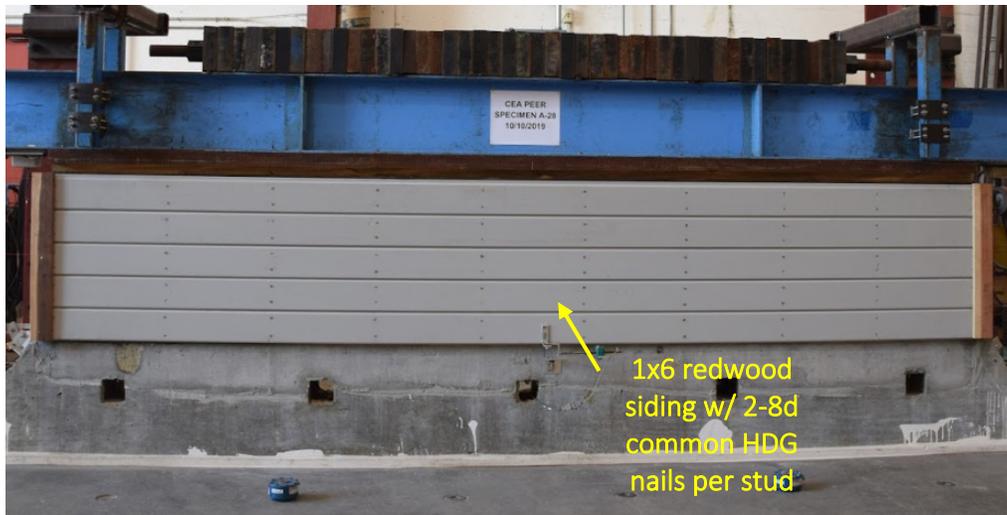
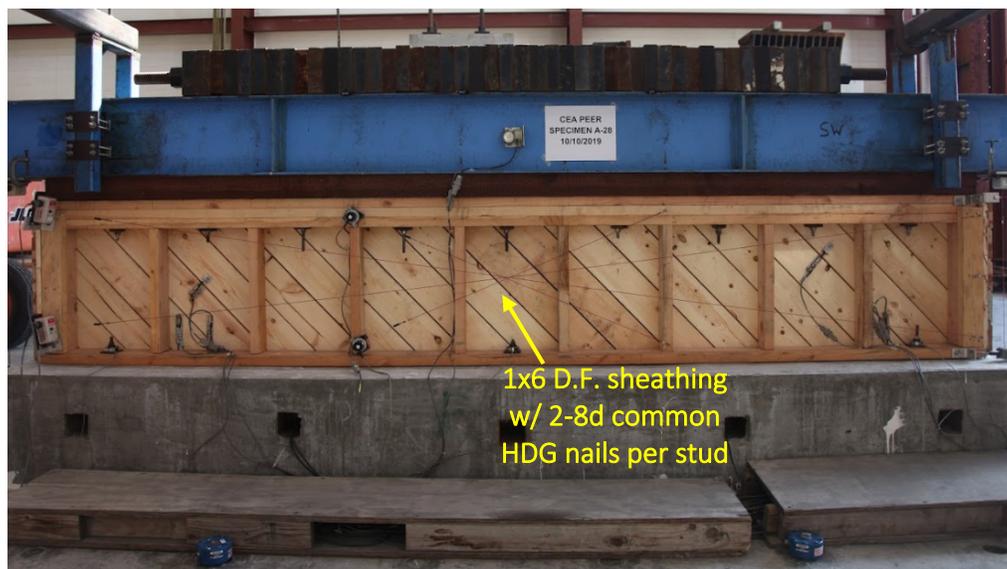
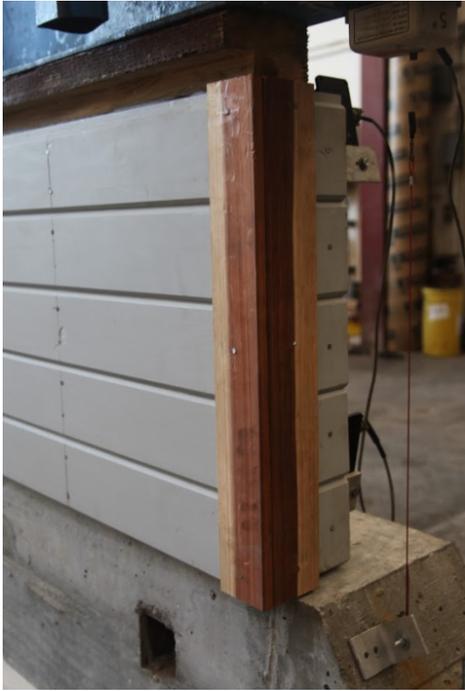
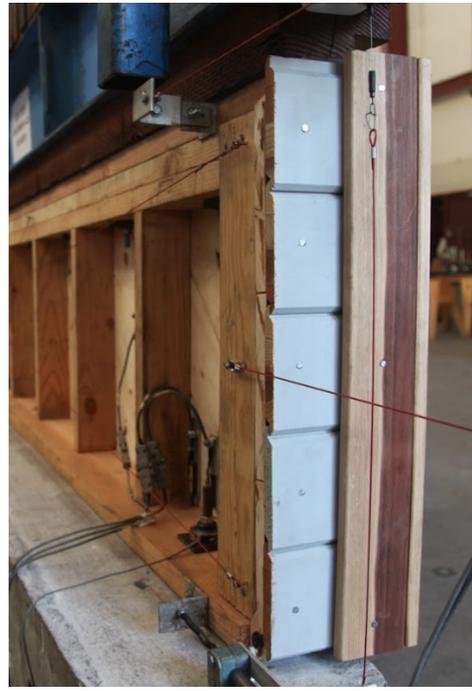
Figure 4.21 Specimen A-28 pre-test photographs for the existing 2-ft-tall cripple wall finished with horizontal siding over diagonal sheathing, light vertical load): (a) exterior elevation; (b) interior elevation; (c) north-end exterior of wall corner view; and (d) north-end interior of wall corner view.

The photographs in Figure 4.21 show the initial state of Specimen A-28 prior to testing. Specimen A-28 is an existing 2-ft-tall cripple wall with horizontal siding over diagonal sheathing exterior finish. It was constructed with the same details as Specimen A-9. The difference between the two tests is the amount of vertical load applied on the cripple wall. Specimen A-9 had 450 plf imposed on it, which is representative of the weight of a two-story dwelling with heavy construction materials. Specimen A-29 had 150 plf of vertical load imposed on it. This weight correlated to the weight of a one-story dwelling with light construction materials. The vertical load came from steel plates placed along the horizontal steel transfer beam, instead of hydraulic jacks imposing two point loads on the steel beam, the configuration for all other cripple walls. The siding is 1 × 6 redwood fastened with two 8d common hot-dipped galvanized nails per stud. The diagonal sheathing boards 1 × 6 construction grade Douglas Fir were oriented at a 45° angle from southwest to northeast. There were 1/8-in. gaps between the sheathing boards and the siding boards. The dimensions of the wall were 12 ft-4-1/2 in. in length and 2 ft-1-1/2 in. in height.

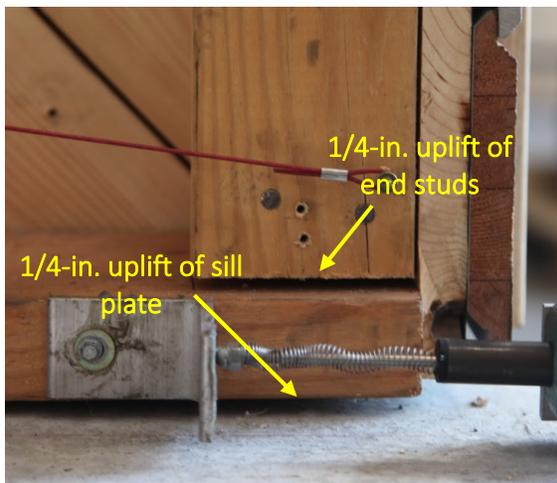
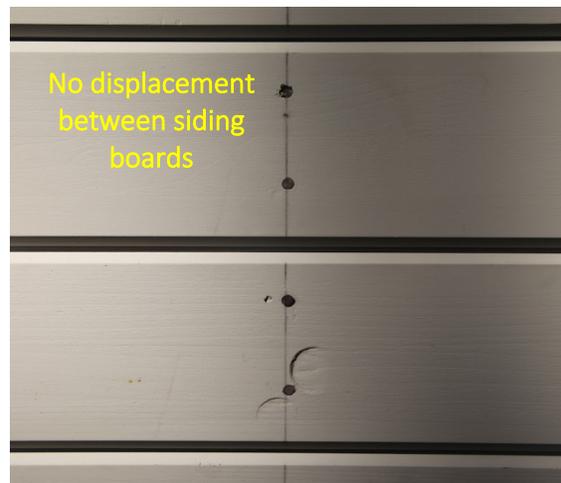
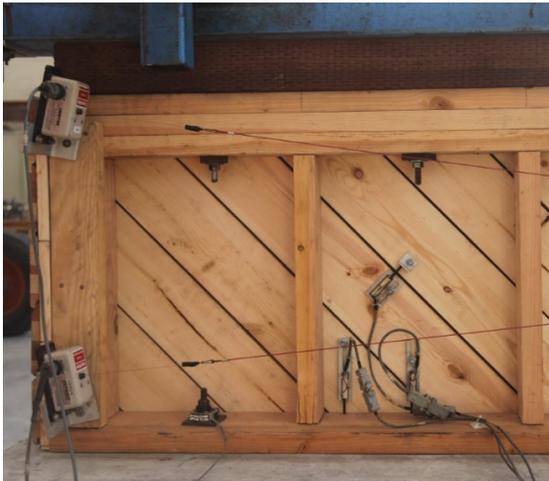
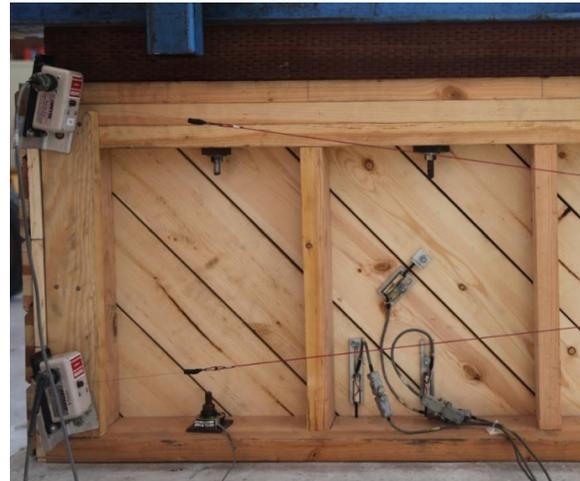
Figure 4.22 Specimen A-28 damage state details at -1.4% drift ratio level @ $\Delta = -0.336$ in. unless otherwise noted: (a) bottom of south-end of interior of wall view; (b) middle interior of wall view; (c) north-end interior of wall view at +1.4% drift; and (d) north-end interior of wall view.

No visible changes to the cripple wall finishes occurred from 0.0% to 0.8% drift. Figure 4.21 gives close-up photographs of the cripple wall at -1.4% drift. There is a 1/4-in. uplift of the end studs and a 1/4-in. uplift of the sill plate; see Figure 4.21(a). The increased uplift at the ends of the cripple wall compared with other specimens is due to the light vertical load as well as the diagonal sheathing. Figure 4.21(c) and (d) show the sheathing boards at +1.4% drift and -1.4% drift. There is no visible opening or closing of the gaps between the sheathing boards.

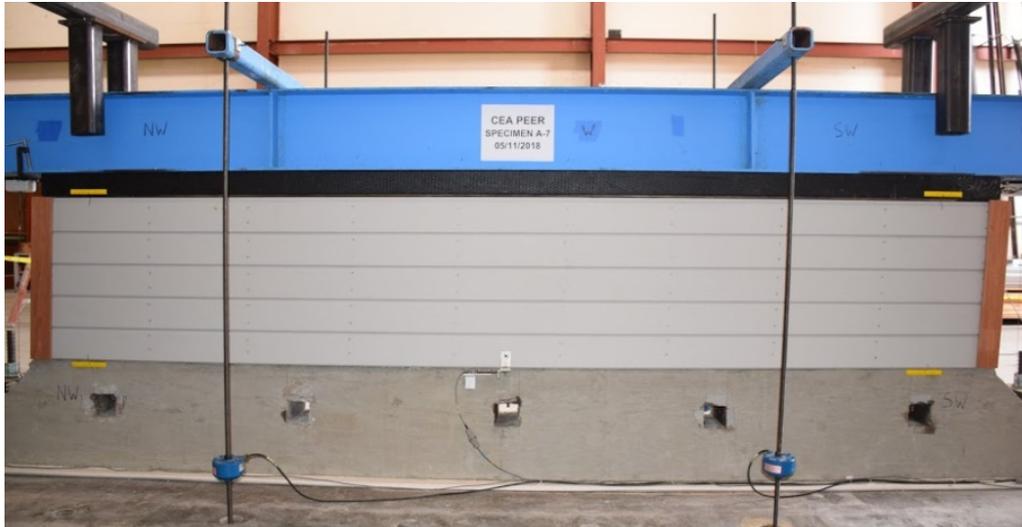
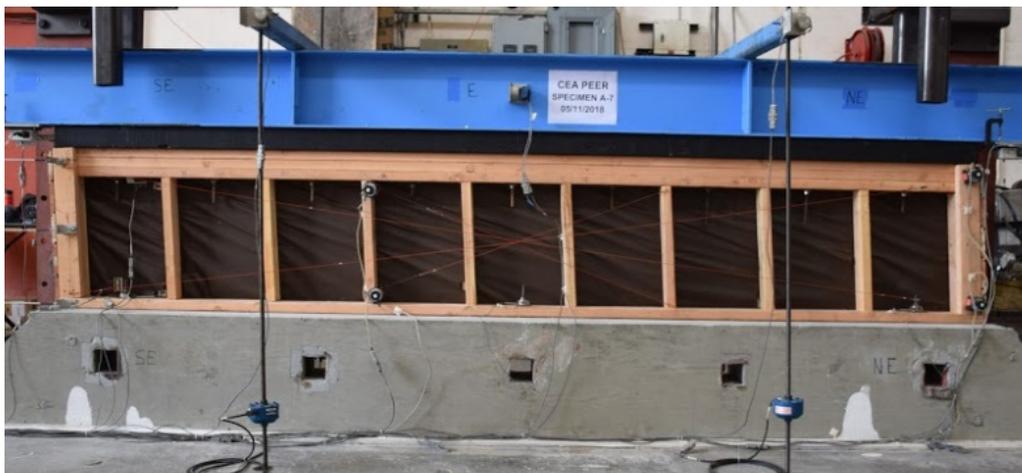
Figure 4.23 Specimen A-7 damage state at lateral strength at -4% drift ratio level @ $\Delta = -0.96$ in.: (a) exterior elevation; and (b) interior elevation.

Figure 4.23 shows the interior and exterior views of the cripple wall for Specimen A-7 at strength (-4% drift). The lateral strength occurred at 4% global and relative drift ratio in both the push and pull direction. Specimen A-7 did not experience any sill slip due to the lack of capacity to overcome the frictional resistance keeping the cripple wall in place. Overall, there were not many visual damages that could be attributed to the cripple wall reaching peak capacity. A comparison of Figure 4.23 and Figure 4.3 (-1.4% drift of Specimen A-7) show little difference besides increased tilt of the cripple wall. The siding boards remained intact and uncracked on the exterior face as well as the corners of the specimen. There was no splitting or cracking of the framing members either. The most prominent change is the condition of the building paper, which began tearing at peak load.

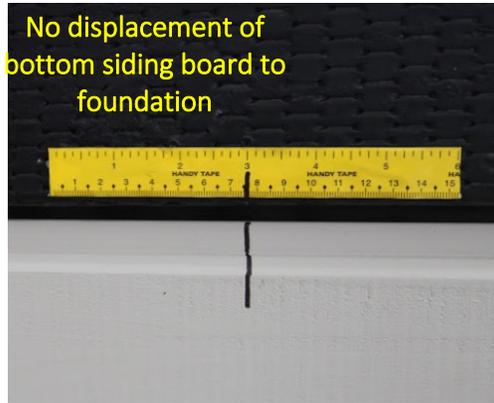
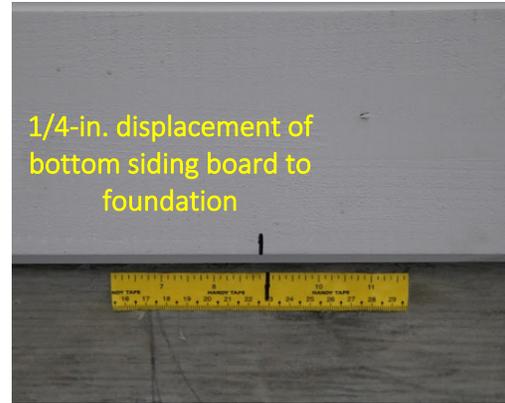
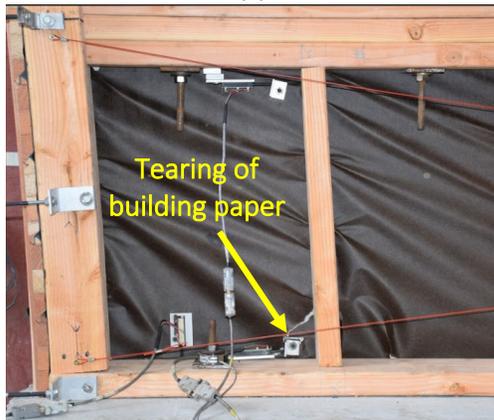
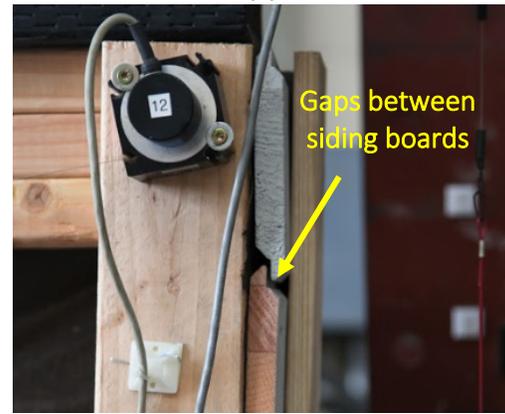
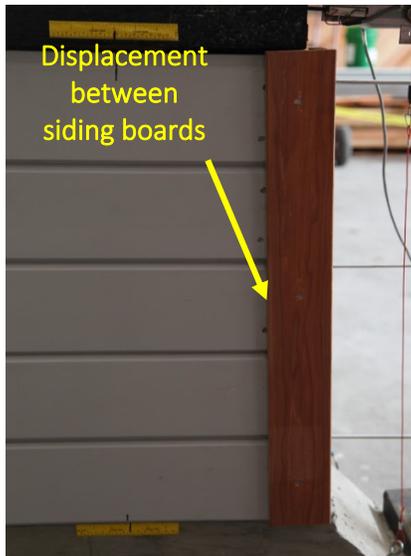
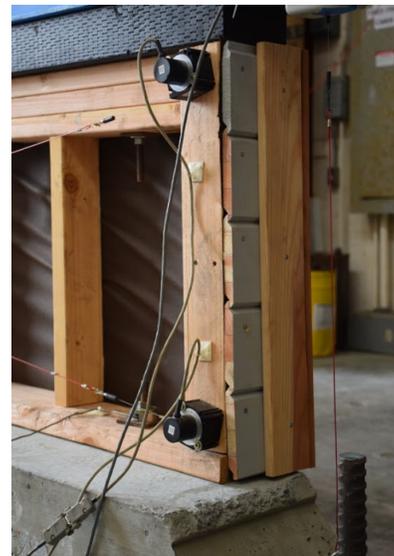
Figure 4.24 Specimen A-7 damage state details at lateral strength at -4% drift ratio level @ $\Delta = -0.96$ in.: (a) top of middle exterior of wall view; (b) bottom of middle exterior of wall view; (c) north-end interior of wall view; (d) top of north-end interior of wall view; (e) south-end exterior of wall view; and (f) north-end interior of wall corner view.

Figure 4.24 shows close-up photographs of Specimen A-7 at -4% drift. There was no displacement between the top siding board and the uppermost top plate of the cripple wall [(Figure 4.24(a)] and an 1/8-in. displacement between the bottom siding board and the foundation; see Figure 4.24(b). The tearing of the building paper originated at the studs where the building paper was stapled and the siding boards were nailed, as seen in Figure 4.24(c). Gaps began increasing in the siding boards, which is most easily seen at the corners; see Figure 4.24(d). The displacement between the siding boards continued to increase through all increases in displacement. This can be seen in Figure 4.24(e) where the corner trim originally covers the nail pattern on the siding boards but now the nails are visible on the upper three siding boards. There was also slight uplift on the corners, as shown in Figure 4.24(f). The lateral strength per linear foot of Specimen A-7 was 186 in the push direction and 162 plf in the pull direction. By 12% drift, these loads had decreased to 135 plf and 127 plf, a 27% decrease in the push direction and a 22% decrease in the pull direction. Compared with other existing cripple walls with different exterior finishes, this is the smallest decrease in capacity for post-peak drift cycles by a wide margin. The reason for a drop of capacity is likely due to the framing rather than the horizontal siding boards. The nails connecting the framing members withdrew from the framing members as displacements were imposed on the wall, and they lost withdrawal strength with repeated cycles of being withdrawn in one direction and then the other direction. Specimen A-7 is unique compared to all other tested cripple walls in the sense that there are no visual cues that would indicate peak capacity had been reached. Much of the strength of the cripple wall came from the framing itself because of the low capacity of the specimen.

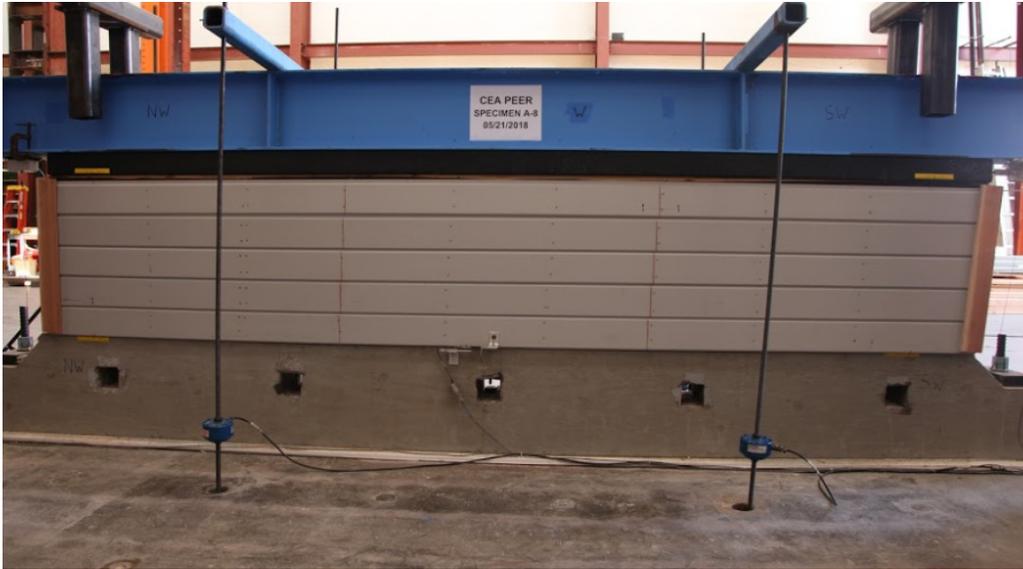
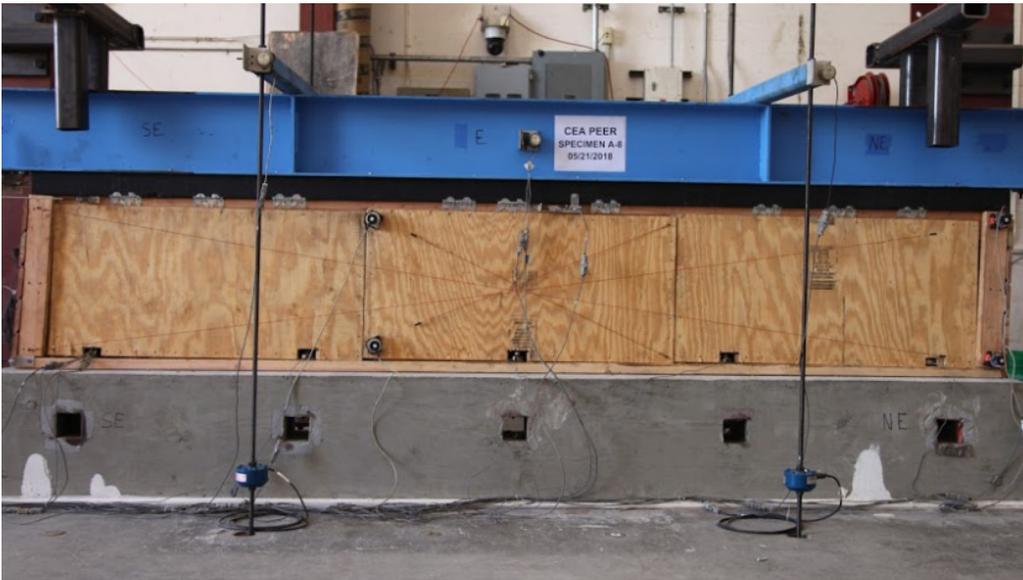
Figure 4.25 Specimen A-8 damage state at lateral strength at +8% drift ratio level @ $\Delta = +1.92$ in. and at -7% drift ratio level @ $\Delta = -1.68$ in.: (a) exterior elevation at +8% drift; and (b) interior elevation at -7% drift.

Figure 4.25 shows the interior and exterior views of the cripple wall for Specimen A-8 at strength. The lateral strength occurred at 8% global drift ratio in the push direction and 7% global drift ratio in the pull direction and 6.4% relative drift ratio in the push direction and 4.7% relative drift ratio in the pull direction. The sill-to-foundation displacement accounted for 1.6% drift in the push direction and 2.3% drift in the pull direction. From Figure 4.42, it can be seen that the exterior face of the cripple wall shows little visual damage (only pronounced tilt of the wall), while the interior face shows extensive damages as the plywood panels cannot rotate to the degree that the cripple wall is tilted over.

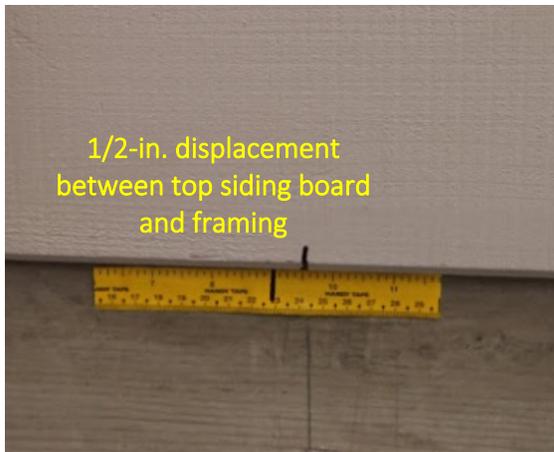
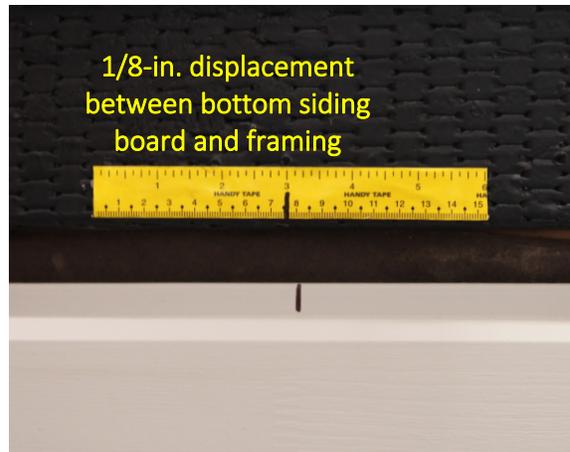
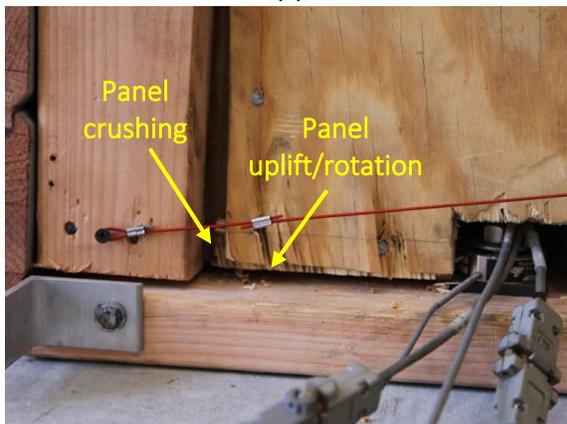
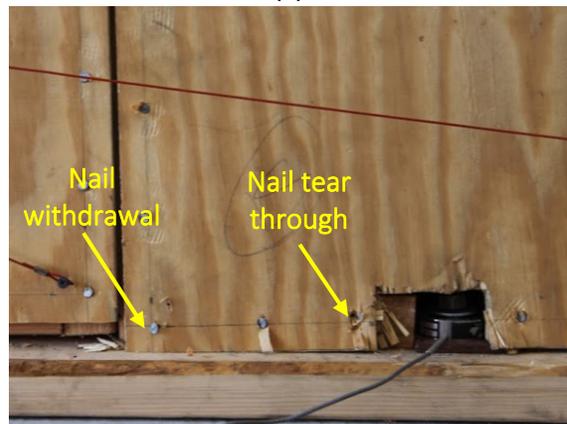
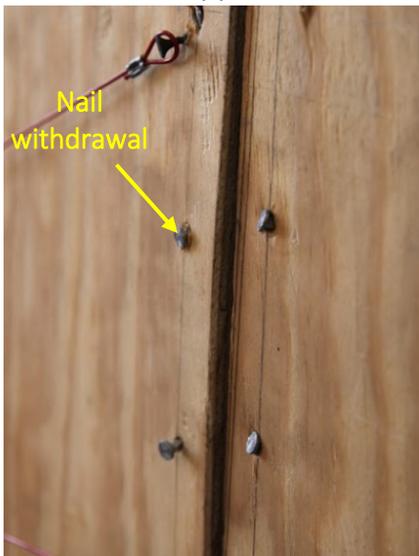
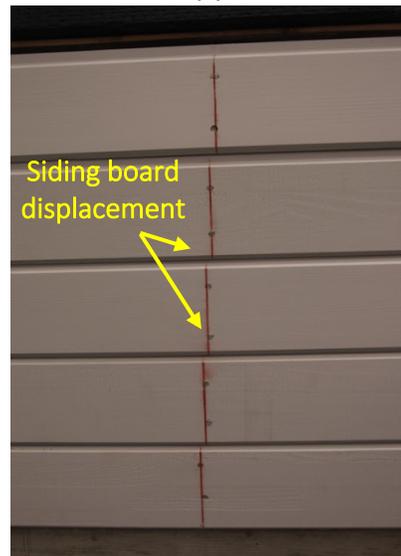
Figure 4.26 Specimen A-8 damage state details at lateral strength at +8% drift ratio level @ $\Delta = +1.92$ in.: (a) top exterior of wall view; (b) bottom exterior of wall view; (c) bottom of north-end interior of wall view; (d) bottom of middle interior of wall view (north and middle panels); (e) middle interior of wall view (south and middle panels); and (f) middle exterior of wall.

Figure 4.24 shows key close-up photographs of the damage to Specimen A-8. There is a 1/8-in. displacement between the top siding board and the uppermost top plate [Figure 4.24(a)], and there is a 1/2-in. displacement between the bottom siding board and the foundation [Figure 4.24(b)], which is the amount of sliding between the sill plate and foundation. In addition, as shown in Figure 4.43(f), there is 3/8-in. displacement between the siding boards. A view of the interior face of the cripple wall demonstrates why the cripple wall reached peak capacity. Figure 4.24(c) shows that the nails attaching the plywood to the framing had heavily rotated and in some cases either ripped through the edges of the plywood, pulled out from the framing, or tore through the plywood. This image shows that the plywood had displaced around a 1/2 in. from the blocking that it was originally flush with. This means that the nails attaching the plywood to the blocking have worked out of the blocking by close to a 1/2 in. At both bottom corners of the cripple wall, the plywood was crushed after abutting against the corner flat stud; see Figure 4.24(d). The corner of the wall was pushed outward by 1/4 in. off the sill plate due to contact with the plywood panel. Typically, nails connecting the blocking to the plywood would tear through the plywood while nails further up the wall would pull out of the framing, as seen in Figure 4.24(e). Regardless if the nails pull out of the framing or tear through the plywood, their mobilization reduces the amount of shear resistance that the plywood is able to provide. In many cases, the blocking of the cripple wall split at the plywood-to-blocking nails points of connection, which greatly reduced the capacity of the nail as there is less frictional resistance required to pull the nail out of the blocking.

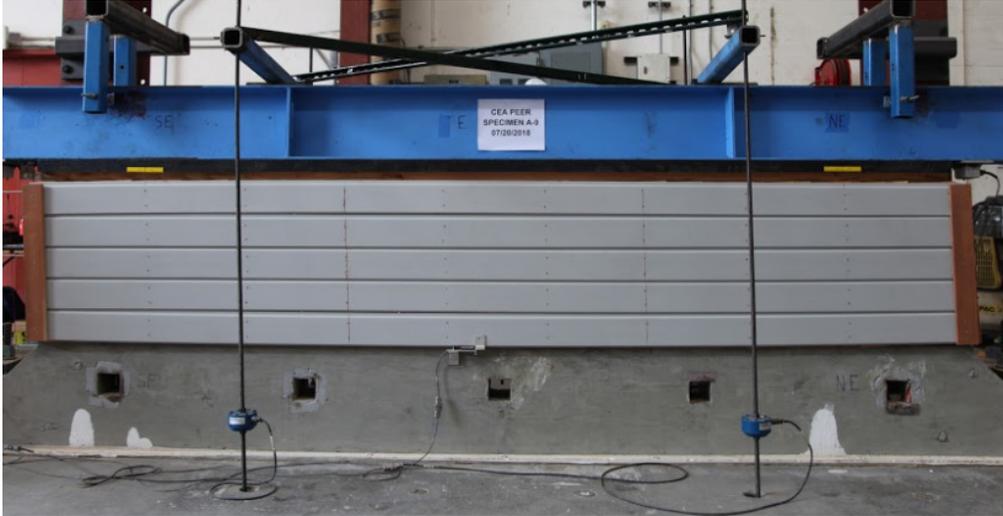
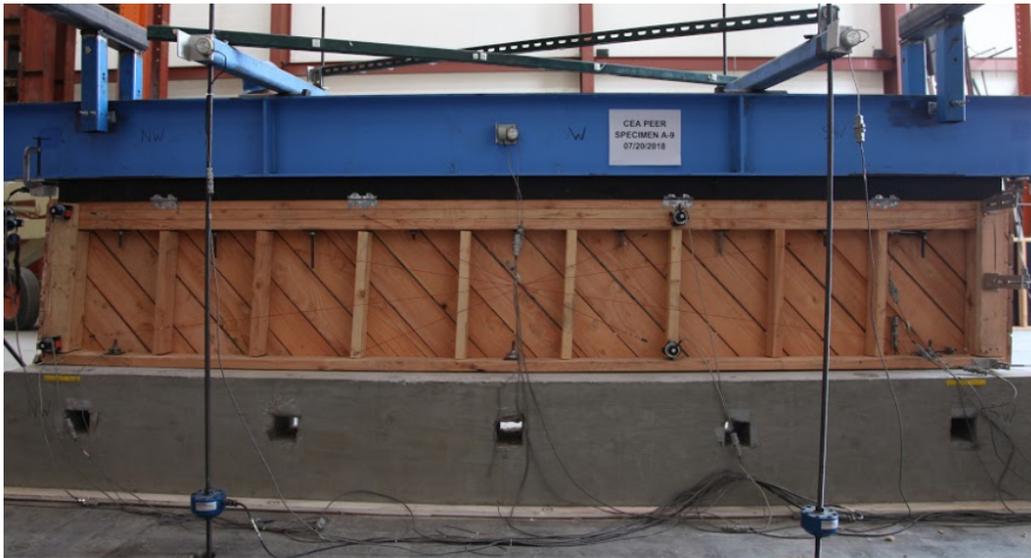
Figure 4.27 Specimen A-9 damage state at lateral strength in push direction at +7% drift ratio level @ $\Delta = +1.68$ in: (a) exterior elevation; and (b) interior elevation.

Figure 4.27 shows the interior and exterior views of the cripple wall for Specimen A-9 at strength in the push direction, and Figure 4.29 shows the interior and exterior views of the cripple wall for Specimen A-9 at strength in the pull direction. The lateral strength occurred at 7% global drift ratio in the push direction and 10% global drift ratio in the pull direction and 5.0% relative drift ratio in the push direction and 5.2% relative drift ratio in the pull direction. The sill-to-foundation displacement accounted for 2.0% drift in the push direction and 4.8% drift in the pull direction. Because the wall achieved strength at largely different displacement amplitudes, they will be treated separately in this discussion.

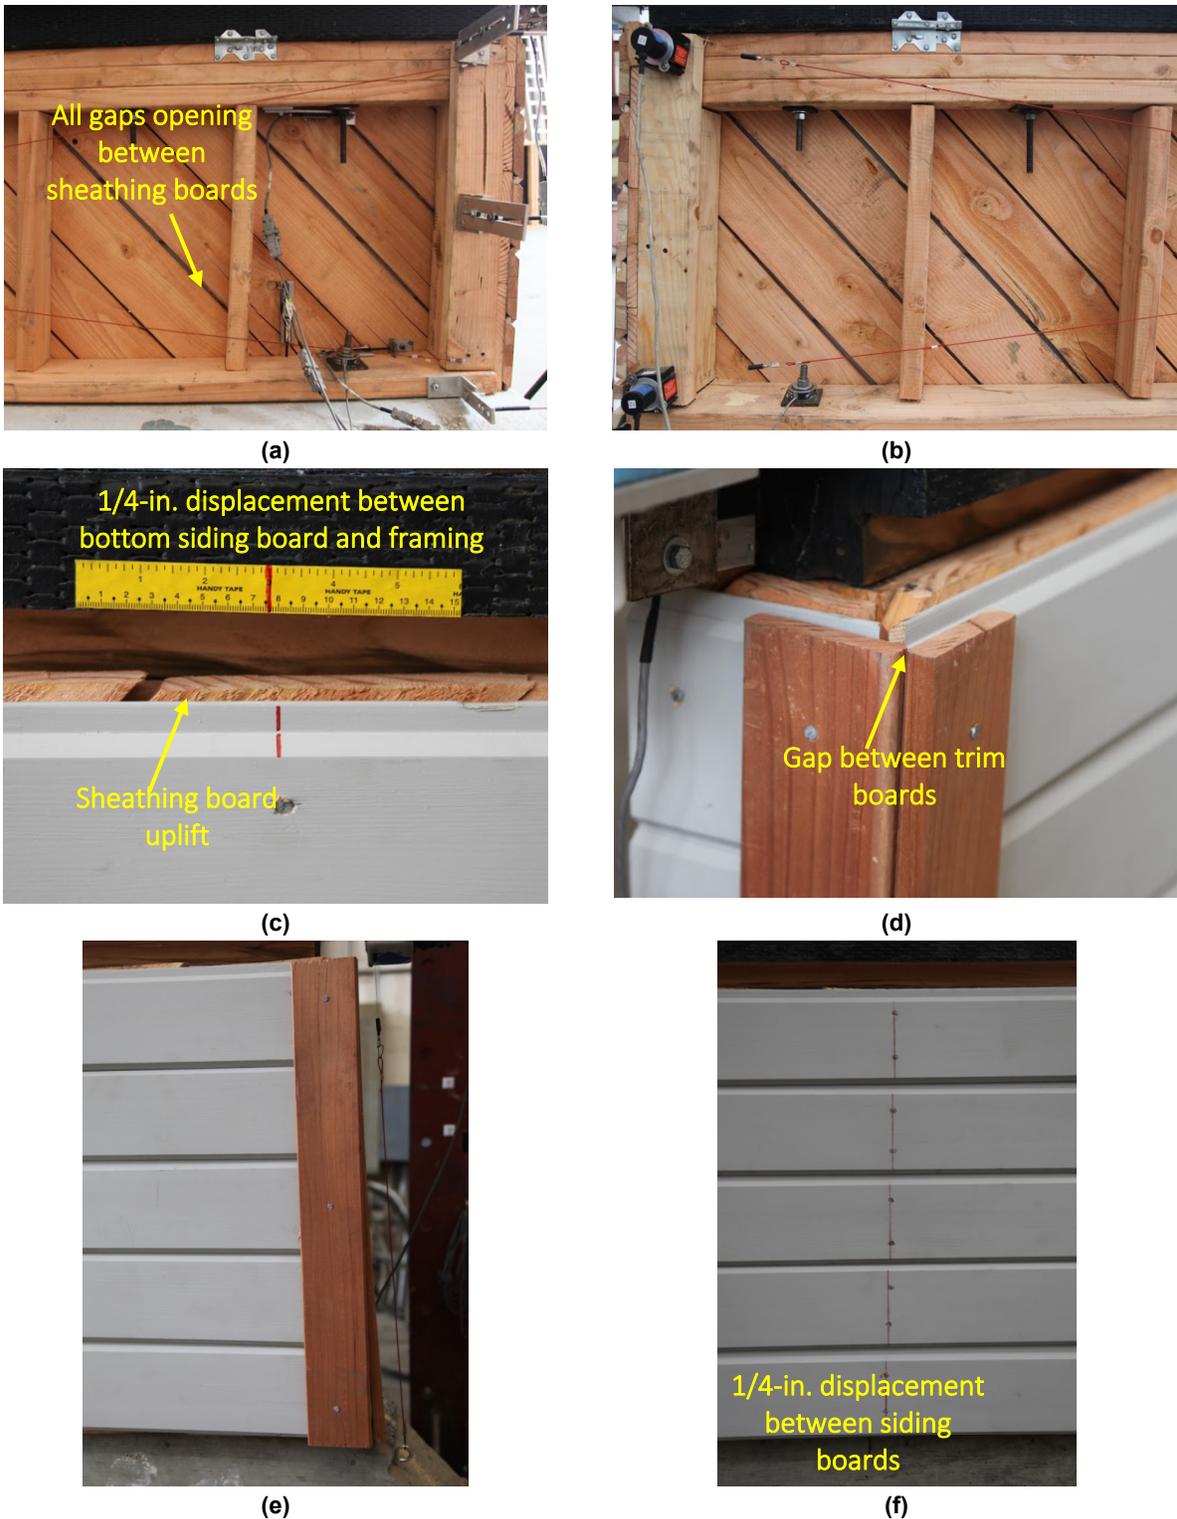
Figure 4.28 Specimen A-9 damage state details at lateral strength in push direction +7% drift ratio level @ $\Delta = +1.68$ in.: (a) south-end interior of wall view; (b) north-end interior of wall view; (c) top exterior of middle of wall view; (d) top of south-end exterior of wall corner view; (e) north-end exterior of wall view; and (f) middle exterior of wall view.

Figure 4.28 shows close-up photographs of the cripple wall at strength in the push direction (+7% drift). On the finish face, a crack formed in the corner trim on the south corner; see Figure 4.28(d). Also, on the finish face, no displacement between the siding and the top plate occurred, and the sheathing boards protrude on the top of the cripple wall, as seen in Figure 4.28(c). If the cripple wall were to have a floor above, it is likely that the sheathing boards would be protruding at the base of the cripple wall due to the fact that the diagonal sheathing boards would run from the cripple wall up to the first floor, increasing their resistance to move upward. Figure 4.28(e) and (f) show the tilt of the cripple wall. There is a 1/4-in. displacement between the siding boards, with the displacement between the top siding two board and the bottom two siding boards slightly larger than all of the other interfaces. Figure 4.28(a) and (b) show the increased gaps that formed between the sheathing boards. In addition, there are several cracks in the sheathing boards originating from where the sheathing was nailed to the studs. These cracks are partly why the cripple wall reached capacity in the push direction. The other reason for peak capacity was caused by the nails of connecting the sheathing to the framing beginning to withdraw from the sheathing. This is not visible with the horizontal siding covering the sheathing, but since the sheathing boards are protruding out of the top of the cripple, the nails must be pulling out of the framing.

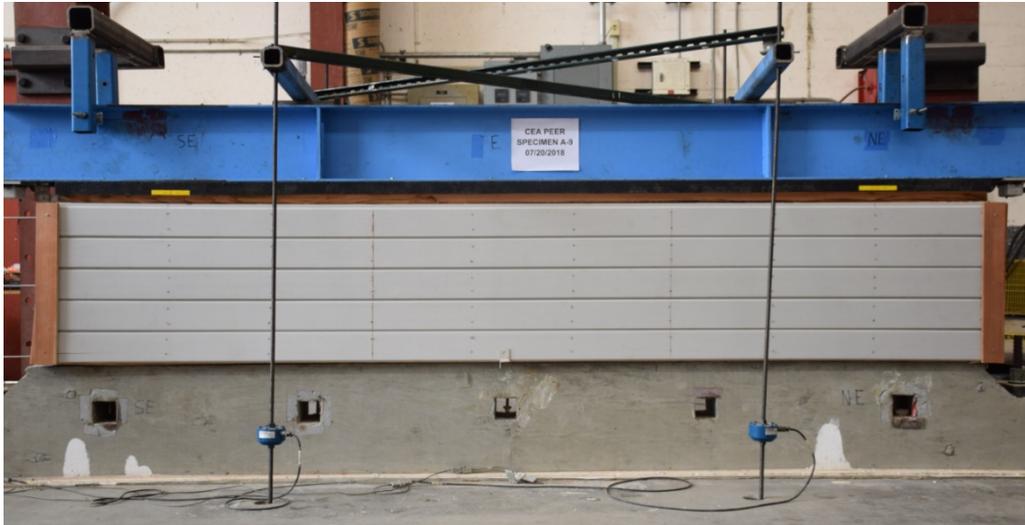
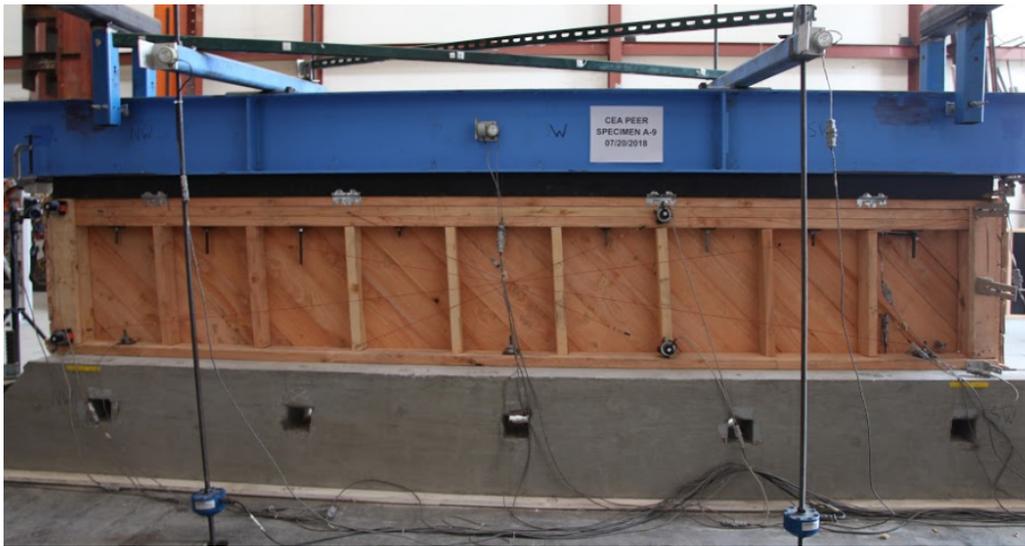
Figure 4.29 Specimen A-9 damage state of at lateral strength in pull direction at -10% drift ratio level @ $\Delta = -2.40$ in.: (a) exterior elevation; and (b) interior elevation.

From 7% drift to 10% drift, Specimen A-9 continued to gain capacity in the pull direction. This is due to the gaps between the sheathing boards closing, and the boards bearing on each other as seen in Figure 4.29(b). Once the sheathing boards began to bear down on each other, they began to act in unison like a wood structural panel. This phenomenon is the reason that the capacity of Specimen A-9 in the pull direction, 1713 plf, is comparable with that of Specimen A-7 (1831 plf averaged between push and pull) and Specimen A-13 (1770 plf averaged between push and pull). It is also the reason that the lateral strength in the push direction is 48% larger in the pull direction than the push direction. The strength that the sheathing provides is so large that it caused the studs to laterally displace by 1/4 in., as shown in Figure 4.30(a), which is the first instance of this happening for any existing cripple wall tested in this program. The large loads also caused the anchor bolts to bend significantly, and a large crack formed in the sill plate at the south end of the wall, as seen in Figure 4.30(c) and Figure 4.30(f), respectively. Cracks also formed on studs; see Figure 4.30(b). On the exterior face, additional cracks formed on the siding boards at the corners, as shown in Figure 4.30(e).

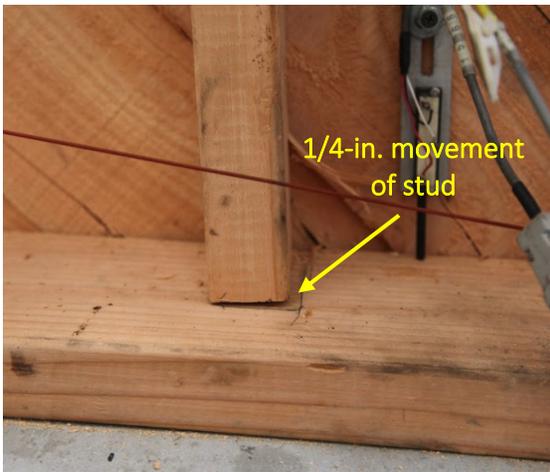
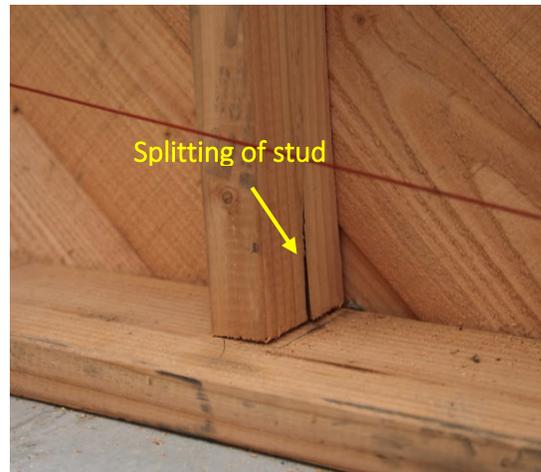
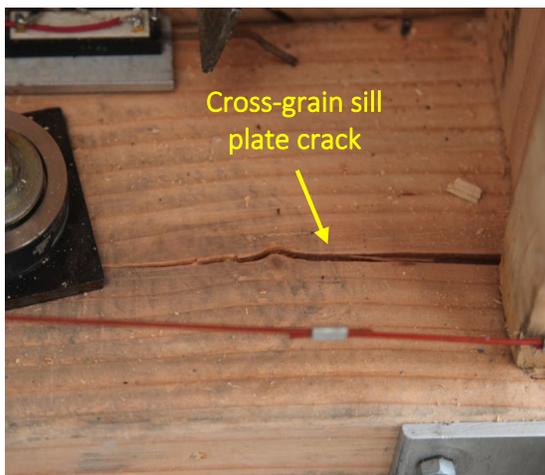
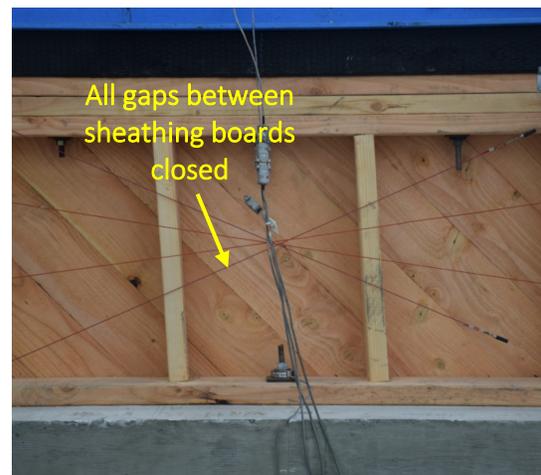
Figure 4.30 Specimen A-9 damage state details for at lateral strength in pull direction at -10% drift ratio level @ $\Delta = -2.40$ in.: (a) bottom interior of wall view; (b) bottom interior of wall view; (c) bottom of south-end interior of wall view; and (d) middle interior of wall view.

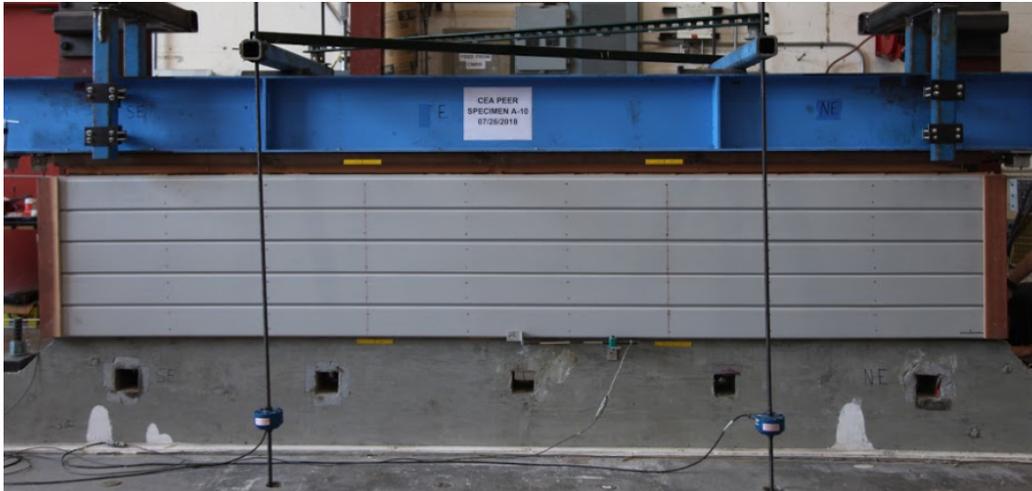
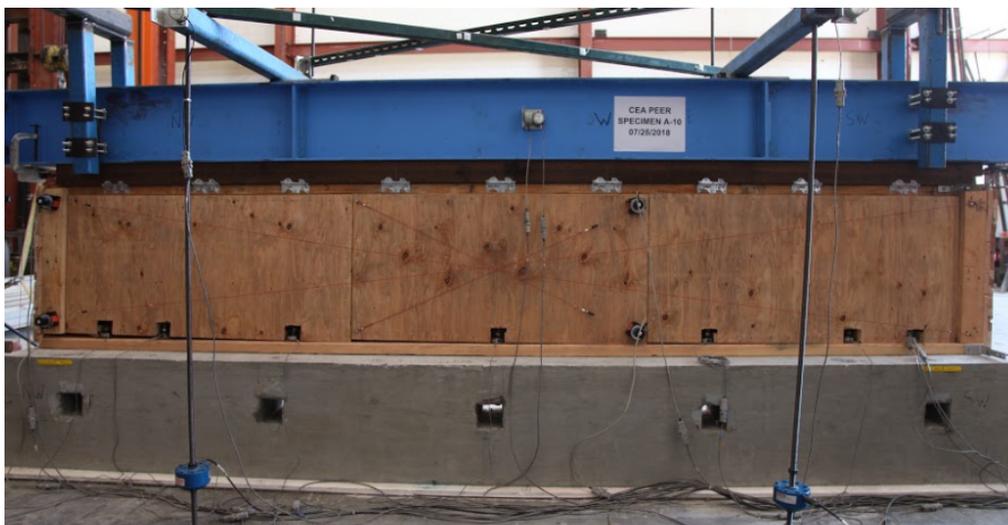
Figure 4.31 Specimen A-10 damage state at lateral strength at +7% drift ratio level @ $\Delta = +1.68$ in. and at -8% drift ratio level @ $\Delta = -1.92$ in.: (a) exterior elevation at +7% drift; (b) interior elevation at +7% drift.

Figure 4.31 shows the interior and exterior views of the cripple wall for Specimen A-10 at lateral strength. The lateral strength occurred at 8% global drift ratio in the push direction and 7% global drift ratio in the pull direction, and 4.5% relative drift ratio in the push direction and 3.6% relative drift ratio in the pull direction. The sill-to-foundation displacement accounted for 3.5% drift in the push direction and 3.4% drift in the pull direction. Unlike existing counterpart Specimen A-10, the response of the cripple wall was close to symmetric, indicating that the plywood originally dominated the response of the cripple. It should be noted that the cripple wall itself never experienced a drop of capacity in the pull direction. The decrease in lateral strength at subsequent displacement cycles was due a fracture in an anchor bolt. It is expected that the cripple wall would
