Cripple Wall Small-Component Test Program: Dry Specimens

**A Report for the “Quantifying the Performance of
Retrofit of Cripple Walls and Sill Anchorage in Single-
Family Wood-Frame Buildings” Project**

PEER Report 2020/17

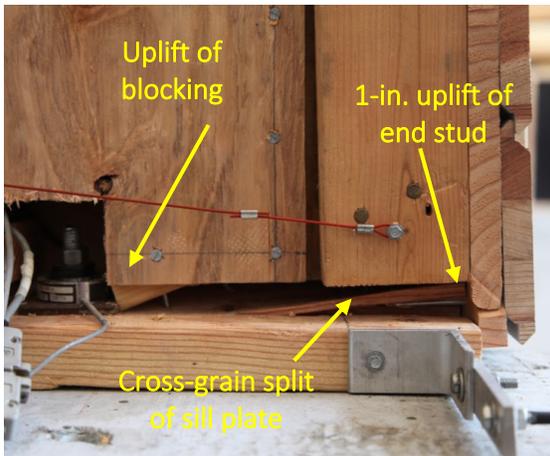
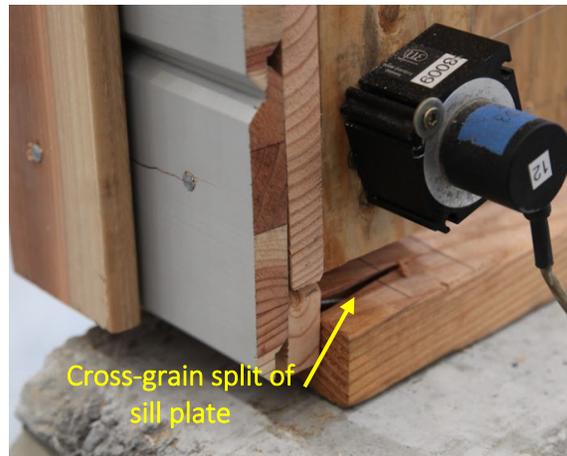
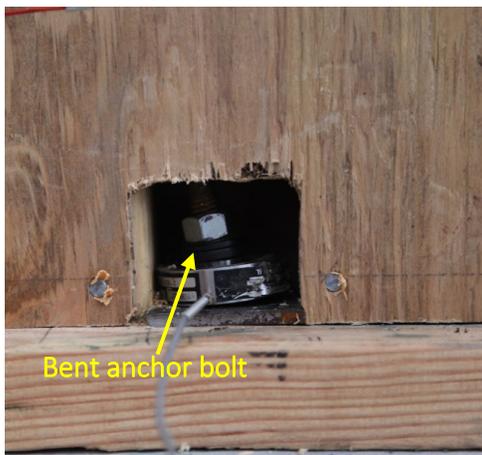
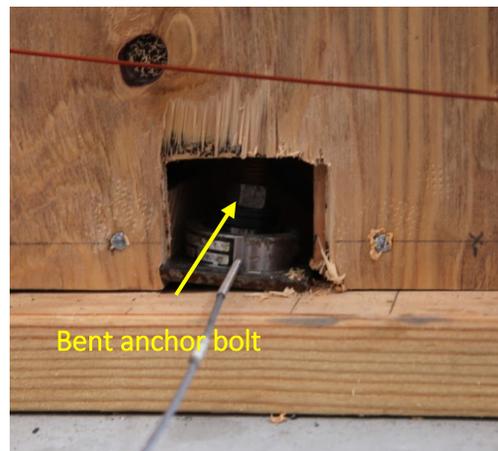
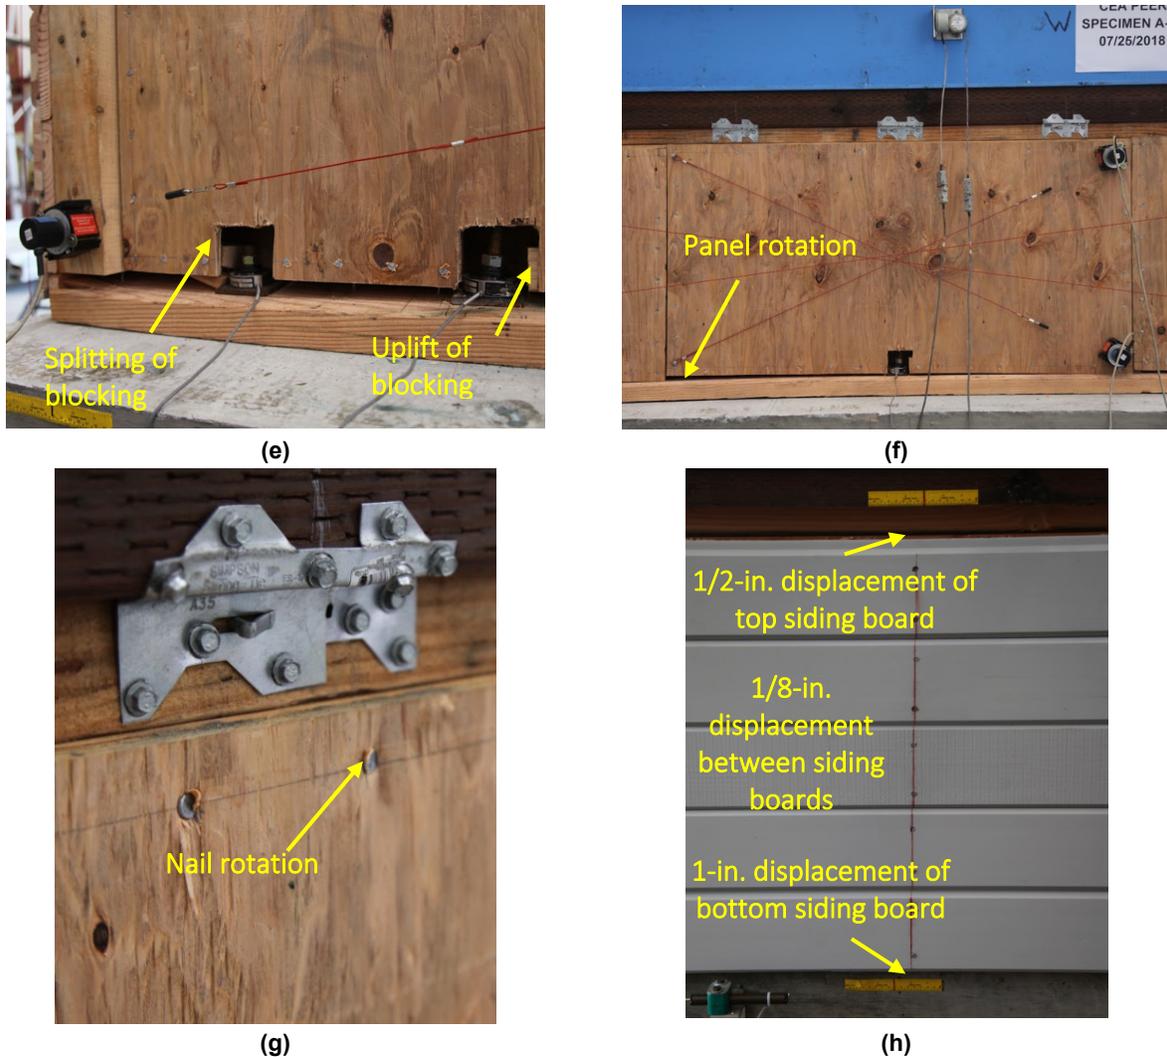
Figure 4.32 Specimen A-10 damage details at lateral strength at +7% drift ratio level @ $\Delta = +1.68$ in. and at -8% drift ratio level @ $\Delta = -1.92$ in.: (a) bottom of south-end interior of wall view at -8 drift; (b) bottom of north-end interior of wall corner view at -8 drift; (c) bottom of middle interior of wall view at +7% drift; (d) bottom of middle interior of wall view at -8% drift; (e) bottom of south-end interior of wall view at -8% drift; (f) middle interior of wall view at -8% drift; (g) top of middle interior of wall view at -8% drift; and (h) middle exterior of wall view at +7% drift.

Figure 4.32 shows close-up photographs of key damages to the cripple wall. The most significant damage to the cripple wall was experienced by the anchor bolts and the sill plate. At both ends, the sill plate cracked as the cripple wall uplifted, as shown in Figure 4.49(a) and (b). Figure 4.32(c) and (d) shows bent anchor bolts. These anchor bolts would fracture over increases in the next two displacement cycles. There was significant uplifting of the plywood panels and the blocking; see Figure 4.32(a), (b), and (e). Most of the blocking uplifted but did not split, which is the opposite of that experienced by Specimen A-8. This can be attributed to the diagonal sheathing providing a vertical force component to the cripple wall due to their 45° orientation. Minimal rotation of the nails attaching the plywood to the framing occurred, and no nails tore through the plywood or were pulled out of the framing; see Figure 4.32(g). On the exterior face, there were less than 1/8-in. displacements between the siding boards, which is the lowest of any cripple wall with horizontal siding. Both of these factors indicate that the cripple wall had additional capacity.

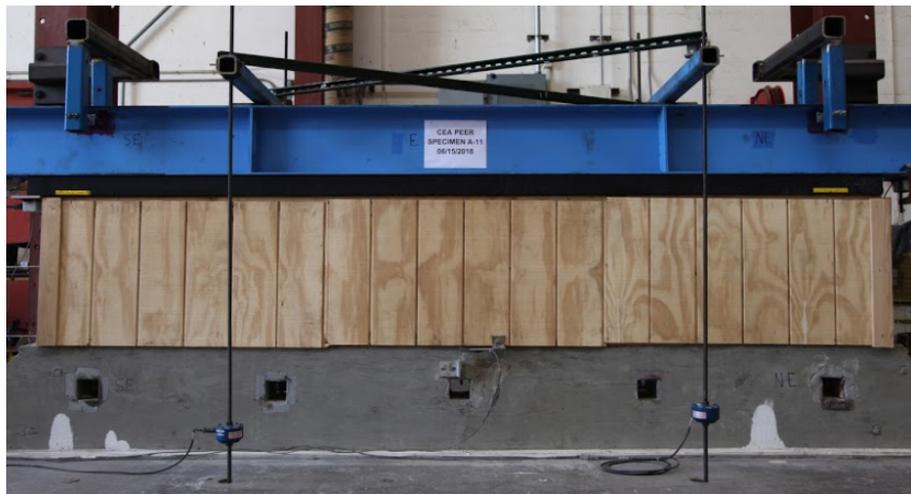
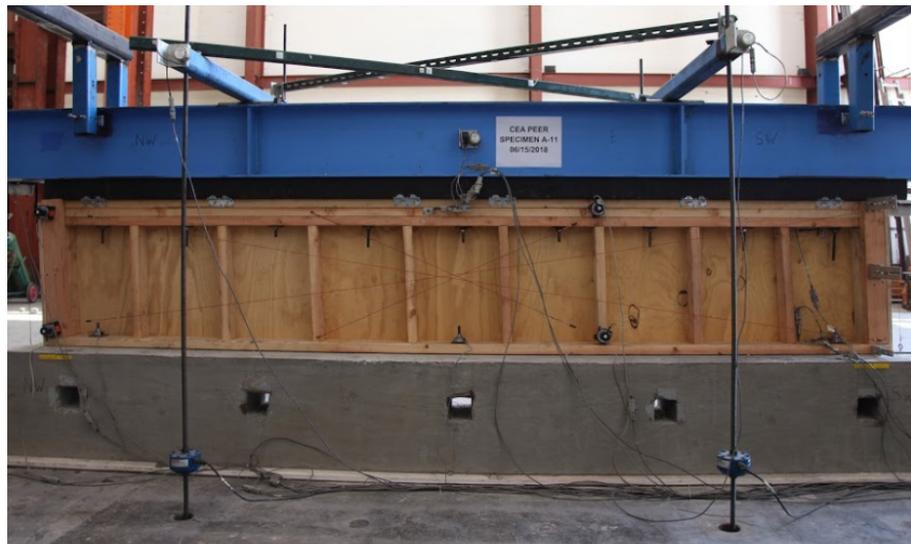
Figure 4.33 Specimen A-11 damage state at lateral strength at -5% drift ratio level @ $\Delta = -1.20$ in.: (a) exterior elevation; and (b) interior elevation.

Figure 4.33 shows the interior and exterior views of the cripple wall for Specimen A-11 at lateral strength (-5% drift). The lateral strength occurred at 6% global drift ratio in the push direction and 5% global drift ratio in the pull direction, and 4.8% relative drift ratio in the push direction and 4.6% relative drift ratio in the pull direction. The sill-to-foundation displacement accounted for 1.2% drift in the push direction and 0.4% drift in the pull direction. From 5% to 6% global drift ratio, the loads increased by 0.5% in the push direction and decreased by 3% the pull direction. Overall, the hysteretic response up to peak was nearly symmetric.

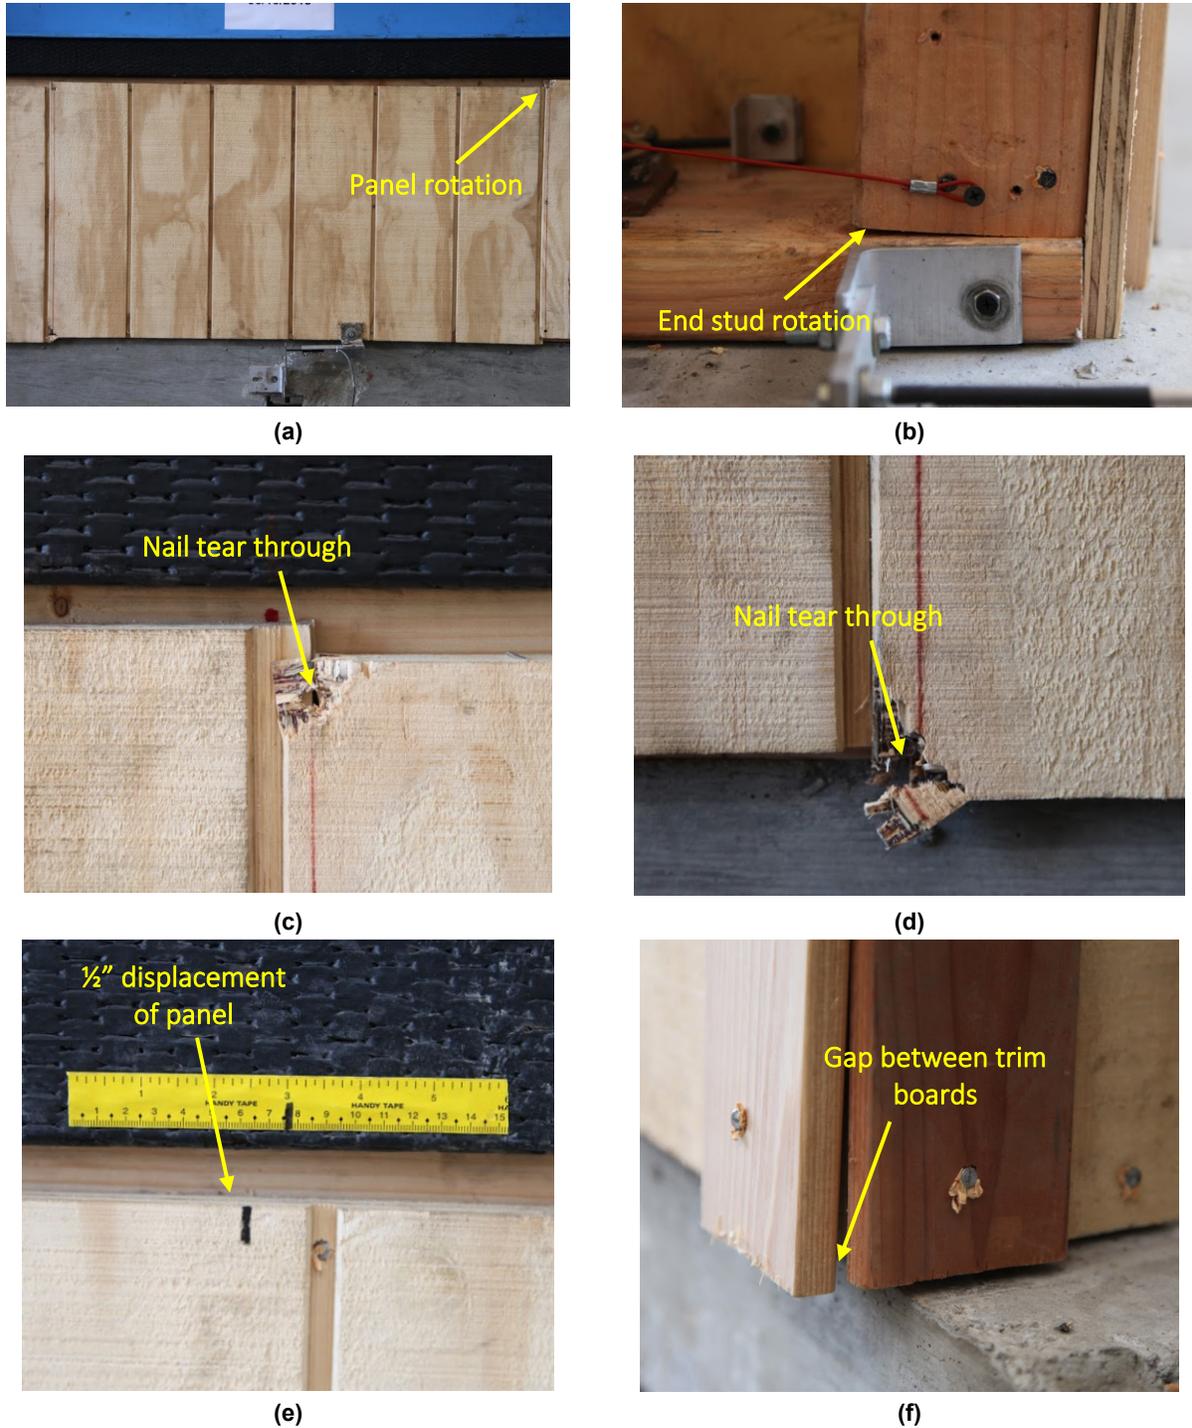
Figure 4.34 Specimen A-11 damage details at lateral strength at lateral strength at -5% drift ratio level @ $\Delta = -1.20$ in.: (a) middle exterior of wall view; (b) bottom of south-end interior of wall view; (c) top of middle exterior of wall view (south and middle panels); (d) bottom of middle exterior of wall view (south and middle panel); (e) top of south-end exterior of wall view; and (f) bottom of north-end exterior of wall corner view.

Figure 4.34 shows close-up photographs of the cripple at lateral strength. At strength, rotations of the panels occurred, which were visible from a distance as shown in Figure 4.33(a). Because the panels were not nailed on one edge—only compressed by the overlying panel—there was less resistance to rotation and ultimately less capacity of the cripple wall if compared with panels having been fastened around their entire perimeter. Figure 4.34(c) and (d) show the underlying panel displacing from the overlying panel as well as the nails on the overlying panel

tearing through the T1-11 plywood. The nails on the top and bottom of the panel had rotated heavily and were near pulling through the grooves in the T1-11 panel, as shown in Figure 4.34(e). This photograph shows that the top of the panels had displaced by 1/2 in. relative to the uppermost top plate, with the nails slightly withdrawn from the top plate. At subsequent displacement cycles, the cripple wall would lose capacity to these nails as full tearing through the grooves in the T1-11 panels occurred, leading to a dramatic loss in capacity. The corner trim boards skirted out at the bottom due to the bottom of the T1-11 panels pushing them outward as the bottom, creating a gap between the siding boards [Figure 4.34(f)] as well as a gap between the sill plate and the T1-11 panels.

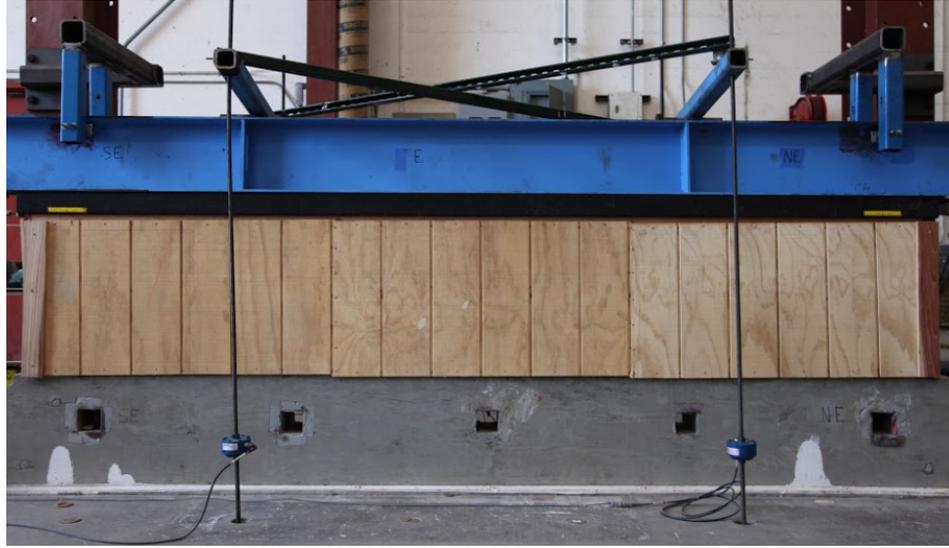
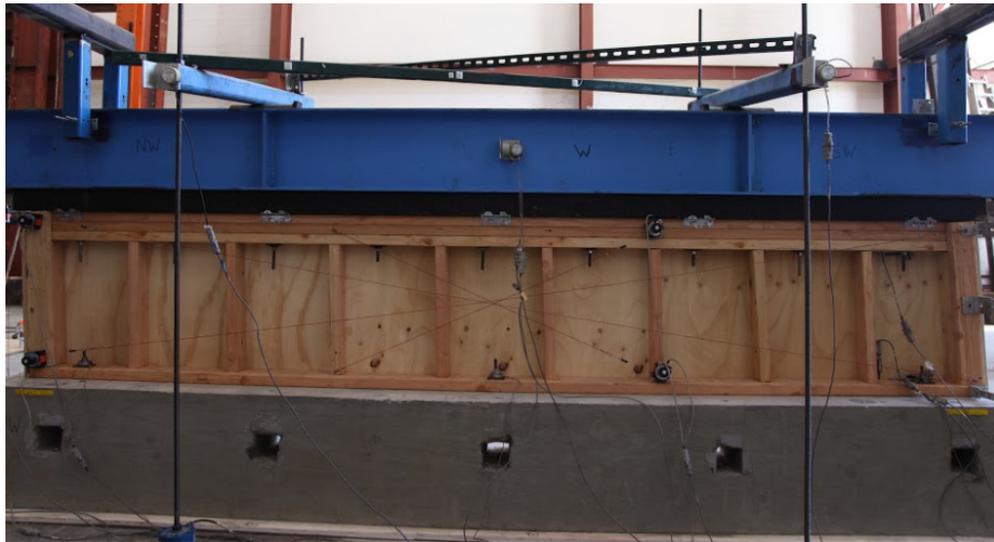
Figure 4.35 Specimen A-12 damage state at lateral strength at +7% drift ratio level @ $\Delta = +1.68$ in.: (a) exterior elevation; (b) interior elevation.

Figure 4.35 shows the interior and exterior views of the cripple wall for Specimen A-12 at lateral strength (+7% drift). The lateral strength occurred at 7% global drift ratio in the push direction and 6% global drift ratio in the pull direction, and 4.0% relative drift ratio in the push direction and 4.4% relative drift ratio in the pull direction. The sill-to-foundation displacement accounted for 2.0% drift in the push direction and 1.6% drift in the pull direction. From 5% to 7% global drift ratio, the lateral strength increased by 2.9% in the push direction and 1.1% in the pull direction. The cripple wall reached 80% of its peak load in the push and pull direction by 3% global drift ratio. Therefore, the cripple wall reached strength early and maintained its load for a large increase in displacement amplitude. Overall, Specimen A-12 had one of the largest drift capacities and symmetric responses of the cripple walls tested in this program. This can be accredited to the properties of the T1-11 panels and the even nailing over the entire perimeter of the panel.

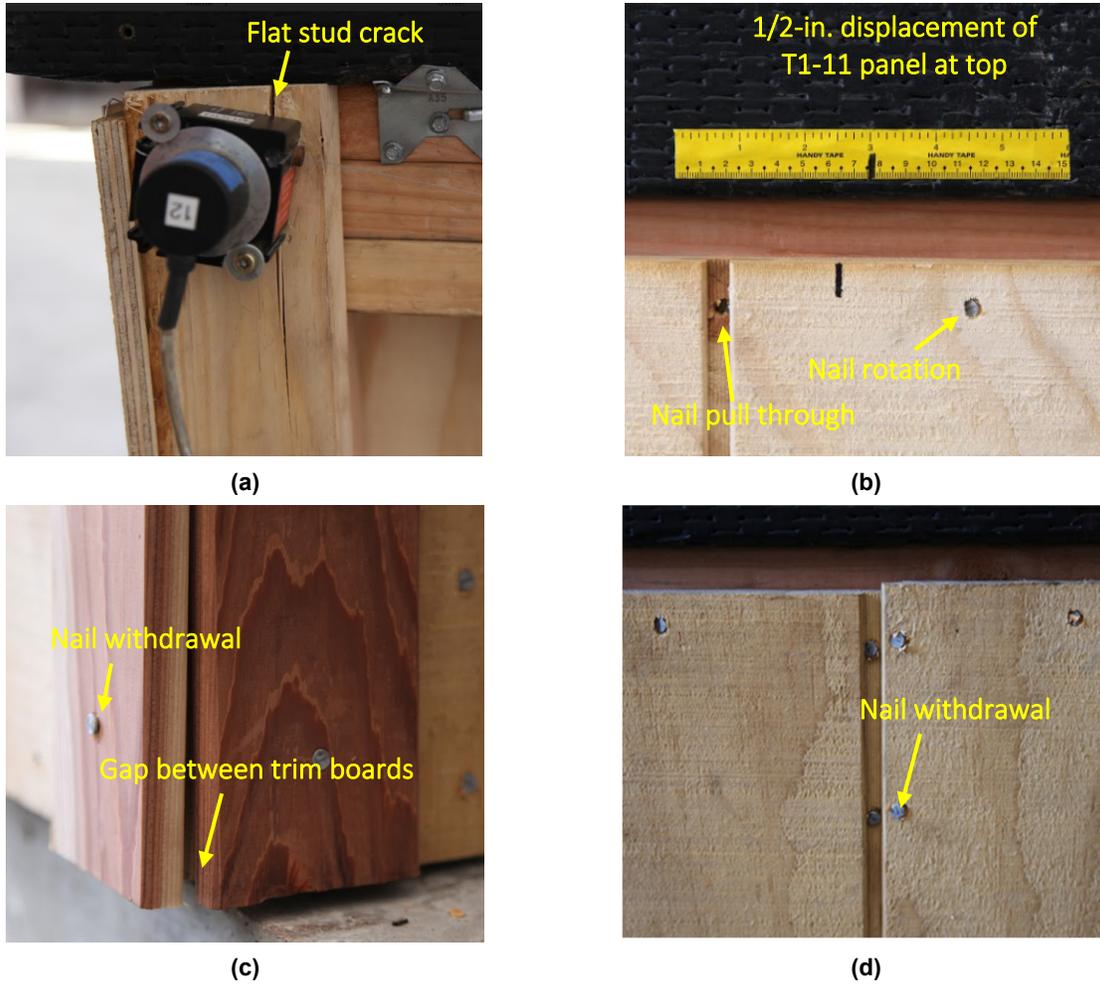
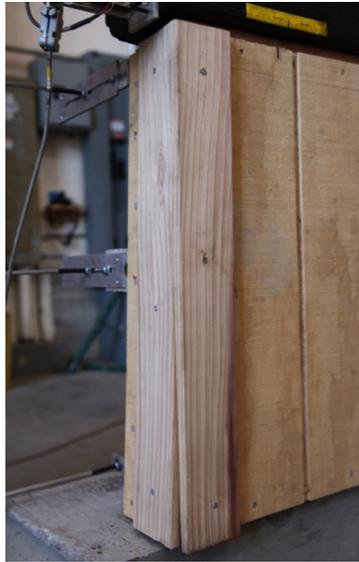
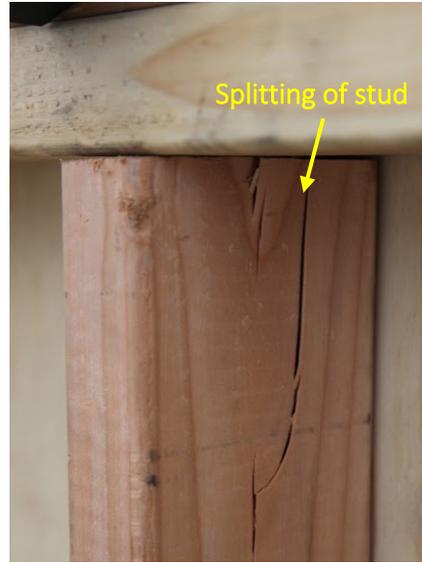
Figure 4.36 Specimen A-12 damage details of damage at lateral strength at +7% drift ratio level @ $\Delta = +1.68$ in.: (a) top of south-end interior of wall view; (b) top of north-end exterior of wall view; (c) bottom of north-end exterior of wall corner view; (d) top of middle exterior of wall view (north and middle panel); (e) south-end exterior of wall view; and (f) top of middle interior of wall view.

Figure 4.36 shows close-up photographs of key areas, indicating the cripple wall had reached capacity. As with Specimen A-11, the top of the plywood panels had displaced 1/2 in. relative to the uppermost top plate, as shown in Figure 4.36(b), indicating that the fastening nails had slightly pulled out of the framing as well as having slightly pulled through the T1-11 panels for a total of around 1/2 in. At the panel overlaps, the nails on the underlying panel ripped through the edge of the panel, and the nails on the overlapping panel were close to ripping through the panel. In some cases, the nails only rotated or pulled slightly out of the framing; see Figure 4.36(d) and (f). There was an insipient tear through the nails in the grooves whereas the nails between the grooves had more heavily rotated; see Figure 4.36(b). The nails between the grooves were much more resistance to tearing through the panel due to the increased thickness of the panels in these areas. Figure 4.36(c) and (e) show a gap that formed between the corner trim boards at the bottom of the cripple wall, as was the case with its existing counterpart. This occurred as the bottom of the T1-11 panels skirted out. The panels maintained a close connection to the top plate and pulled away from the sill plate as displacement amplitudes increased.

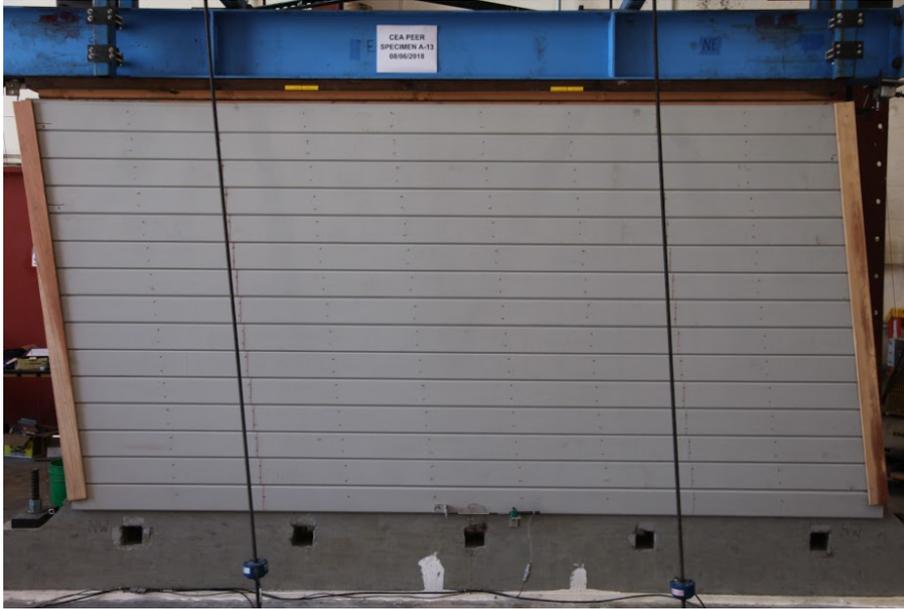
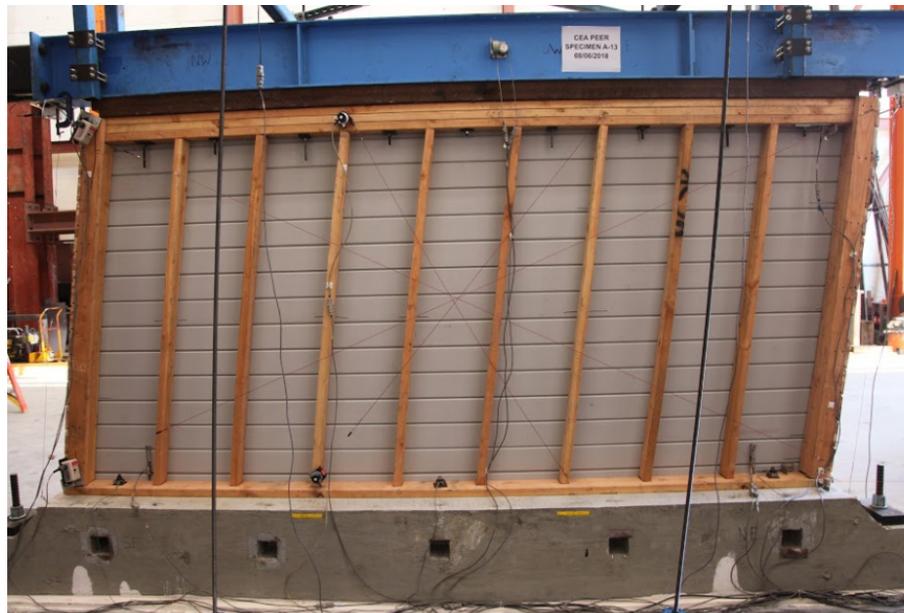
Figure 4.37 Specimen A-13 damage state of at lateral strength at -12% drift ratio level @ $\Delta = -8.64$ in.: (a) exterior elevation; and (b) interior elevation.

Figure 4.37 shows the interior and exterior views of the cripple wall for Specimen A-13 at lateral strength (-12% drift), which occurred at 11% global and relative drift ratio in the push direction and 12% global and relative drift ratio in the pull direction. Specimen A-13 did not experience any sill slip due to the lack of capacity to overcome the frictional resistance, thereby keeping the cripple wall in place. From 4% to 12% drift, there was only a 9.2% increase in capacity in the push direction and a 11.4% increase in capacity in the pull direction. The cripple wall showed no indications that the capacity of the wall was dropping at 12% drift. Due to the height and finish material of specimen, this was the most flexible cripple wall tested. It was the only cripple wall which a monotonic push was initiated before a drop in peak load occurred. Limitations of the instrumentation prevented larger displacements from being imposed. Specimen A-13 was also the weakest of any specimen by a wide margin. With an average peak load per linear foot between push and pull loading of 93 plf, what little resistance being provided was due to the nailing of the siding boards, the friction between the overlap of the siding boards, and the framing. There were no visual cues on both the interior and exterior face that the cripple wall showed damage to the siding boards, nails fastening the siding to the framing, or the framing; see Figure 4.37. The cripple wall was only heavily tilted. Figure 4.55 shows close-up photographs of the specimen at lateral strength. At this point, the displacement between each panel had reached a $\frac{1}{2}$ in.; see Figure 4.38(a). The bottom of the corner trim boards did not displace from each other, but they did at the top, opening a gap between the trim boards; see Figure 4.38(b), (c), and (d). There was significant rotation of the studs as shown by Figure 4.38(e).

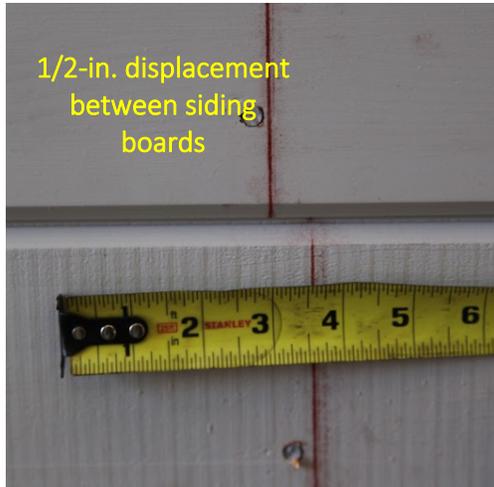
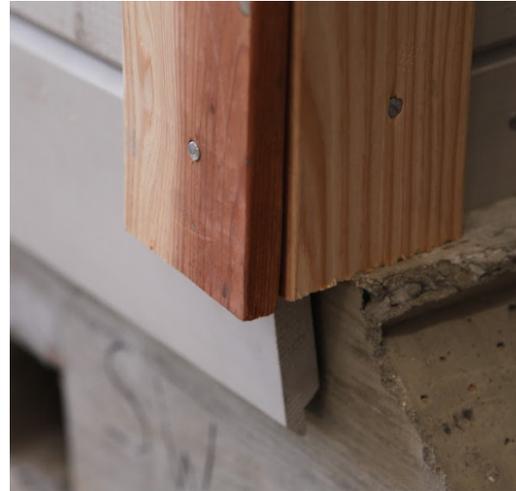
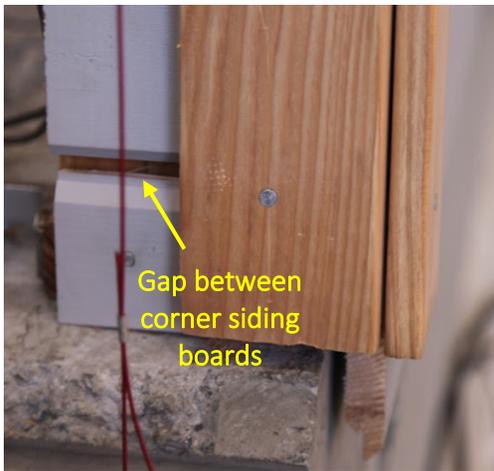
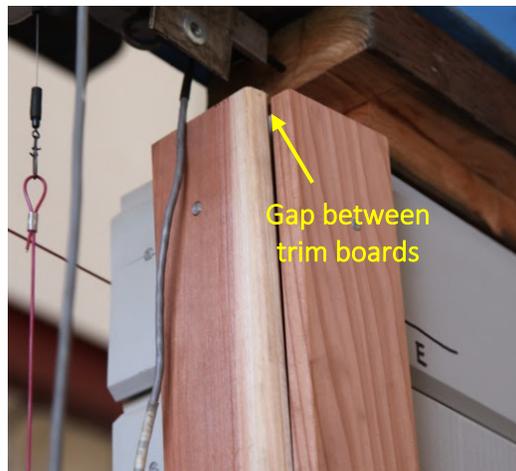
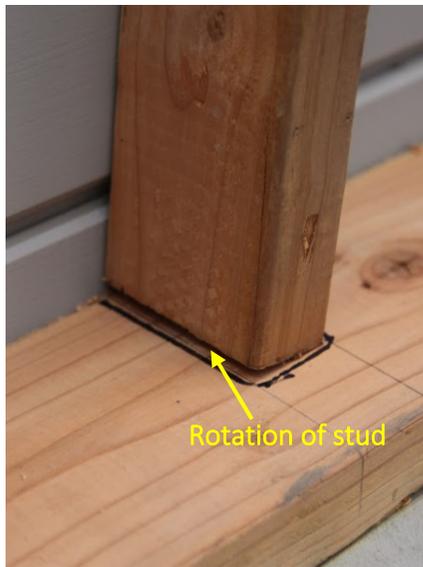
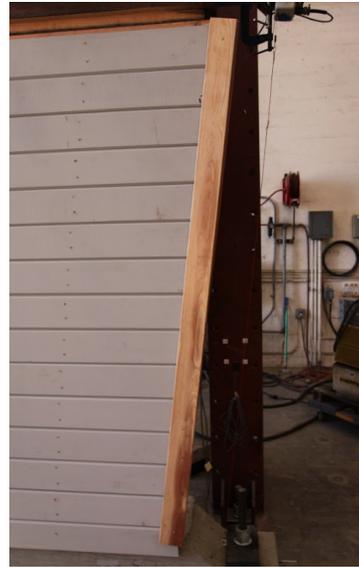
Figure 4.38 Specimen A-13 damage details at lateral strength at -12% drift ratio @ $\Delta = -8.64$ in. unless otherwise noted: (a) middle exterior of wall view; (b) bottom of north-end exterior of wall corner view; (c) bottom of south-end of wall corner view; (d) top of south-end exterior of wall corner view; (e) bottom of middle interior of wall view; and (f) north-end exterior of wall view at +11% drift.

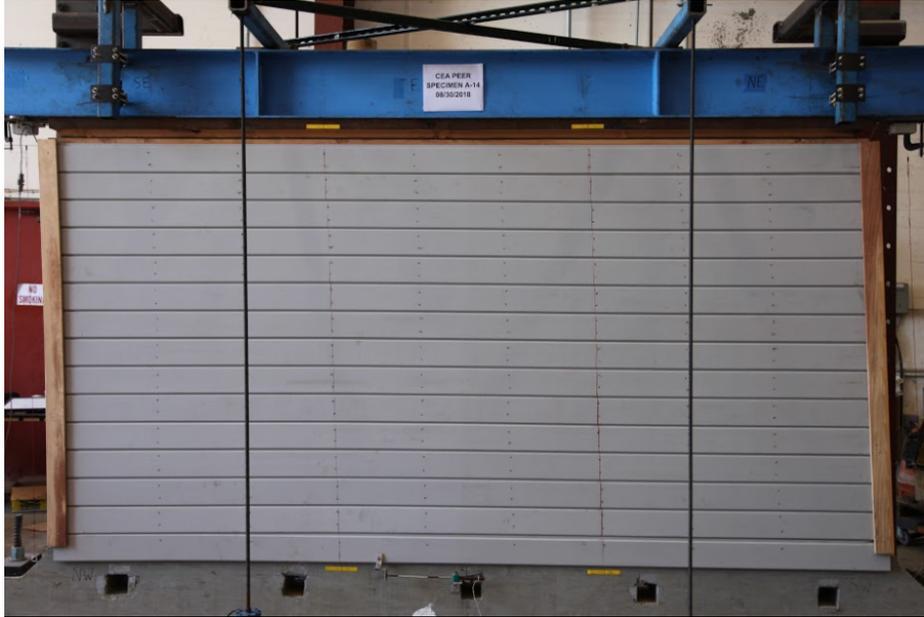
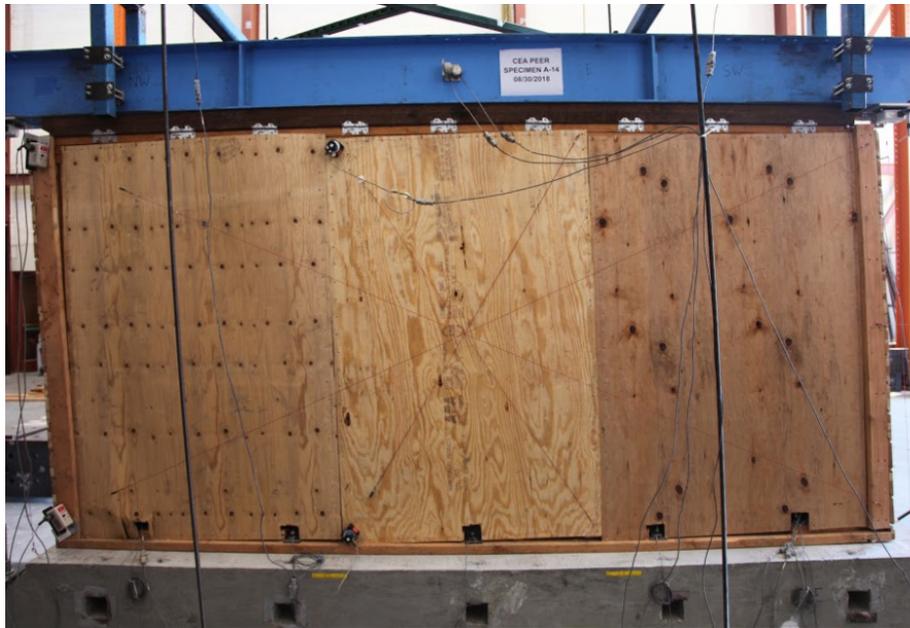
Figure 4.39 Specimen A-14 damage state at lateral strength at -5% drift ratio level @ $\Delta = -3.60$ in.: (a) exterior elevation; and (b) interior elevation.

Figure 4.39 shows the interior and exterior views of the cripple wall for Specimen A-14 at lateral strength (-5% drift), which occurred at 5% global drift ratio in the push and pull direction and 3.5% relative drift ratio in the push and pull direction. The sill-to-foundation displacement accounted for 1.5% drift in the push and pull direction. Specimen A-14 had the most symmetric hysteretic response up to lateral strength of any of the cripple walls tested in this report. The damage accrued by lateral strength were symmetric on both ends of the cripple wall. Due to the taller height and the large lateral strength, this cripple wall experienced the most uplift of any of the cripple walls even with the presence of hold-downs at both corners.

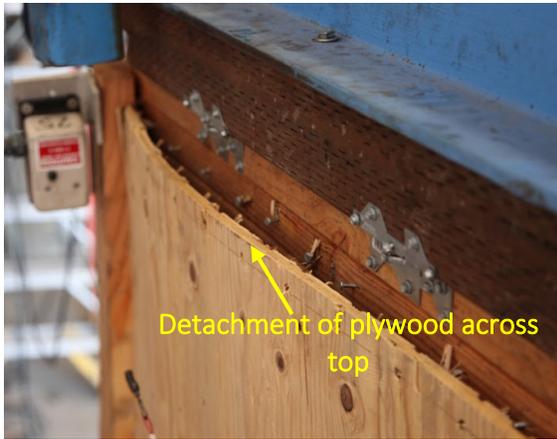
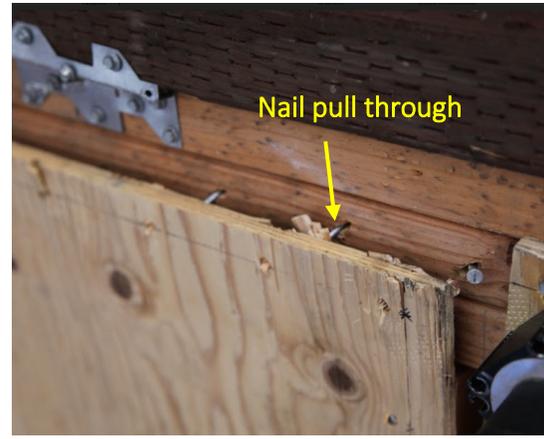
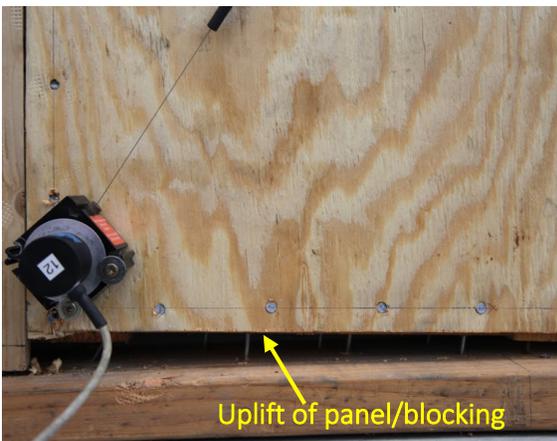
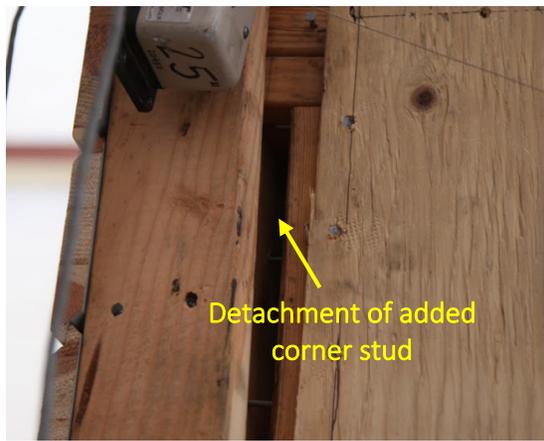
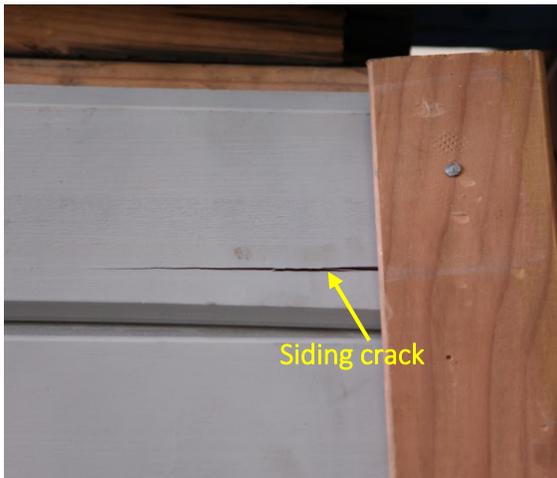
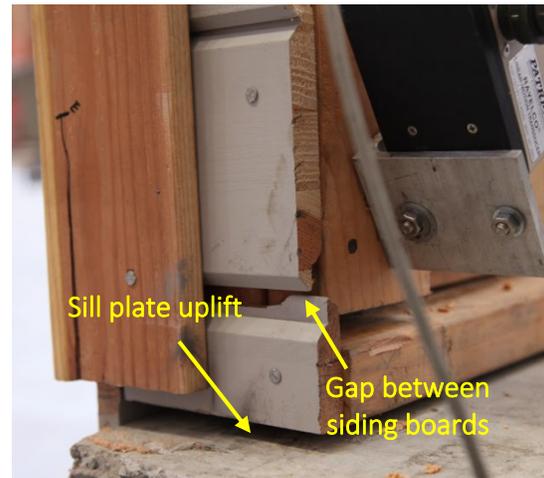
Figure 4.40 Specimen A-14 damage state details at lateral strength at +5% drift ratio @ $\Delta = +3.60$ in. and -6% drift ratio @ $\Delta = -4.32$ in.: (a) top of north-end interior of wall view at 5% drift; (b) top of south-end interior of wall view at +5% drift; (c) bottom of north-end interior of wall view at -6% drift; (d) top of north-end interior of wall view at -6% drift; (e) top of north-end exterior of wall at -6% drift; and (f) bottom of north-end of wall corner view at +5% drift.

Figure 4.40 shows close-up photographs of Specimen A-14 at lateral strength. At peak load the plywood panels detached from the top plate by way of the nails pulling through the plywood, as seen in Figures 4.40(a) and (b). The nails remained fastened to the blocking at the sill plate and caused the blocking to uplift; see Figure 4.40(c). The nails pulled through the plywood at the top instead of the bottom of the cripple wall because the top plates were more restrained than the blocking attached to the sill plate. Once the plywood panels had lost attachment at the top, the cripple wall lost capacity. Intrinsic to a taller wall is increased flexure. This is shown by the detachment of the corner studs added for plywood attachment at the top of the cripple wall and not the bottom; see Figure 4.40(d). Not only was there uplift of the blocking, but the sill plate experienced 3/8-in. uplift at lateral strength. On the exterior face of the cripple wall, cracks formed on the upper siding boards at the corners, as shown in Figure 4.40(e). The corner trim boards remained uncracked.

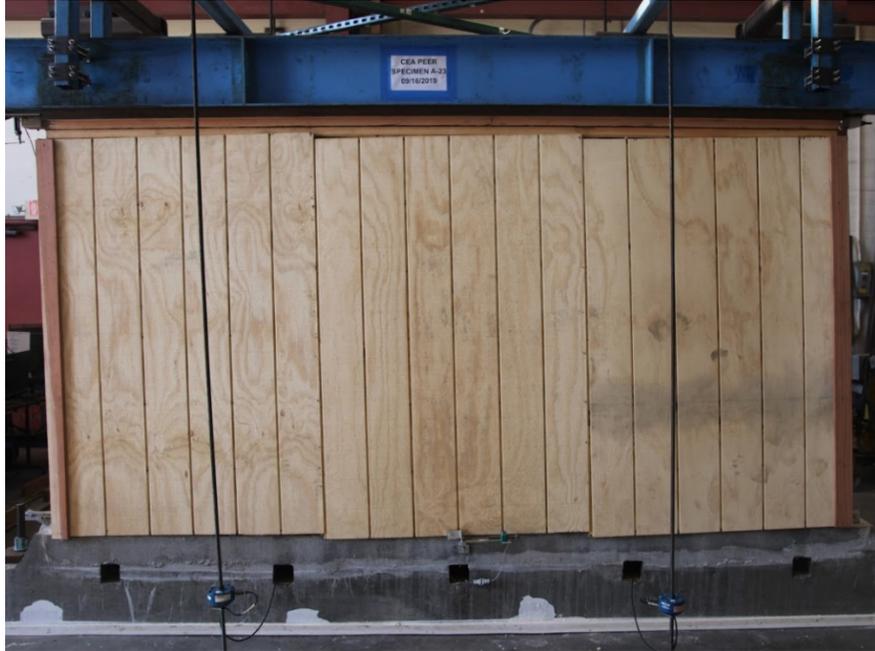
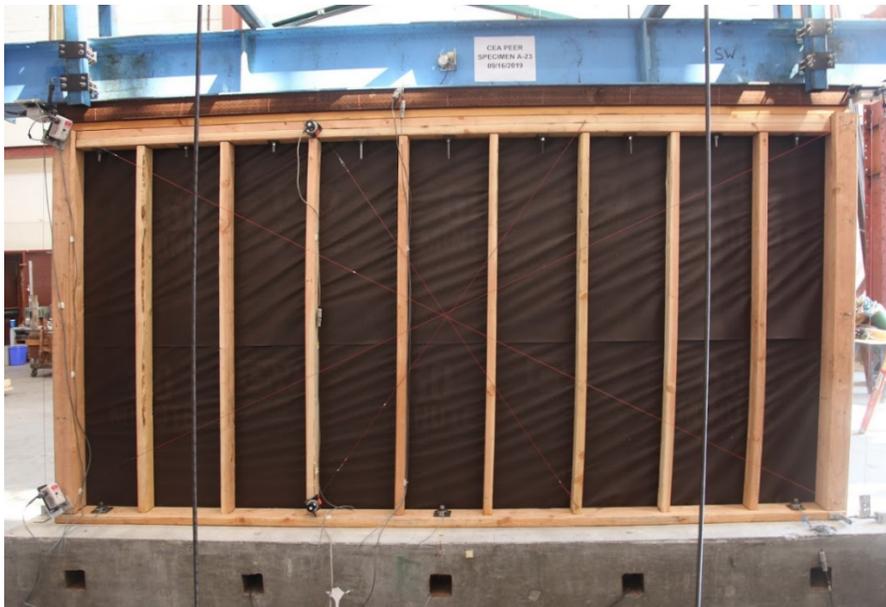
Figure 4.41 Specimen A-23 damage state at lateral strength at -2% drift ratio level @ $\Delta = -1.44$ in.: (a) exterior elevation; and (b) interior elevation.

Figure 4.41 shows the exterior and interior elevations of the cripple wall at lateral strength (-2% drift), which was achieved at 3% global and relative drift ratio in the push direction and 2% global and relative drift ratio in the pull direction, i.e., that the cripple wall did not have any displacement of the sill plate relative to the foundation at lateral strength. The sill plate did not displace because the lateral strength of the cripple wall was not higher than the resistance to displacement from the friction between the sill plate and the foundation as well as the anchor bolts. At lateral strength, the T1-11 panels had rotated heavily, as shown in Figure 4.41(a). Little damage was visible from the elevation view of the interior face. The building paper showed no tearing, but the studs were bending.

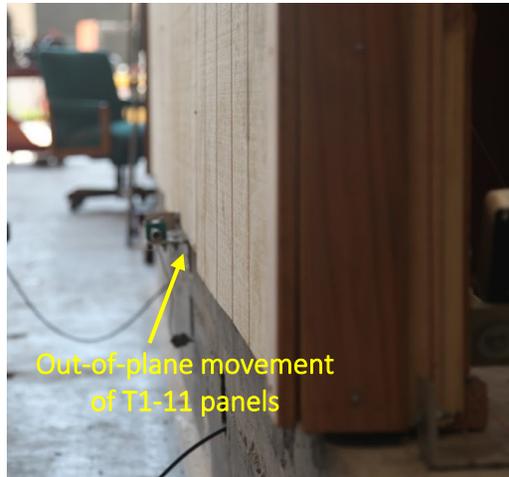
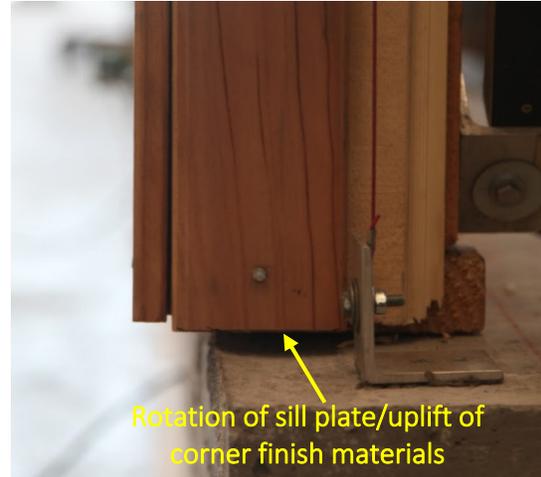
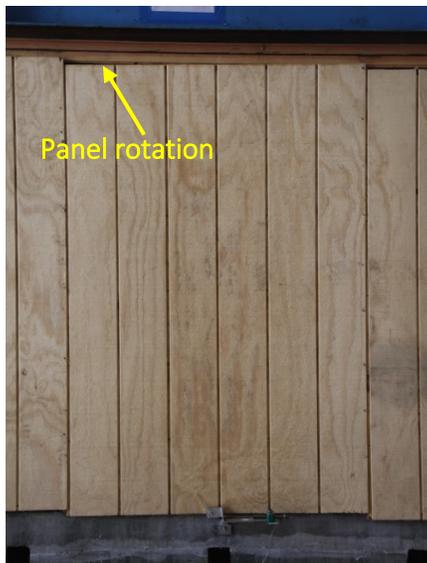
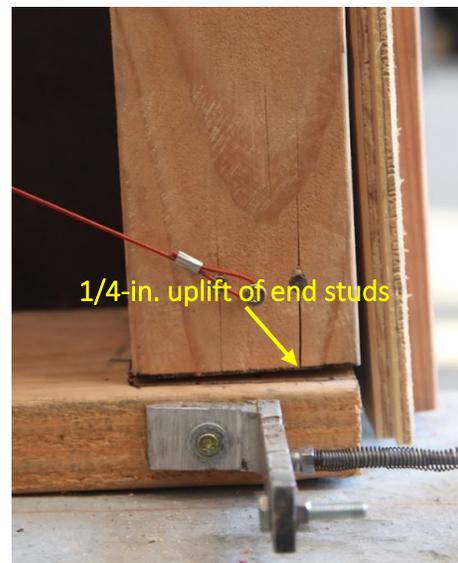
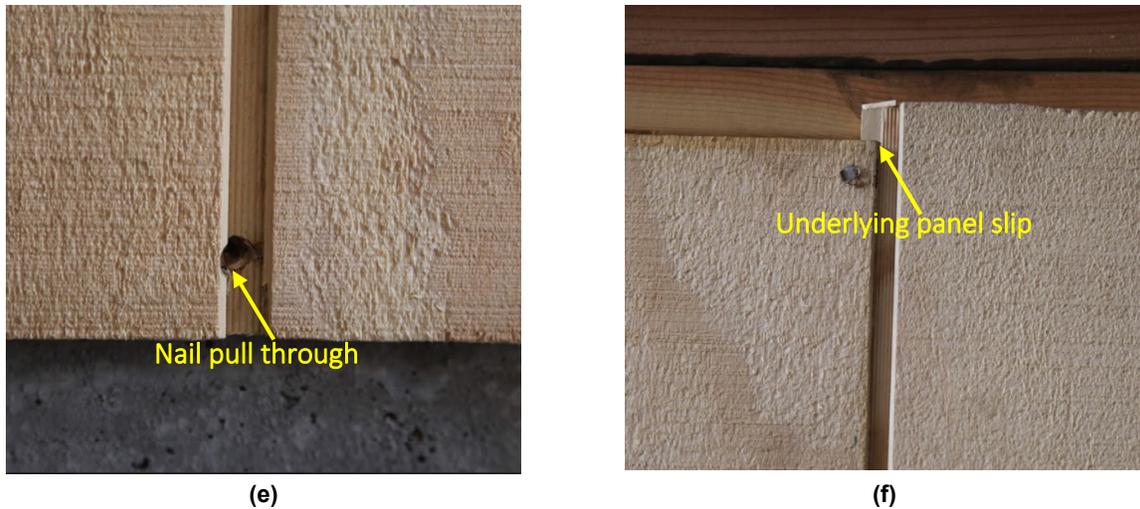
Figure 4.42 Specimen A-23 damaged details at lateral strength at -2% drift ratio @ $\Delta = -1.44$ in. unless otherwise noted: (a) bottom of north-end exterior of wall corner view; (b) bottom of north-end of wall corner view; (c) middle exterior of wall view at +3% drift; (d) bottom of north-end interior of wall view at +3% drift; (e) bottom of middle exterior of wall; and (f) top of middle exterior of wall view (south and middle panels)

Figure 4.42 gives close-up photographs of the specimen at lateral strength. Figure 4.42(a) shows that the panels were pulling away from the sill plate, with the largest gap formed at the panel overlap where the underlying panel had no nails on that edge. At the sill plate, many of the nails had pulled through the T1-11 panels; see Figure 4.42(e). The sill plate shows less uplift and rotation than in previous displacement cycles due to the reduced amount of nailing attaching the sill plate to panels, i.e., the nails pulling through the panel at the sill plate; see Figure 4.42(b). At the corners, the studs had uplifted 1/4 in. from the sill plate. Along the overlap joints of the T1-11 panels, the underlying panel displaced relative to the overlying panel due to the confinement of the overlying panel on the underlying panel being primary source of resistance to its displacement; see Figure 4.42(f).

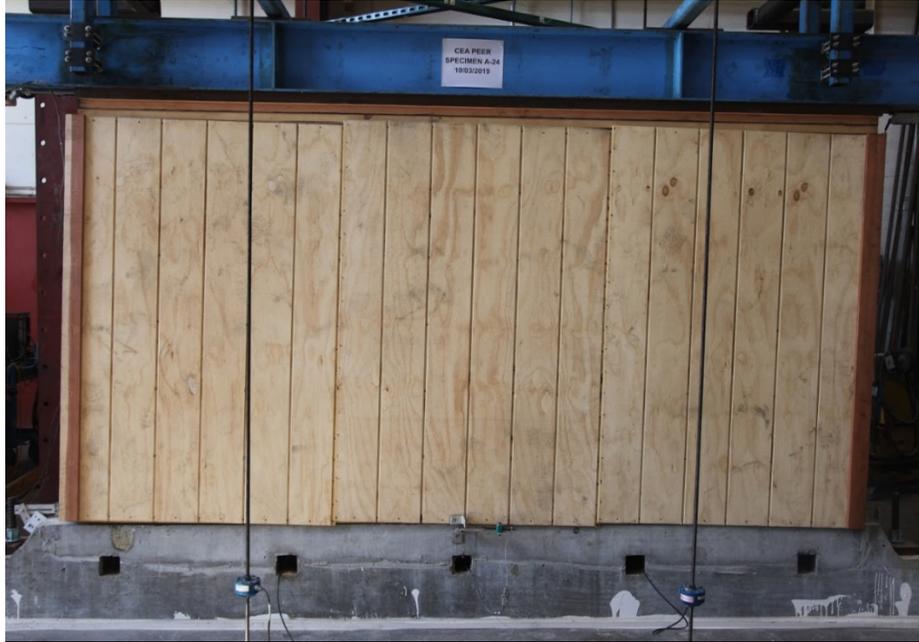
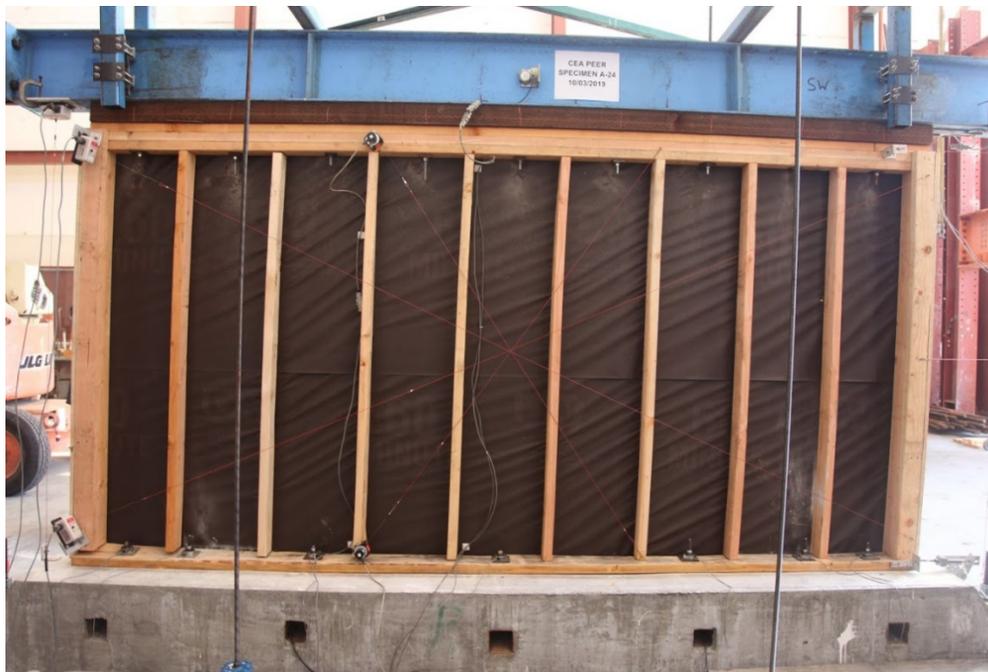
Figure 4.43 Specimen A-24 damage state of at lateral strength at +3% drift ratio @ $\Delta = +2.16$ in. and -2% drift ratio @ $\Delta = -1.44$ in.: (a) exterior elevation at -2% drift; and (b) interior elevation at +3% drift.

Figure 4.43 shows the interior and exterior views of the cripple wall for Specimen A-24 at lateral strength, which was achieved at 3% global and 2.9% relative drift ratios in the push direction and 2% global and relative drift ratios in the pull direction. The retrofitted cripple wall had little displacement of the sill plate relative to the foundation at lateral strength. While the strength of the wall was high enough to overcome the frictional resistance to the sill plate displacing along the foundation, the increased amount of anchor bolts prevented the movement of the sill plate from occurring. From the interior and exterior elevation, the cripple wall almost appears trapezoidal, i.e., there was significant uplift. The T1-11 panels also showed visible rotation from far away; see Figure 4.43(a).
