Cripple Wall Small-Component Test Program: Dry Specimens

**A Report for the “Quantifying the Performance of
Retrofit of Cripple Walls and Sill Anchorage in Single-
Family Wood-Frame Buildings” Project**

PEER Report 2020/17

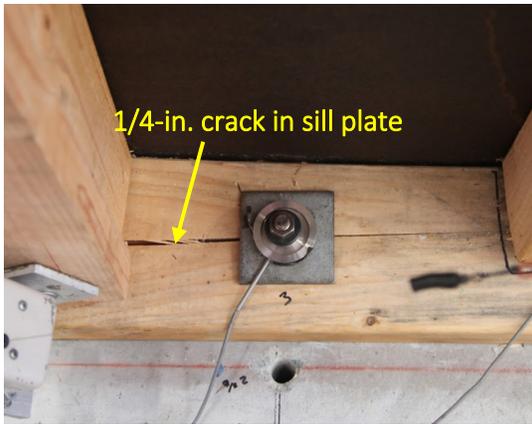
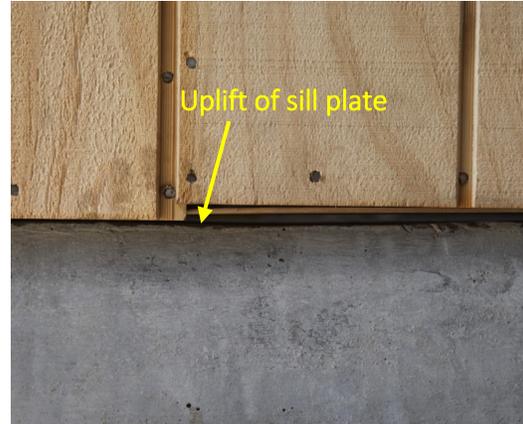
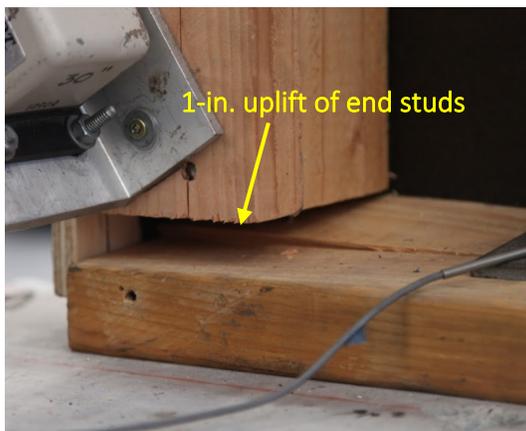
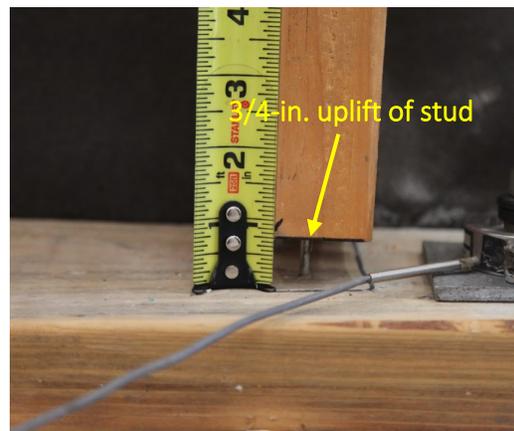
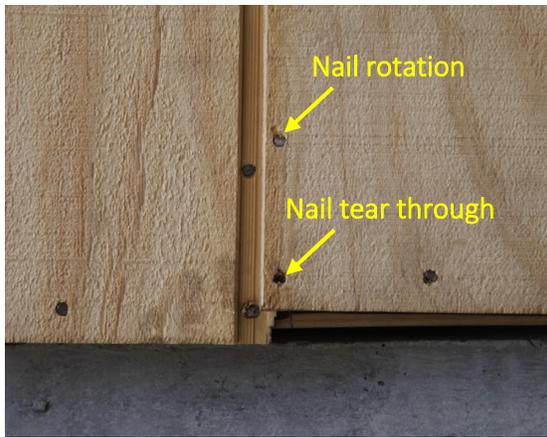
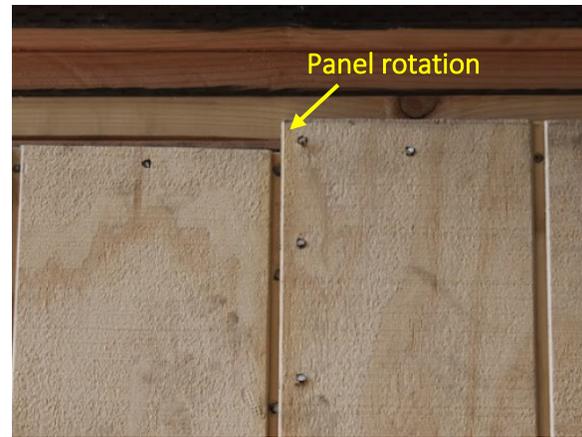
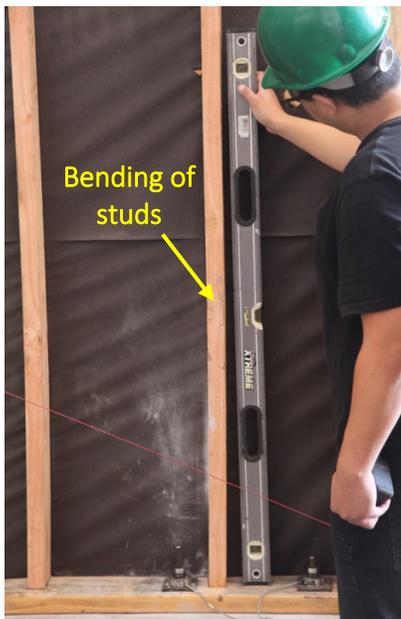
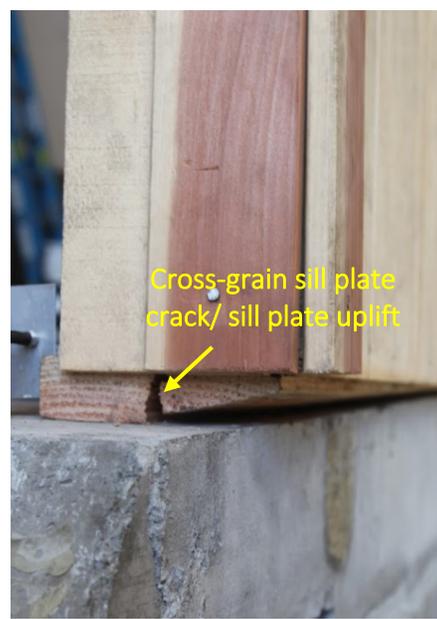
Figure 4.44 Specimen A-24 damage details at lateral strength at -2% drift ratio @ $\Delta = -1.44$ in. unless otherwise noted: (a) bottom of north-end interior of wall view; (b) bottom of exterior of wall view (north and middle panels); (c) bottom of north-end interior of wall view; (d) bottom of middle interior of wall view; (e) bottom of exterior of wall view (south and middle panels); (f) top of exterior of wall view (south and middle panels); (g) south-end interior of wall view at +3% drift; and (h) bottom of south-end of wall corner view.

Close-up photographs of the damage can be seen in Figure 4.44. The corner studs were uplifted 1 in. from the sill plate on the interior face of the cripple wall and uplifted as well along the span of the sill plate. At this point, three-quarters of the studs showed visible uplift, with studs close to the center of the wall uplifted around 3/4 in.; see Figure 4.44(d). The cross-grain cracks in the sill plate at the ends of the wall continued to increase in size and length. The sill plate remained resting on the foundation along the interior face of the wall, while it is rotated and uplifted on the exterior face of the wall; Figure 4.44(h). From the finish face, a visible gap in the center of wall between the sill plate and the foundation can be seen in Figure 4.44(b). Along the T1-11 panels, nails that were connecting the thin sections of the 5/16-in.-thick T1-11 panels to the framing had pulled through or torn through the edges of the panel. The nails fastened to the 5/8-in.-thick sections of the T1-11 panels rotated; see Figure 4.44(e) and (f). There was visible bending of the studs as well; see Figure 4.44(g).

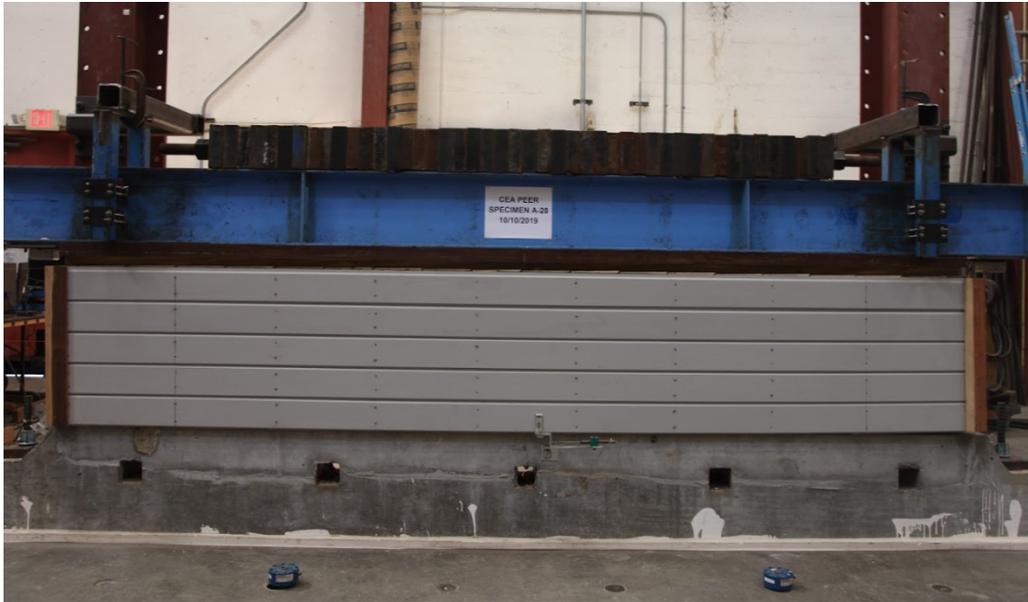
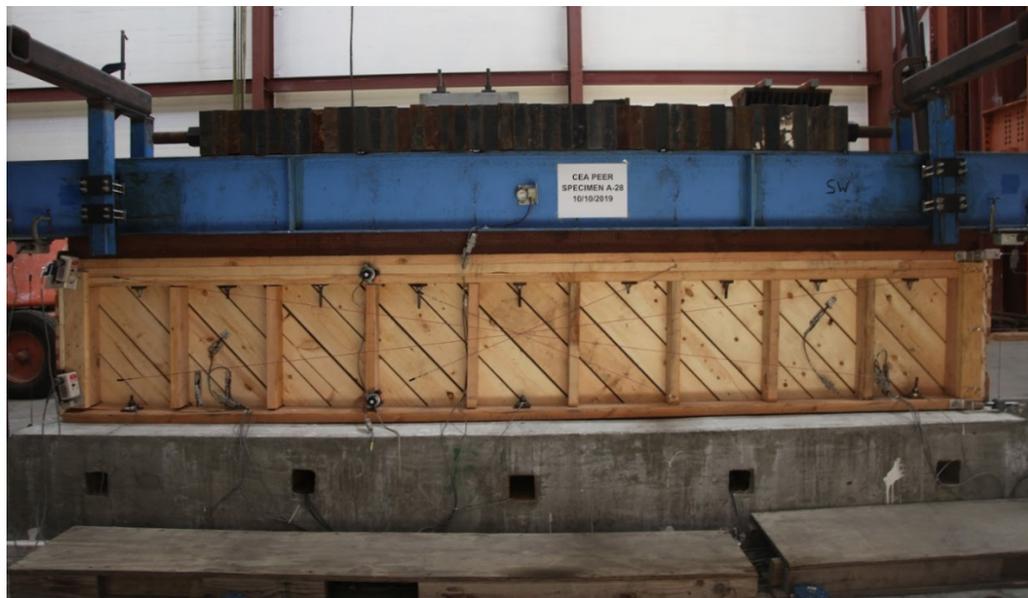
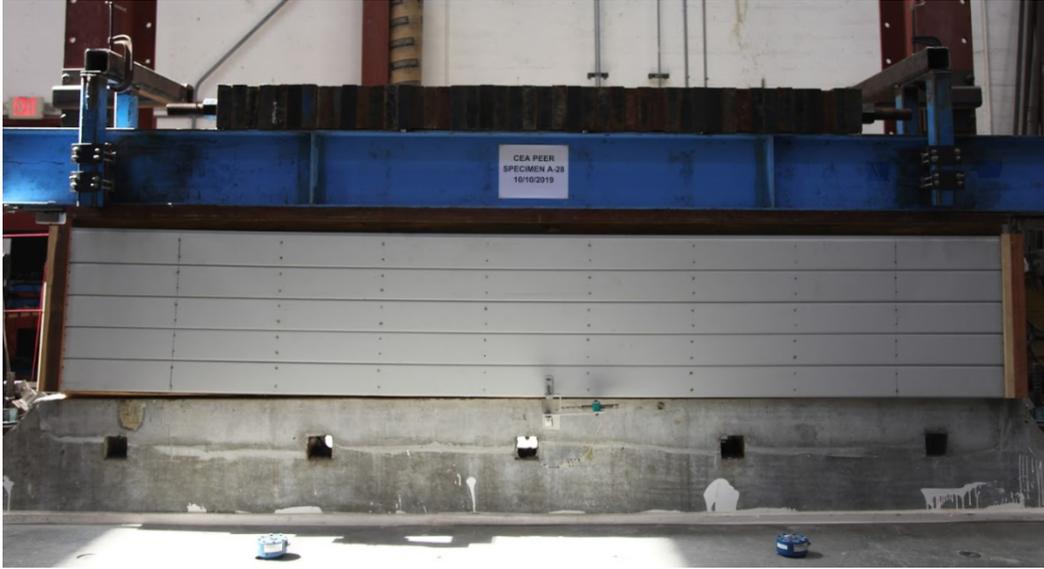
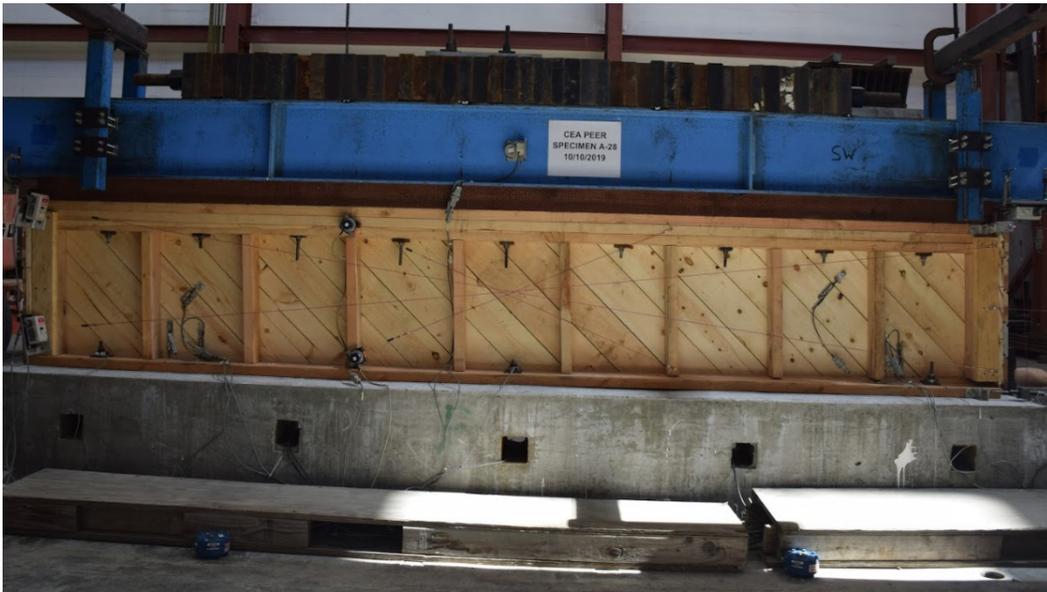
Figure 4.45 Specimen A-28 damage state at lateral strength at +5% drift ratio @ $\Delta = +1.20$ in. and -7% drift ratio @ $\Delta = -1.68$ in.: (a) exterior elevation at +5% drift; (b) interior elevation at +5% drift; (c) exterior elevation at -7% drift; and (d) interior elevation at -7% drift.

Figure 4.45(a) and (b) shows the interior and exterior views of the cripple wall for Specimen A-28 at lateral strength in the push direction. Figure 4.45(c) and (d) shows the interior and exterior views of the cripple wall for Specimen A-28 at lateral strength in the pull direction. The lateral strength occurred at 5% global drift and 3.4% relative drift ratios in the push 7% global drift and 4.2% relative drift ratios in the pull direction. The displacement of the sill plate relative to the foundation at lateral strength accounted for 1.6% drift in the push direction and 2.8% drift in the pull direction. Exterior and interior elevation of the cripple wall at lateral strength in both loading directions is shown. On the interior face of the cripple wall, the gaps between the sheathing boards have widened at lateral strength in the push direction [Figure 4.45(b)], and the gaps had closed at lateral strength in the pull direction; see Figure 4.45(d). The hysteretic response is highly asymmetric with a lateral strength of 786 plf in the push direction and 1123 plf in the pull direction.

This asymmetry is due to the orientation of the sheathing boards. When the gaps between the sheathing boards are fully closed, the bearing between the sheathing boards causes the strength of the wall to dramatically increase.

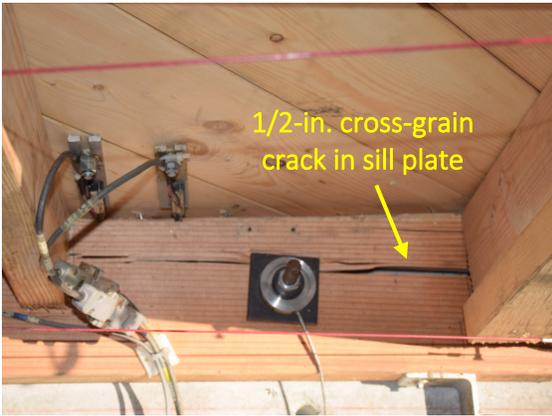
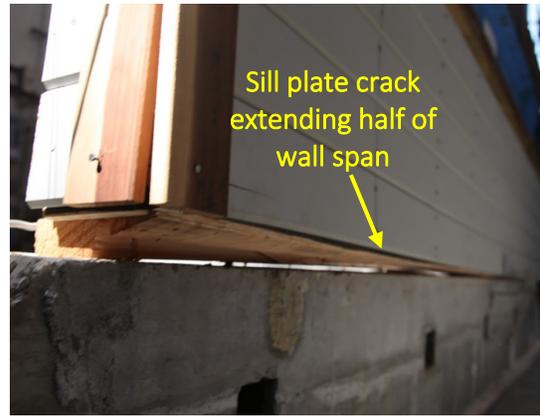
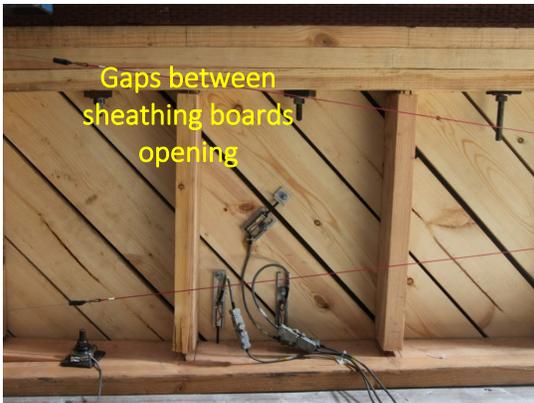
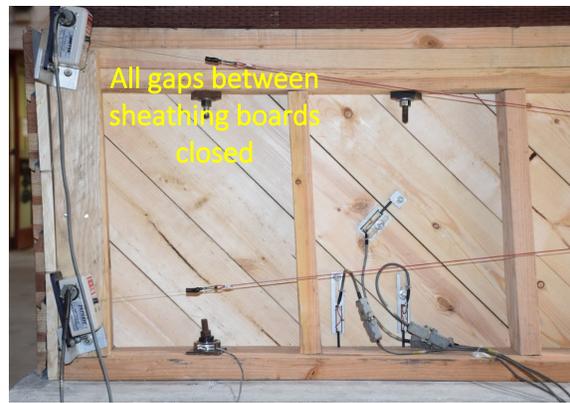
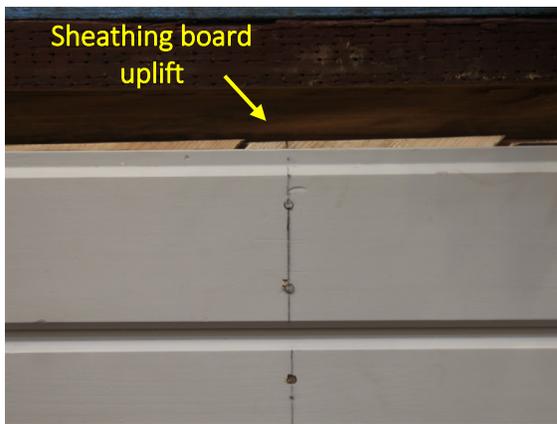
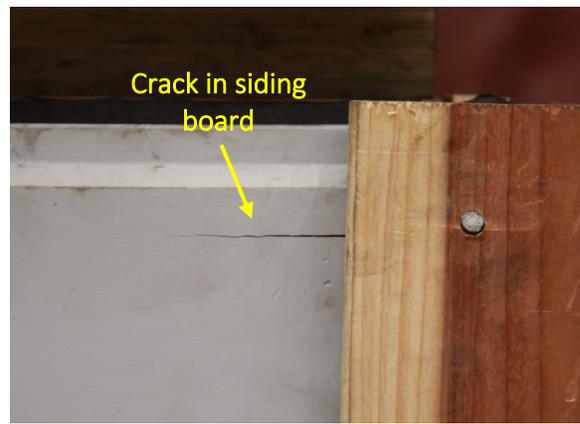
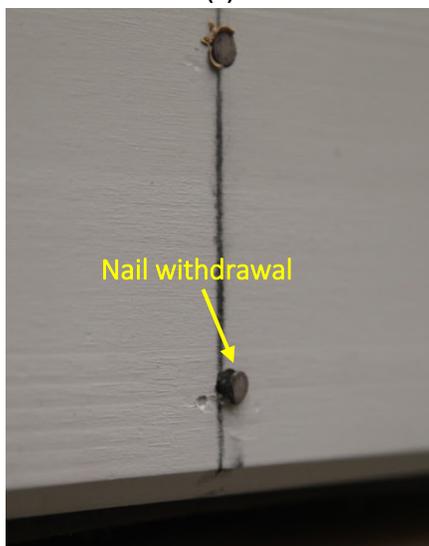
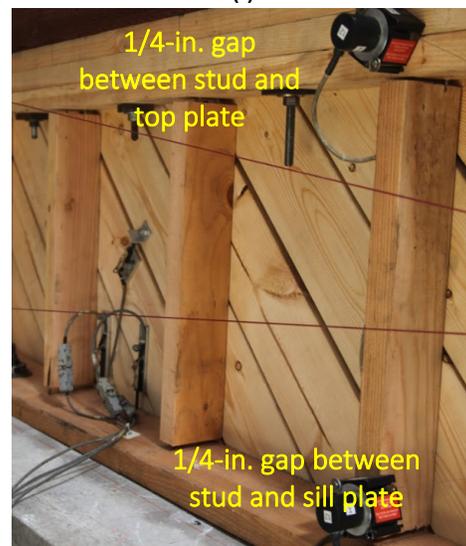
Figure 4.46 Specimen A-28 damage details at lateral strength at +5% drift ratio @ $\Delta = +1.20$ in. unless otherwise noted: (a) bottom of south-end interior of wall view; (b) bottom of south-end exterior of wall corner view; (c) north-end interior of wall view; (d) north-end interior of wall view at -7% drift; (e) top of middle exterior of wall view; (f) middle interior of wall view; and (h) middle interior of wall view.

Figure 4.46 shows close-up photographs of Specimen A-28 at lateral strength. The opening and closing of the gaps between the sheathing boards can be seen in Figure 4.46(c) and (d). The damage to the sill plate can be seen in Figure 4.46(a) and (b). Cracking of the sill plate on both ends extended through two stud bays at each end. The sill plate had uplifted across half of its span. When compared with the behavior of Specimen A-9, the increased amount of uplift is due to the decreased vertical load imposed on the cripple wall. There is also uplift attributed to the gap between the top plates and the studs, which was not observed in Specimen A-9. On the finish face of the wall, displacement between siding boards is visible as well as increased uplift of the sheathing boards; see Figure 4.46(e). Some cracking of the siding boards occurred at the corners, as seen in Figure 4.46(f). The nails attaching the siding to the sheathing and framing are slightly withdrawn; see Figure 4.46(g).

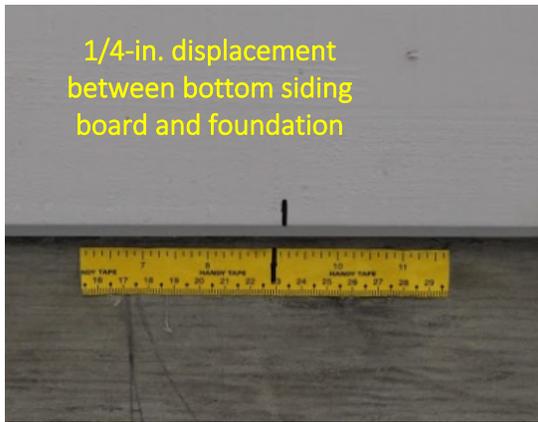
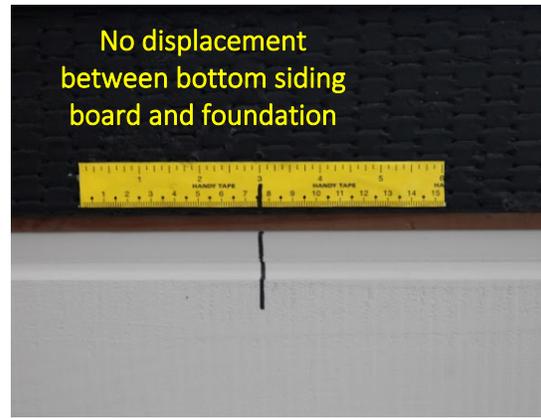
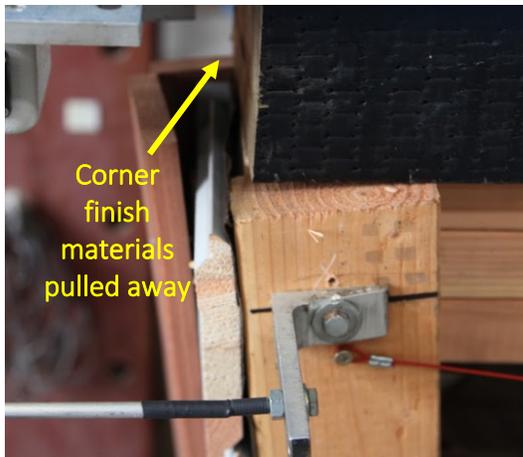
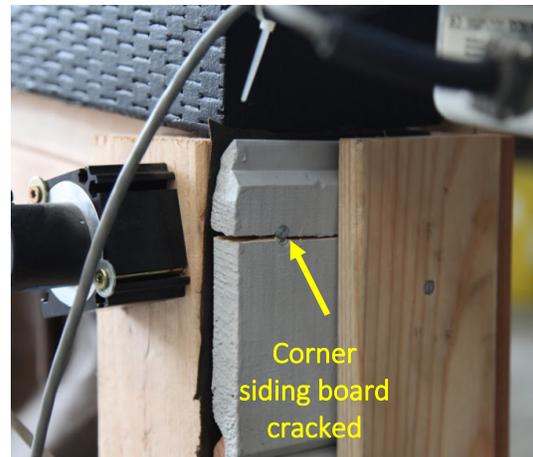
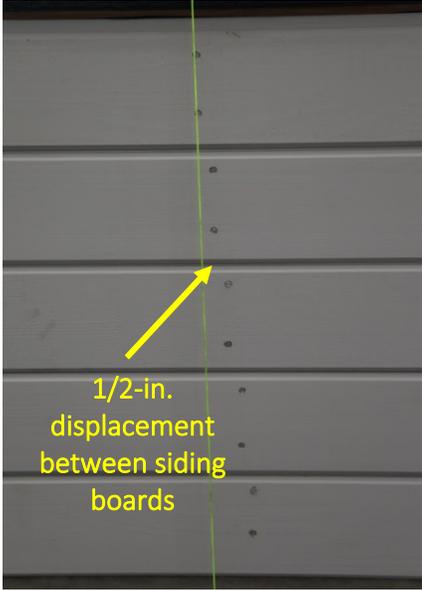
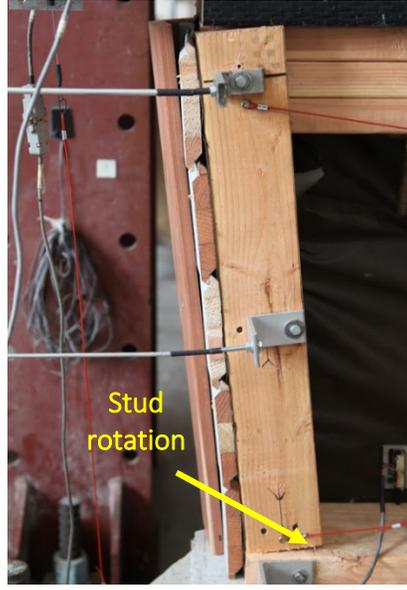
Figure 4.47 (a) bottom exterior of wall view at +9% drift; (b) top exterior of wall view at +9% drift; (c) top of south-end interior of wall view at +11% drift; (d) top of north-end interior of wall corner view at +11% drift; (e) middle exterior of wall view at -12% drift; and (f) south-end interior of wall view at +11% drift.

Figure 4.47 shows close-up photographs of the cripple wall at various post-strength drift ratio levels. The siding boards remained uncracked on the face of the cripple wall throughout the entire

test. At the corner, some siding boards on the top and bottom of the cripple wall split, as shown in Figure 4.47(d). Cracks to siding boards at the base of the wall were due to the bearing of the siding boards on the foundation. Figure 4.47(a) and (b) shows an almost negligible displacement of the bottom siding board to the foundation and the top siding board to the uppermost top plate. This is due to the low capacity of the cripple wall. The displacement of the siding boards relative to each other was constant at each interface and reached nearly 1/2 in. by 12% drift; see Figure 4.47(e). The top siding board pushed away the corner trim boards as the cripple wall displacement increased, as seen in Figure 4.47(a). Large tears continued to propagate across the building paper as the displacement increased.

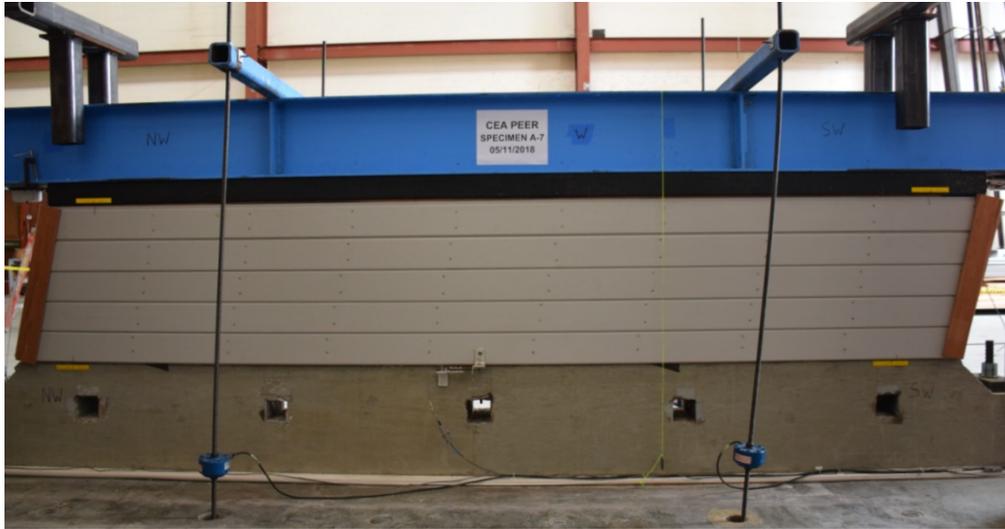
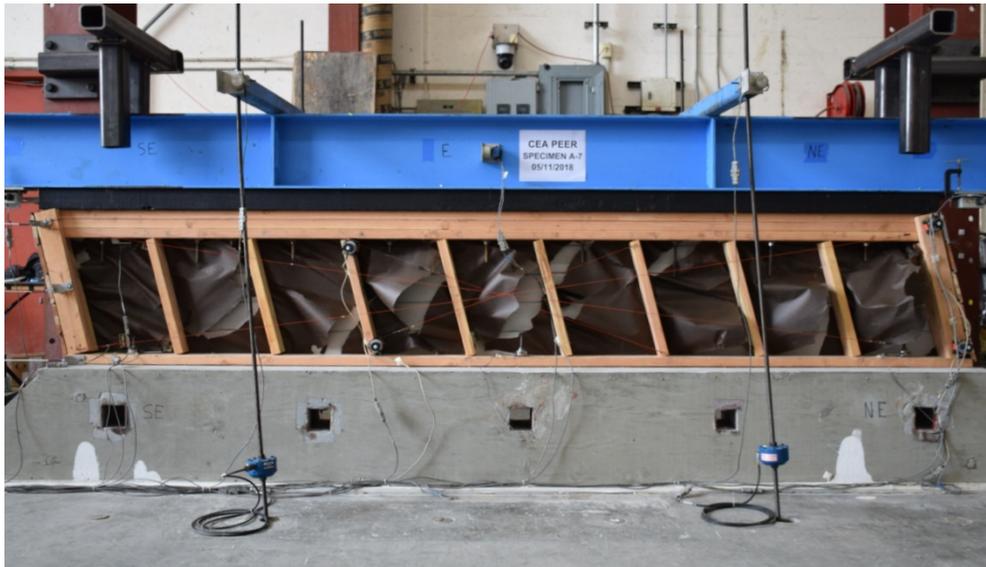
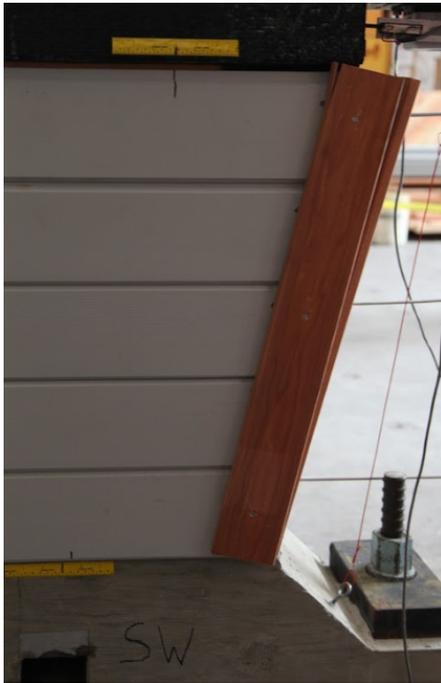
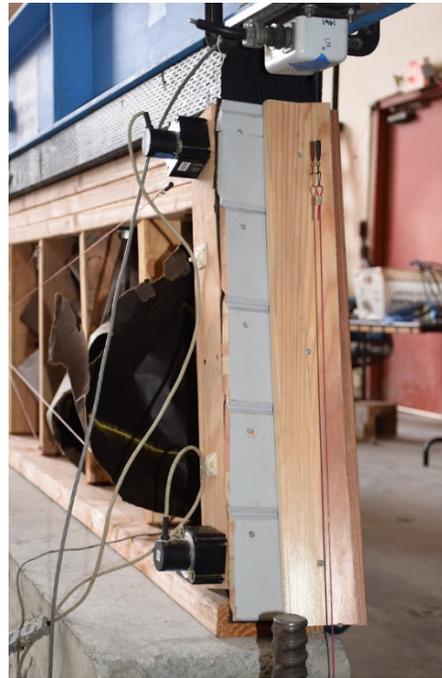
Figure 4.48 Specimen A-7 post-test photographs with lateral load = 0 kips, residual displacement = +4.78 in. @ +19.9% drift ratio after monotonic push to +5.0 in. @ +20.8% drift ratio: (a) exterior elevation; (b) interior elevation; (c) south-end exterior of wall view; and (d) north-end interior of wall view.

Figure 4.48 shows photographs of the cripple wall in the residual state after a monotonic push to +5.0 in. (+20.8% drift ratio). Specimen A-7 never dropped below 80% in strength. From 4% drift where strength occurred, to 12% drift where the monotonic push was initiated, the load only dropped 25.4% in the push direction and 22.2% in the pull direction. When the monotonic push to +5.0 in. (+20.8% drift ratio) was initiated, the capacity of the cripple wall came within 3.6% of its peak load. This is due to the increased resistance of the nail couples fastening the siding boards to the framing. The residual state of the cripple wall had a displacement of +4.78 in. (+19.9% drift ratio).

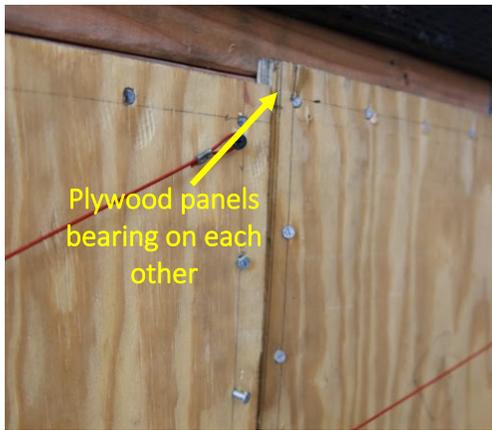
Figure 4.49 Specimen A-8 damage state details at various post-strength drift ratio levels: (a) top interior of wall view at -9% drift (south and middle panels); (b) bottom interior of wall view at +10% drift (south and middle panels); (c) bottom of south-end interior of wall view at -11% drift; (d) bottom of south-end interior of wall view at +12% drift; (e) bottom of south-end of wall view at +13% drift; and (f) middle exterior of wall view at -15% drift.

Figure 4.49 shows close-up photographs of the cripple wall at various post-strength drift ratio levels. The cripple wall achieved strength at 8% global drift ratio in the push direction and 7% global drift ratio in the pull direction. It should be noted that the lateral loads in either direction from 7% to 8% were within 1% of each other. These loads dropped by 40% by 13% drift and dropped by 80% by 15% drift. The drop of loads occurred as the nails attaching the plywood to the framing had torn through the plywood or pulled out from the framing. The most common scenario was for the nails to pull through the plywood or tear through the edges of the plywood and remain attached to the framing, as seen in Figure 4.49(b), (c), and (d). The plywood panel would remain attached to the top plate [Figure 4.49(a)] and lose connection to the blocking at the sill plate and the studs. Once multiple edges of the plywood had detached from the framing, the capacity of the plywood dramatically decreased. The bottom of the corner plywood panels pushed out the corners of the cripple walls by 1 in. on the north end, as seen in Figure 4.49(d). The plywood panels bowed out in the middle [Figure 4.49(b)] and crushed at the corners; see Figure 4.49(c) and (d). On the exterior face of the cripple wall, the displacement between the siding boards increased consistently with increasing displacement, reaching 1/2 in. by 15% drift, as shown in Figure 4.49(f). The corner trim boards remained uncracked.

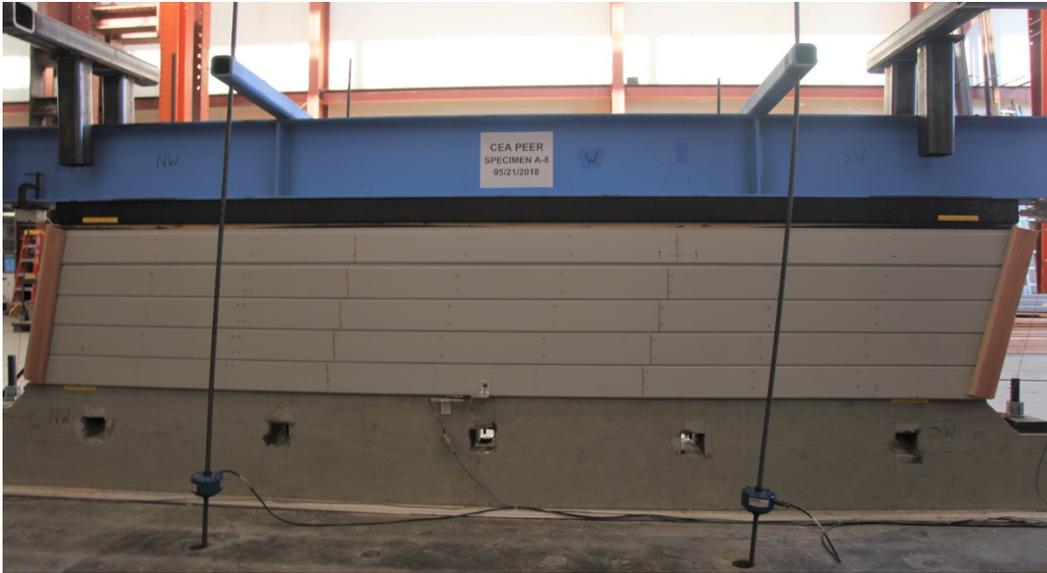
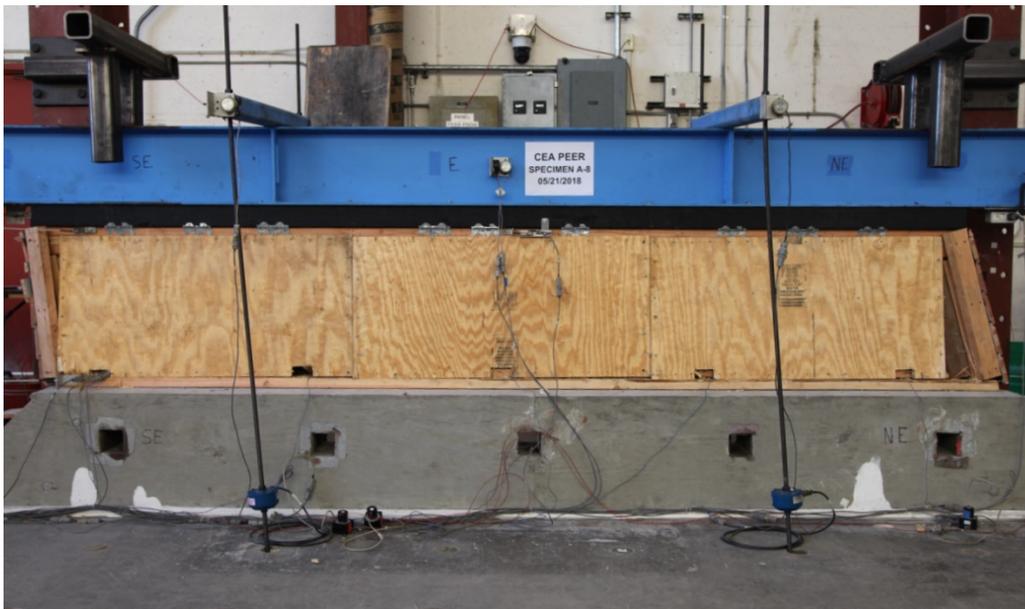
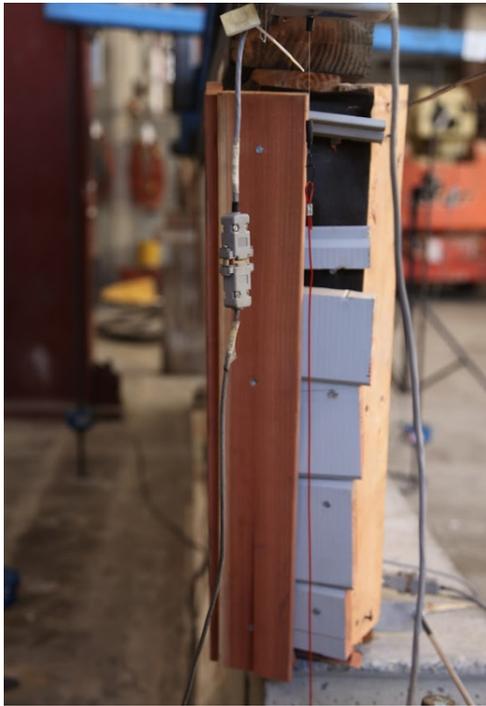
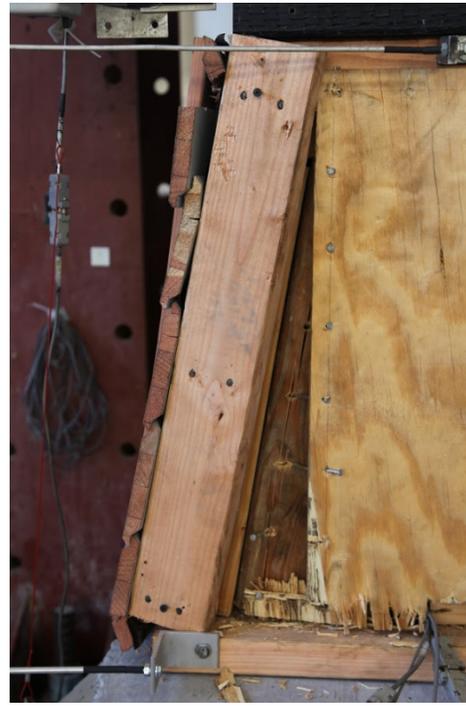
Figure 4.50 Specimen A-8 post-test photographs with lateral load = 0 kips at residual displacement = +4.72 in. @ +19.7% drift ratio after monotonic push to +5.0 in. @ +20.8% drift ratio: (a) exterior elevation; (b) interior elevation; (c) south-end of wall corner view; and (d) north-end interior of wall view.

Figure 4.50 shows photographs of the cripple wall in the residual state after a monotonic push to +5.0 in. (+20.8% drift ratio). The monotonic push was initiated after the 15% drift ratio cycle group, which is where an 80% drop in strength occurred. The residual state of the cripple wall had a displacement of +4.72 in. (+19.7% drift ratio).

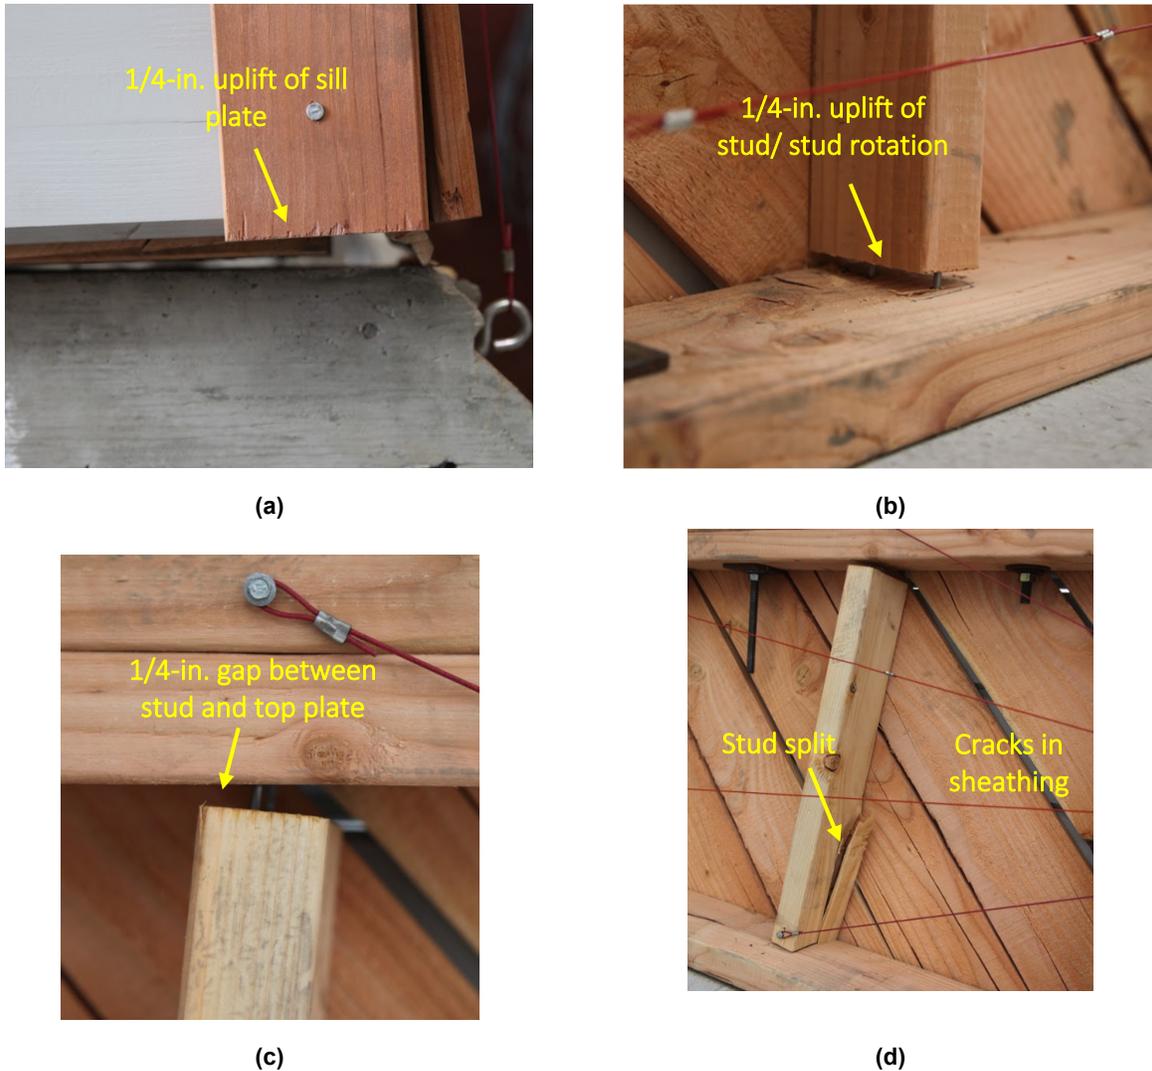
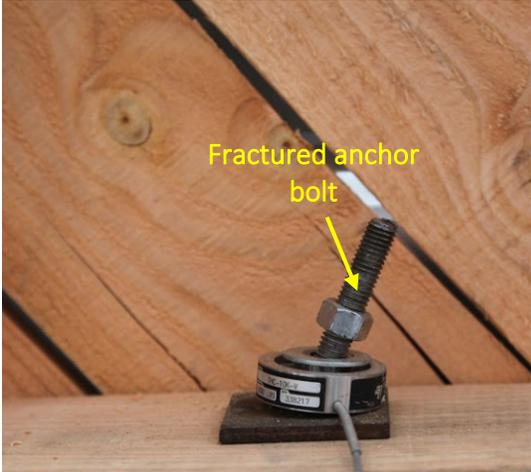
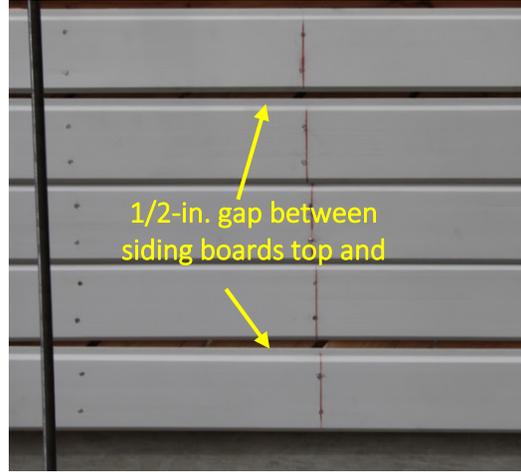
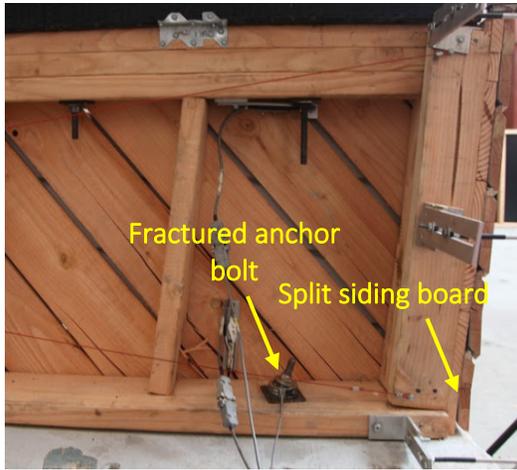
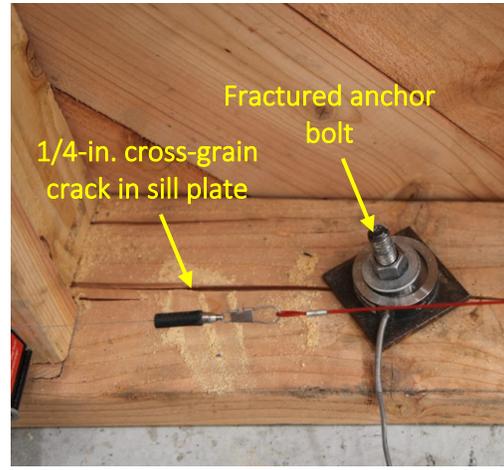
Figure 4.51 Specimen A-9 details of damage states at various post-strength drift ratio levels: (a) bottom of north-end exterior of wall view at +9% drift; (b) bottom of middle interior of wall view at +9% drift; (c) top of middle interior of wall view at +9% drift; (d) middle interior of wall view at +10% drift; (e) bottom of middle interior of wall view at +11% drift; (f) middle exterior of wall view at +11% drift; (g) south-end interior of wall at +12% drift; and (h) bottom of north-end interior of wall at +12% drift.

Fractured anchor bolt

1/2-in. gap between siding boards top and

Fractured anchor bolt
Split siding board

Fractured anchor bolt
1/4-in. cross-grain crack in sill plate

Figure 4.51 shows close-up photographs of the cripple wall at various post-strength drift ratio levels. The cripple wall reached strength at 7% drift in the push direction and 10% drift in the pull direction. From 8% to 10% drift, the lateral strength in the push direction dropped 4.3%; by the end of the test, the push strength only dropped 21.3%. The peak load in the push direction dropped 6.4% from 10% to 12% drift. The cripple wall maintained close to peak load in both directions until the anchor bolts fractured, resulting in massive drops of capacity. If there had been additional anchorage, the specimen would have likely held close to peak load for larger displacement amplitudes, as indicated by the sheathing boards still being mostly intact when the anchor bolts had all fractured. The loss of capacity is a result of cracks forming in the sheathing boards as well as mobilization of the nails attaching the sheathing to the framing. Cracking of the sheathing boards can be seen in Figure 4.51(d), (e), and (g). Instead, the anchor bolts fractured, and a large crack formed in the north end of the sill plate; see Figure 4.51(e), (g), and (h). There was significant uplift experienced by the cripple wall, which opened up gaps between the studs and the sill plate as well as the studs and the top plates [Figure 4.51(b), (c), and (d)] and caused the sill plate to uplift 1/4 in.; see Figure 4.51(a). Specimen A-9 exhibited the most visible damage to the exterior face of all the cripple walls containing horizontal siding. In Figure 4.51(f), a 1/2 in. gap between the top two and bottom two siding boards had accumulated by +11% drift. The corner trim boards remained intact.

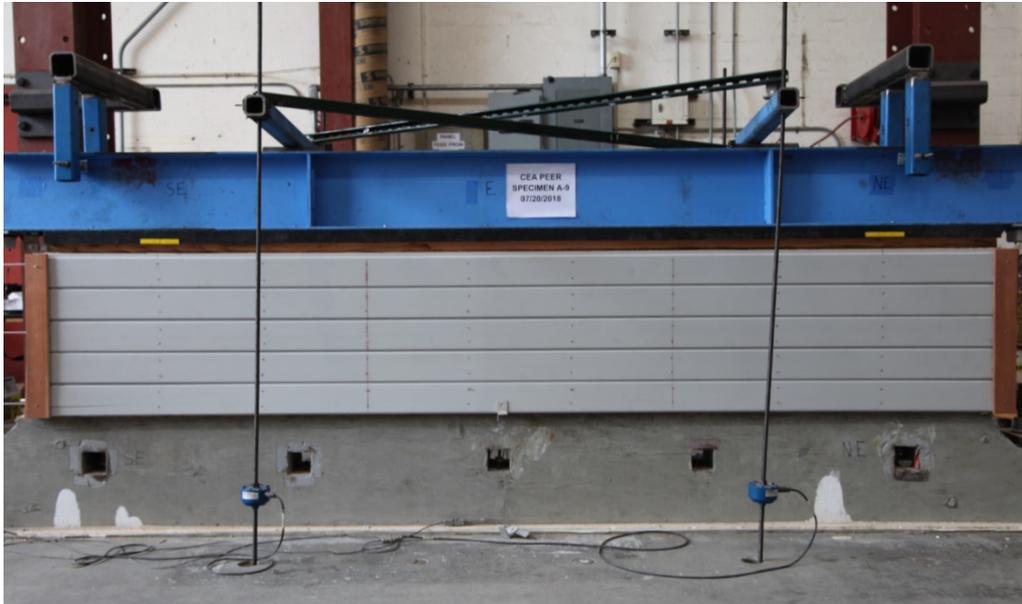
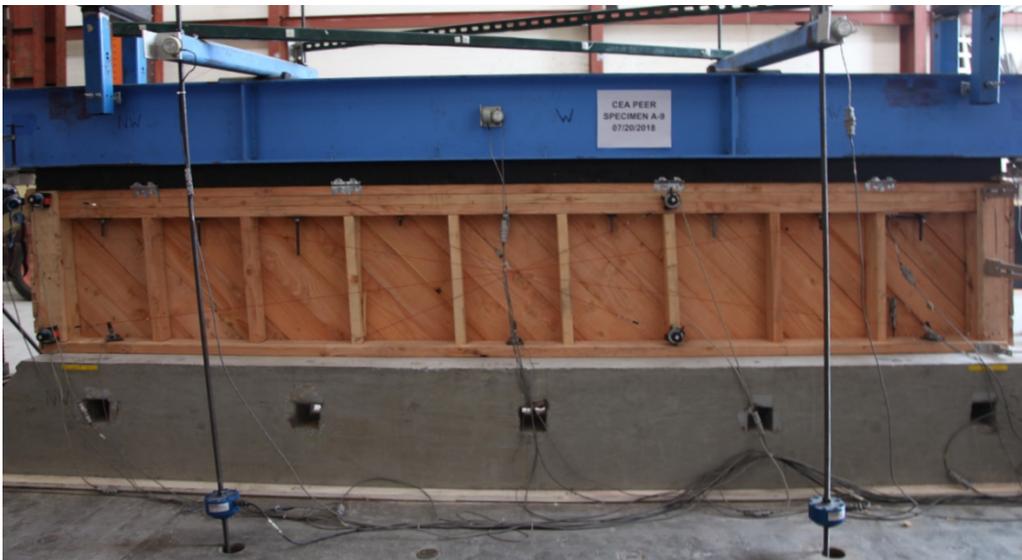
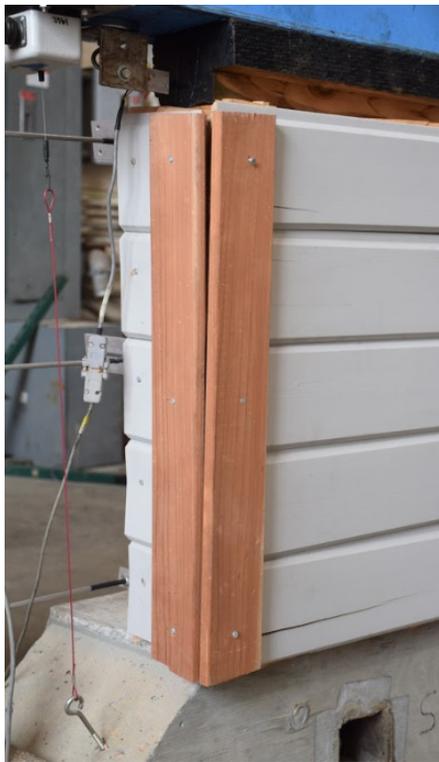
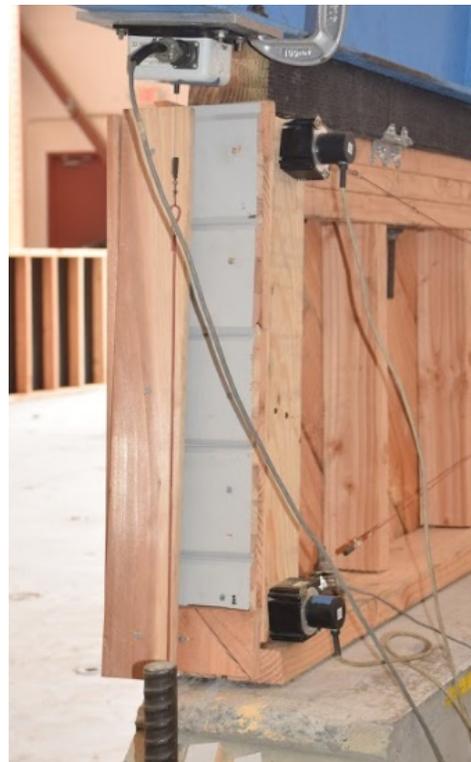
Figure 4.52 Specimen A-9 post-test photographs with lateral load = 0 kips at residual displacement = -2.61 in. @ -10.9% drift ratio after finishing first cycle of -13% drift ratio cycle group: (a) exterior elevation; (b) interior elevation; (c) south-end exterior of wall corner view; and (d) north-end interior of wall corner view.

Figure 4.52 shows photographs of the cripple wall in the residual state after the reaching the target displacement in the pull direction of the 13% drift ratio cycle group. The decision was

made to end the test at this point due to the fracturing of all anchor bolts, which subsequently resulted in an 80% reduction in capacity for the specimen. The residual state of the cripple wall had a displacement of -2.61 in. (-10.9% drift ratio).

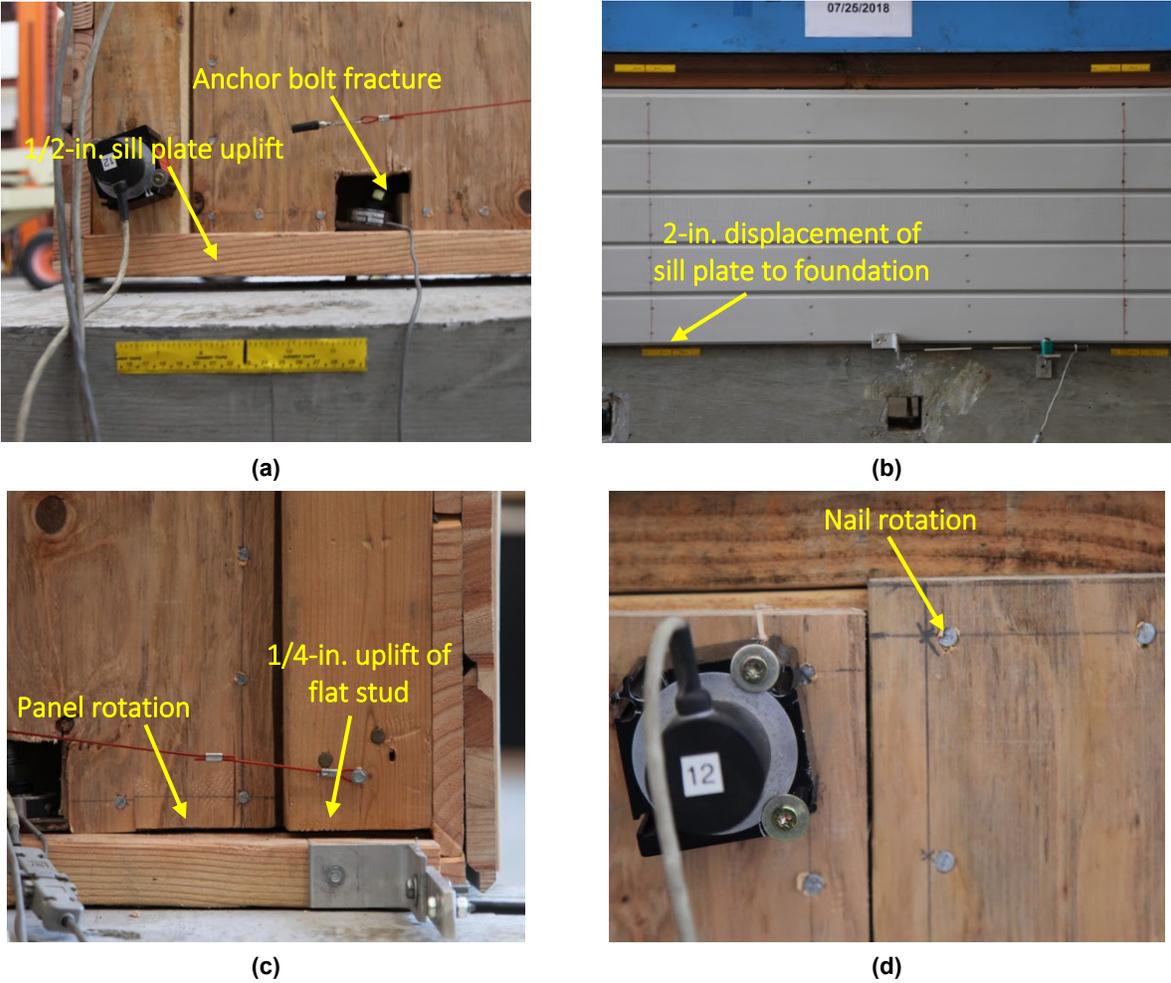
Figure 4.53 Specimen A-10 damage state details at various post-strength drift ratio levels: (a) bottom north-end exterior of wall view at +9% drift; (b) middle interior of wall view +9% drift; (c) bottom of south-end interior of wall view at +10% drift; and (d) top of middle interior of wall view at +10% drift (south and middle panels).

Figure 4.53 shows close-up photographs of the cripple wall at various post-strength drift ratio levels. The cripple wall reached peak load at 7% drift in the push direction and 8% drift in the pull direction. From 6% to 9% drift, the lateral load in the push direction increased 3.4% to achieve peak load and then decreased 1.8%, and the lateral load in the pull direction increased 3.7% to achieve peak load and then decreased 9.5%. From 9% to 12% drift, the peak push load decreased 83%, and the peak pull load decreased 84%. The sudden massive drops of capacity are a result of the anchor bolt fractures on the specimen. At 8% drift, the first anchor bolt fractured. At 9%, four more anchor bolts fractured, and at 10%, the last two anchor bolts fractured. Looking at Figure 4.54, both the exterior and interior of the cripple walls remain relatively intact, showing little physical damage compared to other cripple walls at these drift ratio levels. The cripple wall itself had not reached peak capacity as evidenced by the small amount of rotation in the nails fastening the plywood to the framing; see Figure 4.53(c) and (d). The exterior face of the cripple wall shows around 1/8 in. of displacement between the siding boards, as seen in Figure 4.53(b). Typically, at this drift ratio level, the horizontal siding boards were displaced by around 1/2 in. between each other. By 12% drift, the cripple wall was sliding on top of the foundation. Only 0.5% of the imposed drift was being carried by the cripple wall itself. The average lateral load at 12% drift was 4.85 kips, which can be taken as the amount of force required to overcome to frictional resistance at wood–concrete interface of the sill plate and the foundation. If sufficient anchorage had been present, it would be expected that the peak strengths would be significantly larger than what were

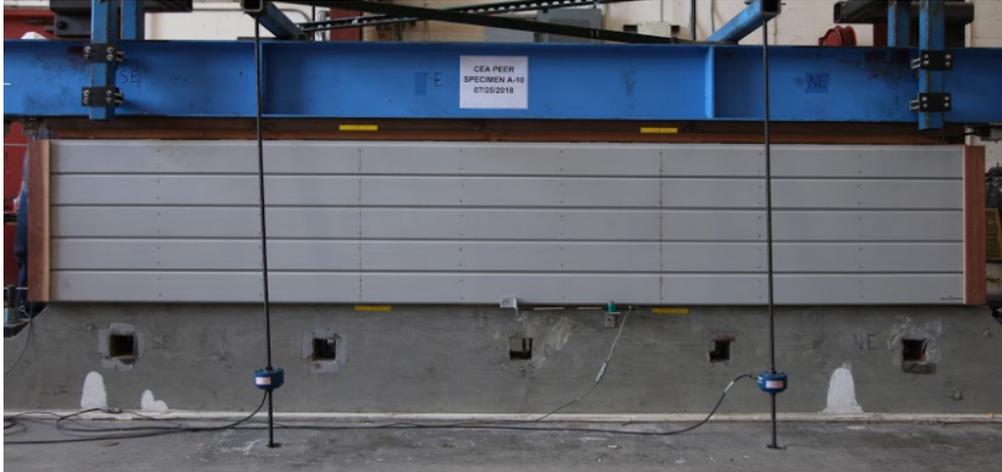
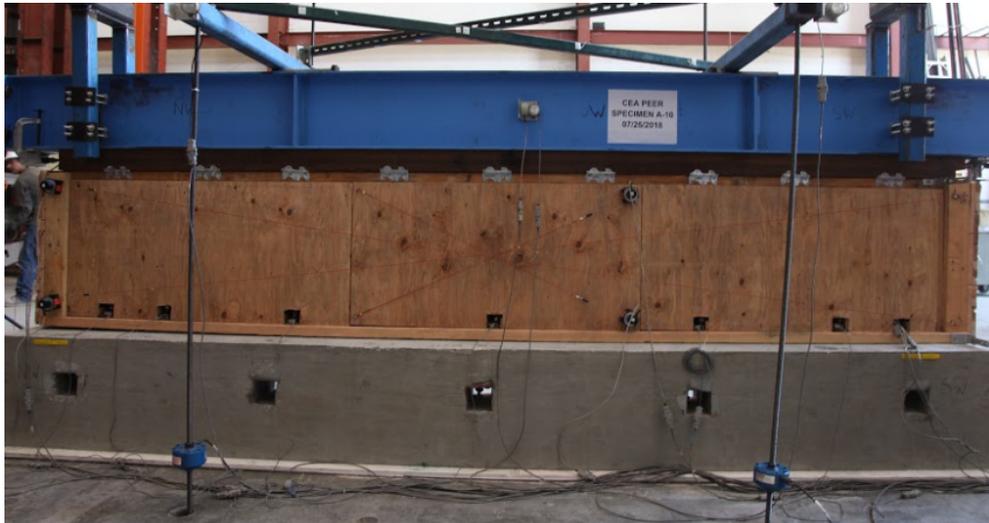
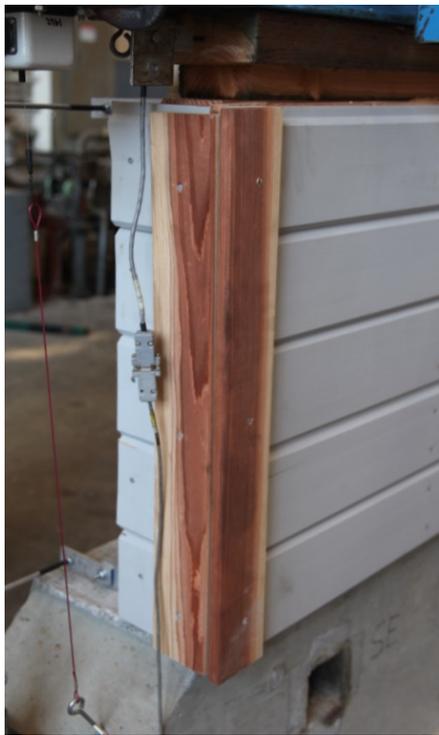
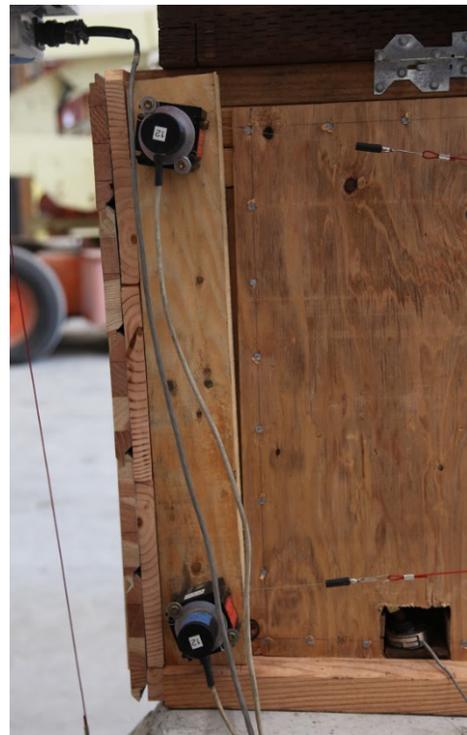
Figure 4.54 Specimen A-10 post-test photographs with lateral load = 0 kips at residual displacement = -2.81 in. @ -11.7% drift ratio after finishing first cycle of -12% drift ratio cycle group: (a) exterior elevation; (b) interior elevation; (c) south-end exterior of wall corner view; and (d) north-end interior of wall view.

Figure 4.54 shows photographs of the cripple wall in the residual state after the reaching the target displacement in the pull direction of the 12% drift ratio cycle group. The decision was made to end the test at this point due to the fracturing of all anchor bolts, which subsequently results in an 80% reduction in capacity for the specimen. The residual state of the cripple wall had a displacement of -2.81 in. (-11.7% drift ratio).
