Cripple Wall Small-Component Test Program: Dry Specimens

**A Report for the “Quantifying the Performance of
Retrofit of Cripple Walls and Sill Anchorage in Single-
Family Wood-Frame Buildings” Project**

PEER Report 2020/17

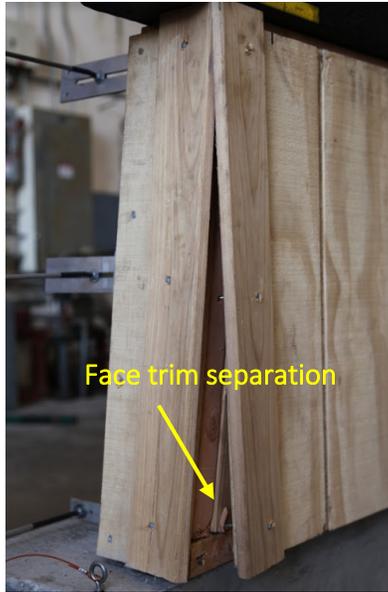
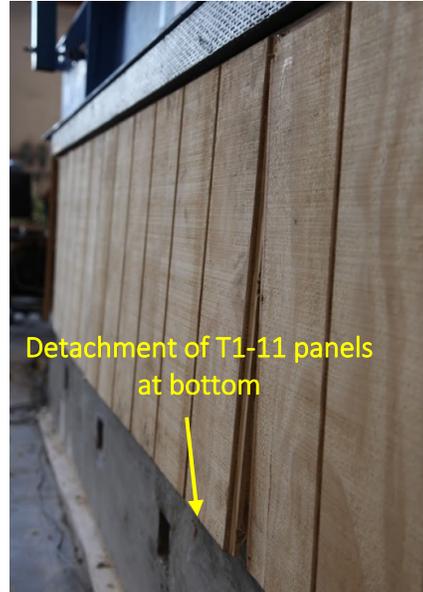
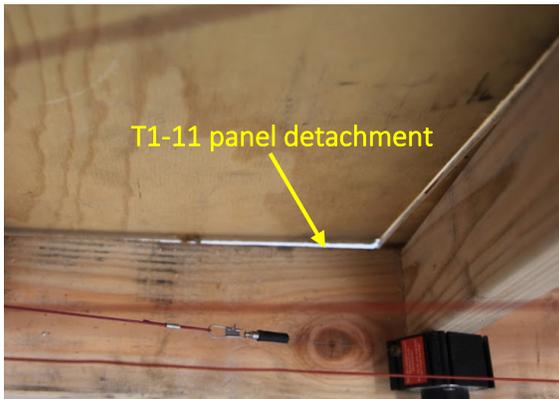
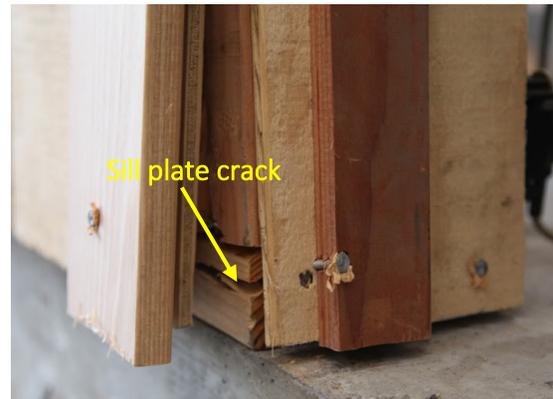
Face trim separation

Detachment of T1-11 panels at bottom

T1-11 panel detachment

Sill plate crack

Figure 4.55 Specimen A-11 damage details for post-strength drift ratio levels: (a) south-end exterior of wall corner view at -9% drift; (b) exterior view of wall looking south at -9% drift; (c) bottom of middle interior of wall view at -9% drift; and (d) bottom of north-end exterior of wall corner view at +11% drift.

Figure 4.55 shows close-up photographs of the cripple wall at various post-strength drift ratio levels. The cripple wall reached strength at 6% drift in the push direction and 5% drift in the pull direction. From 4% to 6% drift, the lateral load in the push and pull directions remained consistent with a 6.2% increase in lateral push load and the same lateral pull load (3.1% increased to peak load and then a 3.1% decrease from drift a peak load to 6% drift). After 6% drift, the cripple wall lost 62.3% of its load in the push direction and 61.9% of its load in the pull direction by 9% drift. By 13% drift, there was an 80% decrease in peak strength for both directions of loading. The loss of capacity was a result of the detachment of the T1-11 panels. From all photographs in Figure 4.56, it can be seen that the bottom of the plywood panels has fully detached from the sill plate and skirt outward. The only edge that remains fully attached is the top of the panels to the top plate. Cracks formed on the corner trim boards as the outward movement of the T1-11 panels increased. In addition, a crack formed in the sill plate at the location of the nailing of the T1-11 panel to the sill plate at the north end of the wall.

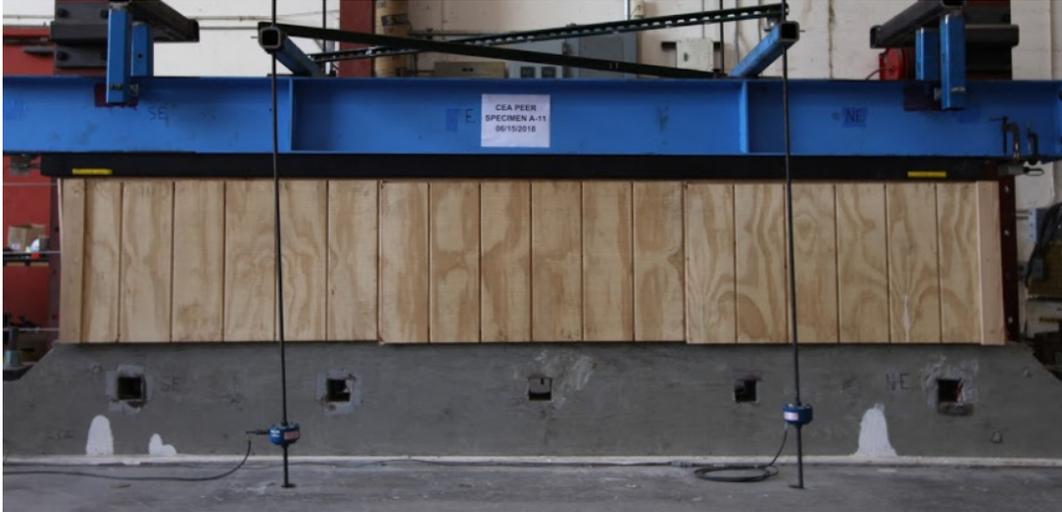
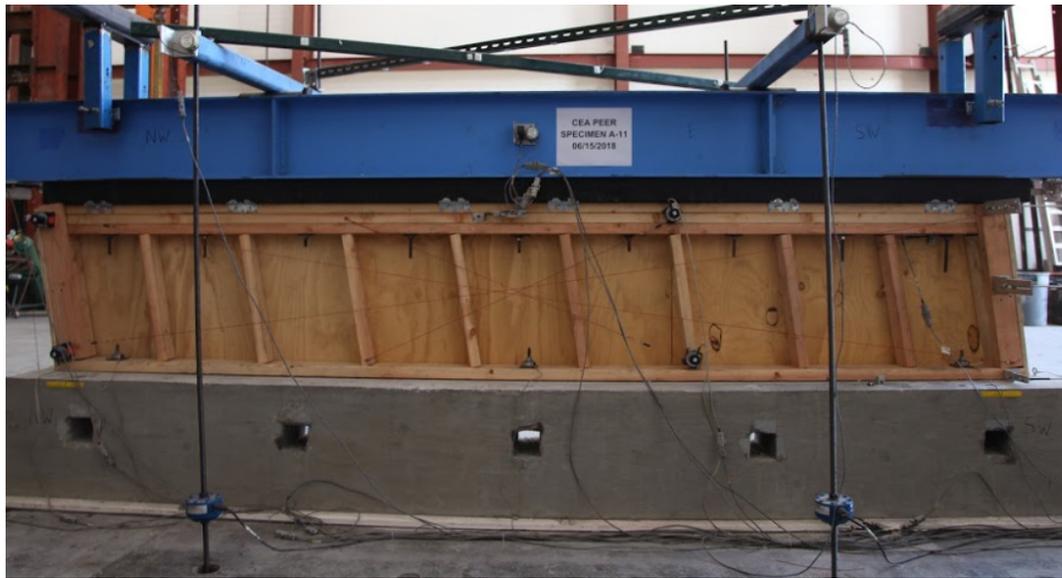
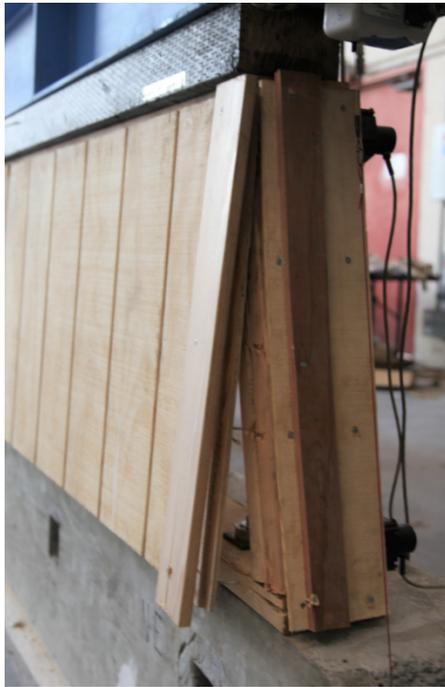
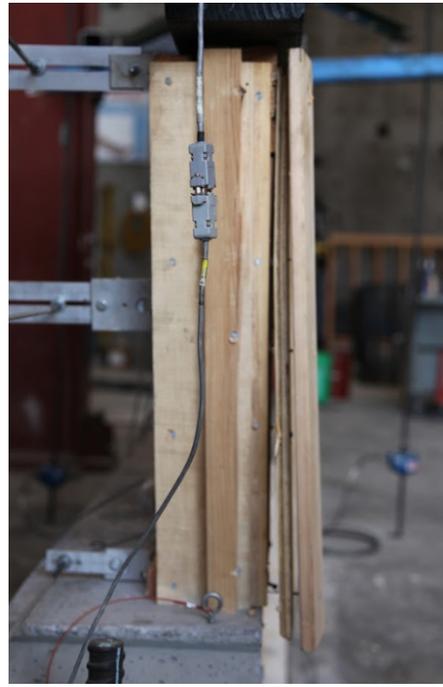
Figure 4.56 Specimen A-11 post-test photographs with lateral load = 0 kips at residual displacement = +4.72 in. @+19.7% drift ratio after monotonic push to +5.0 in. @ +20.8% drift ratio: (a) exterior elevation; (b) interior elevation; (c) north-end exterior of wall corner view; and (d) south-end of wall corner view.

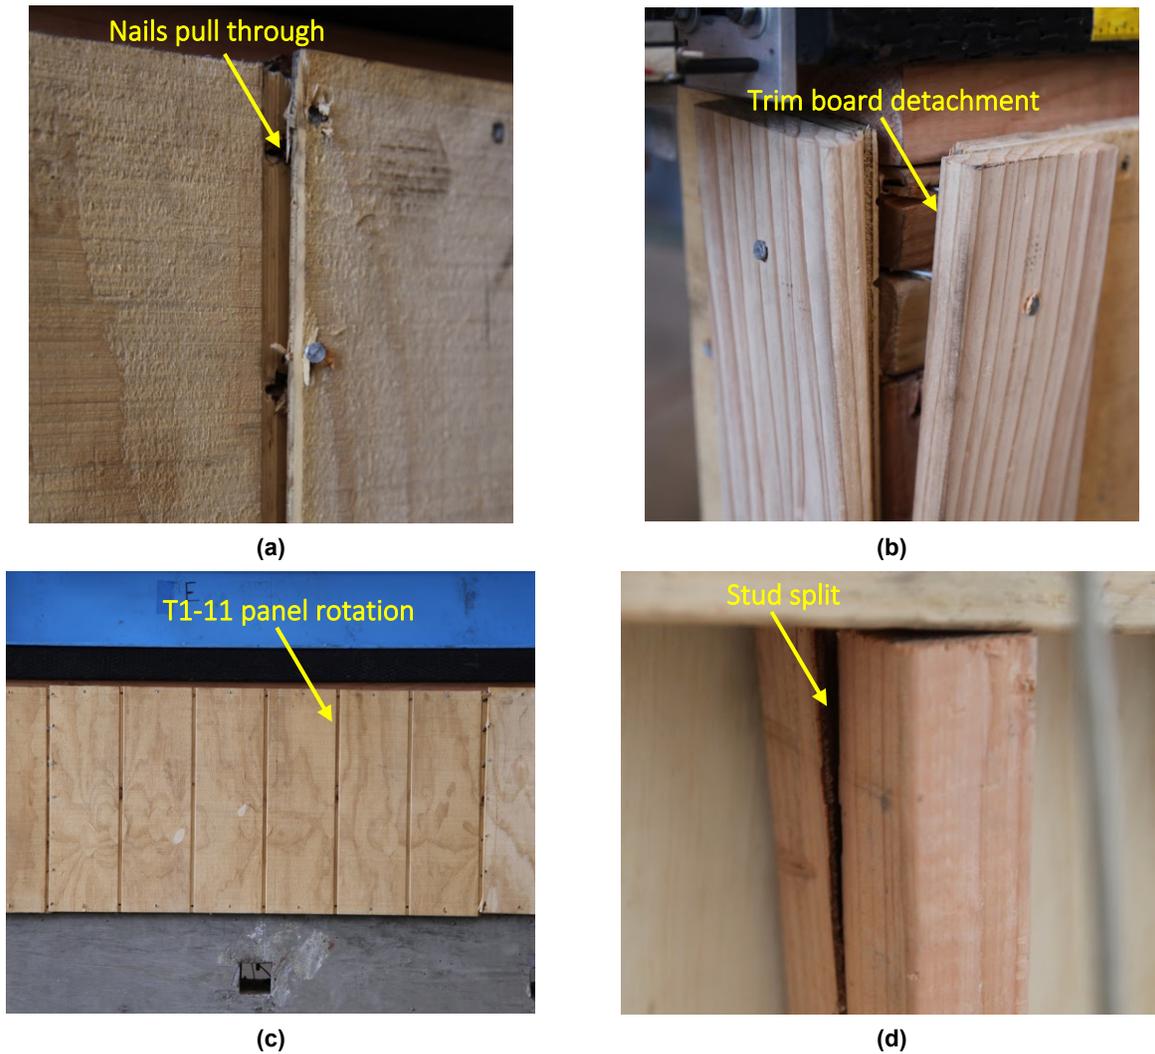
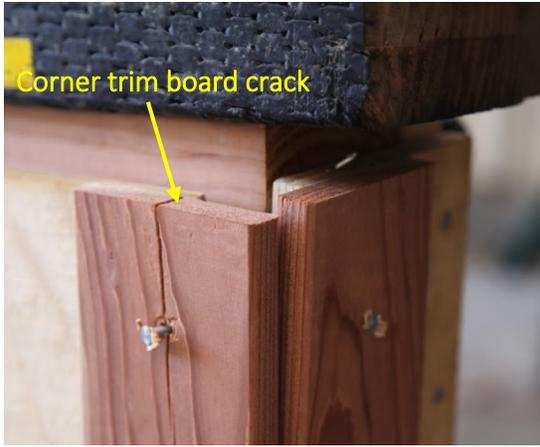
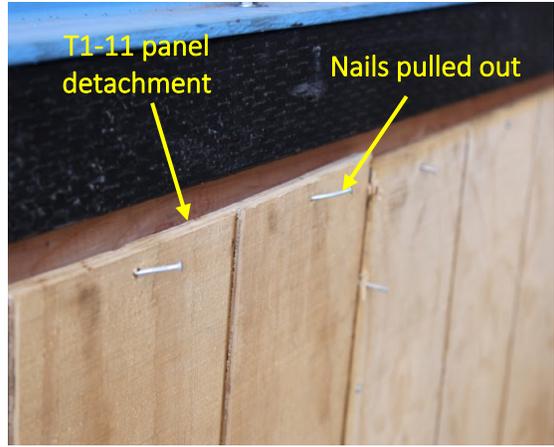
Figure 4.57 Specimen A-12 damage details for post-strength drift ratio levels: (a) top exterior of wall view at -9% drift (north and middle panels); (b) top of south-end exterior of wall corner view at +9% drift; (c) middle exterior of wall view at -9% drift; (d) top of middle interior of wall view at -11% drift; and (d) top of north-end exterior of wall corner view at -11% drift; and top of middle exterior of wall view at -13% drift (south and middle panels).

Figure 4.57 shows close-up photographs of the cripple wall at various post-strength drift ratio levels. The cripple wall reached strength at 7% drift in the push direction and 6% drift in the pull direction. From 5% to 8% drift, the lateral load in the push direction increased 3.6% to achieve peak load and then decreased 3.5%; the lateral load in the pull direction increased 3.5% to achieve peak load and then decreased 7.9%. By 10% drift, the loads had dropped 23.5% in the push direction and 40.2% in the pull direction. Each push and pull from 10% drift onward caused a large drop of capacity until the cripple wall lost 82% of its capacity by 12% drift. The peak load of the monotonic push to 20% drift was only 10% of the peak strength (1.43 kips). This is the lowest lateral load for a monotonic push of any of the retrofitted cripple walls. The loss of load is a consequence of the T1-11 panels losing attachment to the cripple wall at most of the attachment locations. At 9% drift, the nails on the underlying panel had torn through the edge of the T1-11 plywood, as seen in Figure 4.57(a). The corner trim boards had also detached from the exterior face of the framing. By 11% drift, there was pronounced rotation of the panels as the nails had either rotated or fully lost connection between the T1-11 panels and the framing; see Figure 4.57(c). At 13% drift, the attaching of the T1-11 plywood to the top plates had almost fully withdrawn from the top plate, as seen in Figure 4.57(f). The corner trim board began to crack at this drift ratio level as well; see Figure 4.57(e). As with all retrofitted specimens that failed due to the loss of capacity in the actual cripple wall (no anchor bolt fractures), the loss of capacity occurred when multiple edges of the plywood detached from the framing.

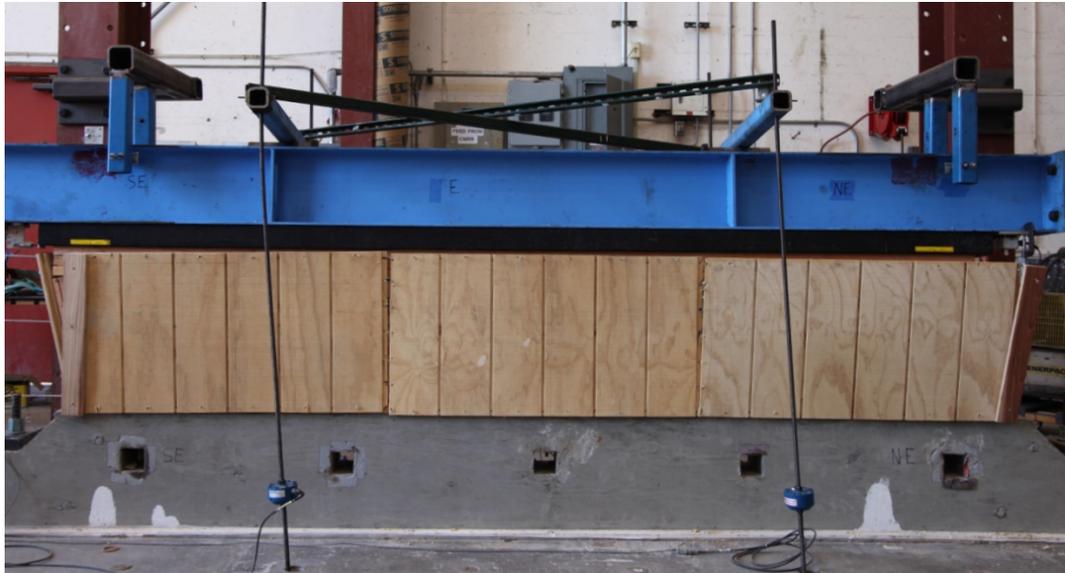
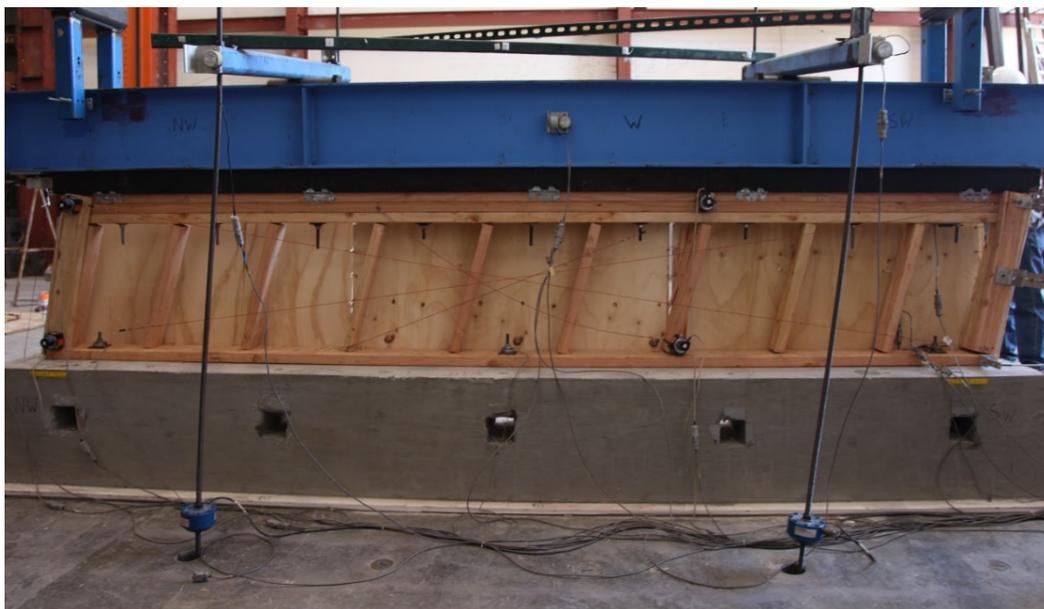
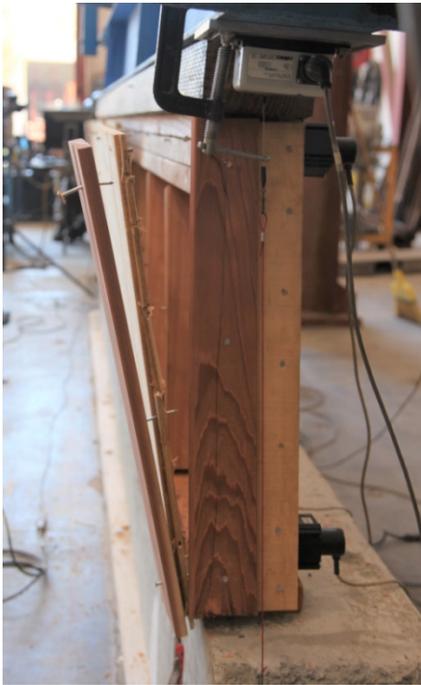
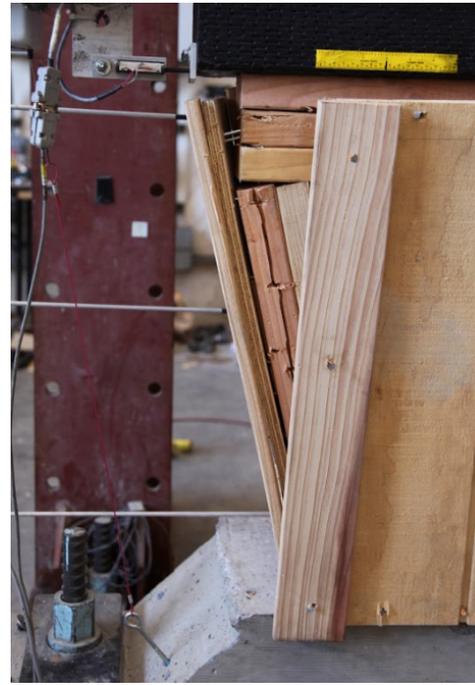
Figure 4.58 Specimen A-12 post-test photographs with lateral load = 0 kips at residual displacement = +4.12 in. @ +17.2% drift ratio after monotonic push to +5.0 in. @ +20.8% drift ratio: (a) exterior elevation; (b) interior elevation; (c) north-end exterior of wall corner view; and (d) south-end exterior of wall view.

Figure 4.58 shows photographs of the cripple wall in the residual state after a monotonic push to +5.0 in. (+20.8% drift ratio). The monotonic push was initiated after the 12% drift ratio

cycle group, which is where there was an 80% drop in strength from peak. The residual state of the cripple wall had a displacement of +4.12 in. (+17.2% drift ratio).

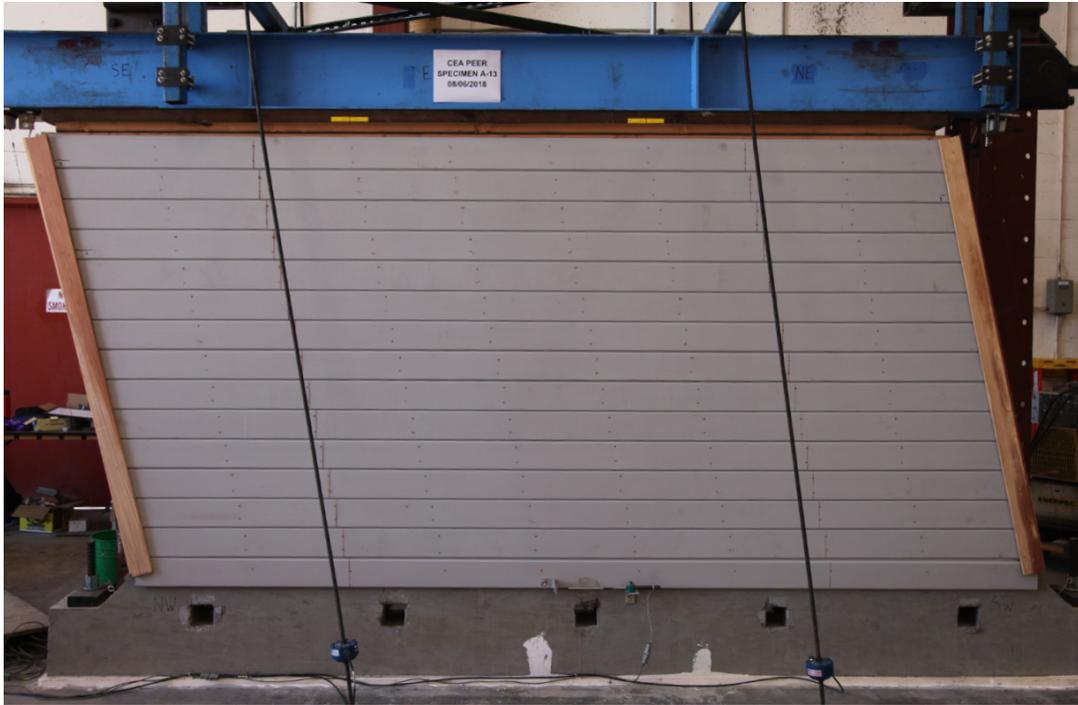
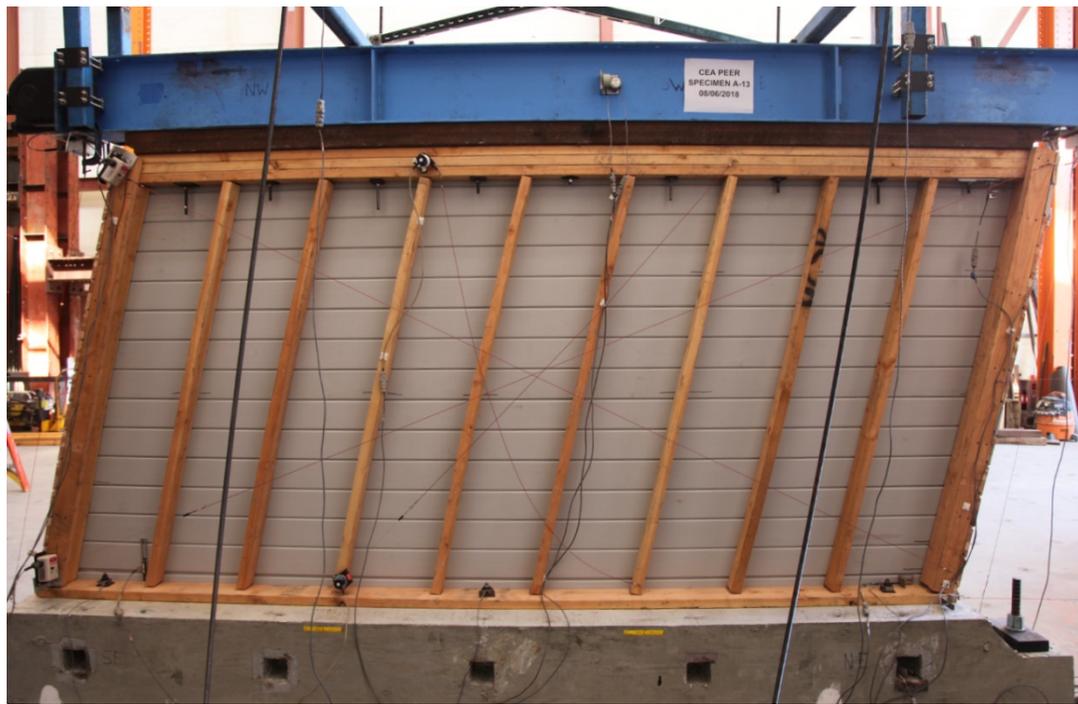
Figure 4.59 Specimen A-13 post-test photographs with lateral load = 0 kips at residual displacement = +14.3 in. @ +19.9% drift ratio after monotonic push to +15.0 in. @ +20.8% drift ratio: (a) exterior elevation; (b) interior elevation; (c) north-end exterior of wall corner view; and (d) north-end exterior of wall view.

Figure 4.59 shows photographs of the cripple wall in the residual state after a monotonic push to +15.0" in. (+20.8% drift ratio). The residual state of the cripple wall had a displacement of +14.3 in. (+19.9% drift ratio). The lateral strength in the push direction occurred at 11% drift, and the lateral strength in the pull direction occurred at 12% drift. From 11% to 12% drift, the peak push load decreased by 0.9%. The monotonic push was initiated after the 12% drift ratio cycle group. Because there was no significant post-strength loads for Specimen A-13, there will not be any further discussion.

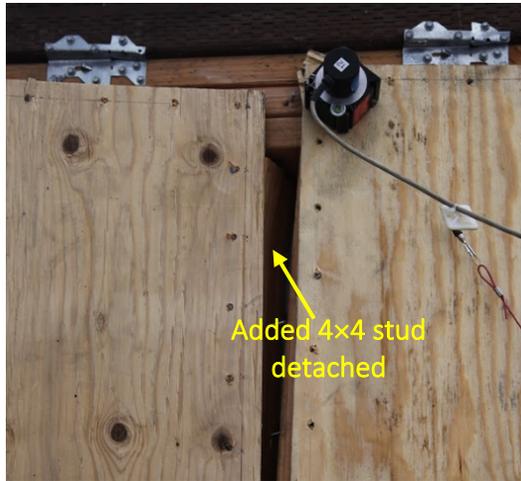
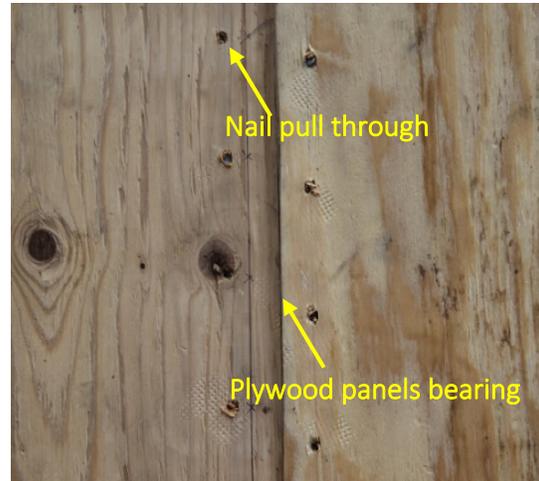
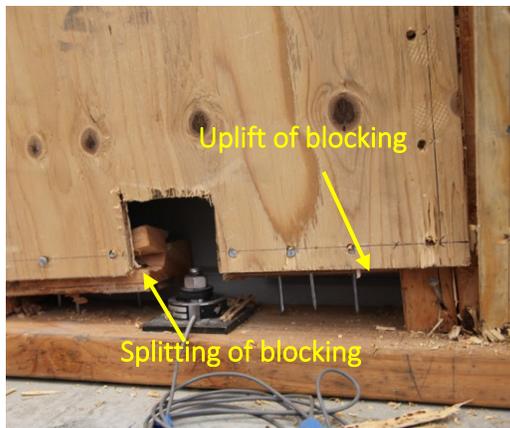
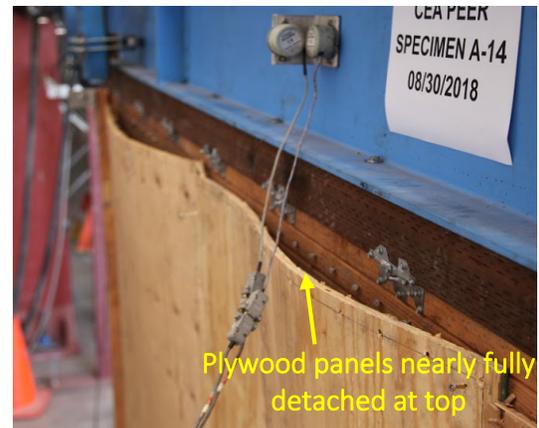
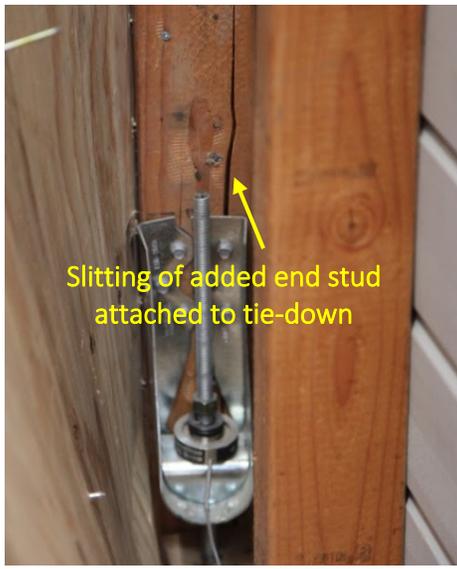
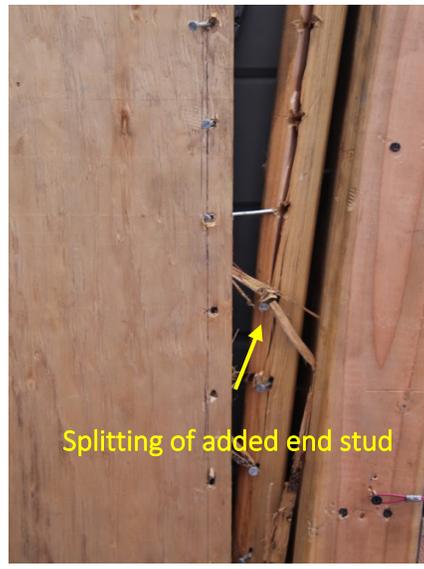
Figure 4.60 Specimen A-14 damage details post-strength drift ratio levels: (a) top of middle interior of wall view at +6% drift (south and middle panels); middle interior of wall view at +6% drift (north and middle panels); (c) bottom of south-end interior of wall view at -8% drift; (d) top of interior of wall view at -8% drift (north and middle panels); (d) bottom of north-end interior of wall view at +9% drift; and (f) bottom of south-end interior of wall view at +10% drift.

Figure 4.60 (continued).

Figure 4.60 shows close-up photographs of the cripple wall at various post-strength drift ratio levels. The cripple wall reached peak load at 5% in the push direction and pull directions. From 5% to 6% drift, the lateral load in the push direction decreased by 8.6%, and the lateral load in the pull direction decreased by 2.7%. By 8% drift, the push load had decreased 75.7% from peak, and the pull load had decreased 62.3%. These large drops of capacity from 6% to 8% drift are the result of the plywood nearly fully detaching from the top plate across the entire wall, as seen in Figure 4.60(b) and (d). The detachment occurred when the nails pulled through the plywood and remained attached to the framing. At the bottom of the cripple wall, the opposite occurred. The plywood panels remained attached to the nails. Significant uplift of the panels occurred as the blocking either split or was uplifted with the panels; see Figure 4.60(c) and (f). Along the studs there was a combination of nails pulling through the plywood and nails pulling out of the framing. The large amounts of uplift forces were carried in tension by the hold-downs on both ends. Eventually, this caused the stud attaching the hold-down to the framing to split, as seen in Figure 4.60(f).

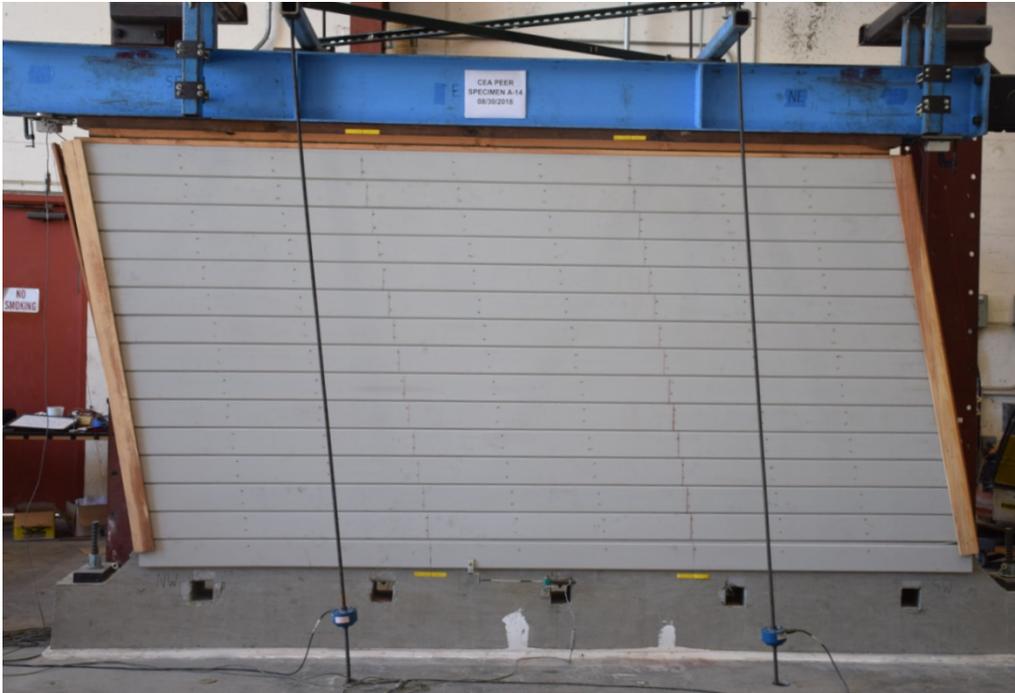
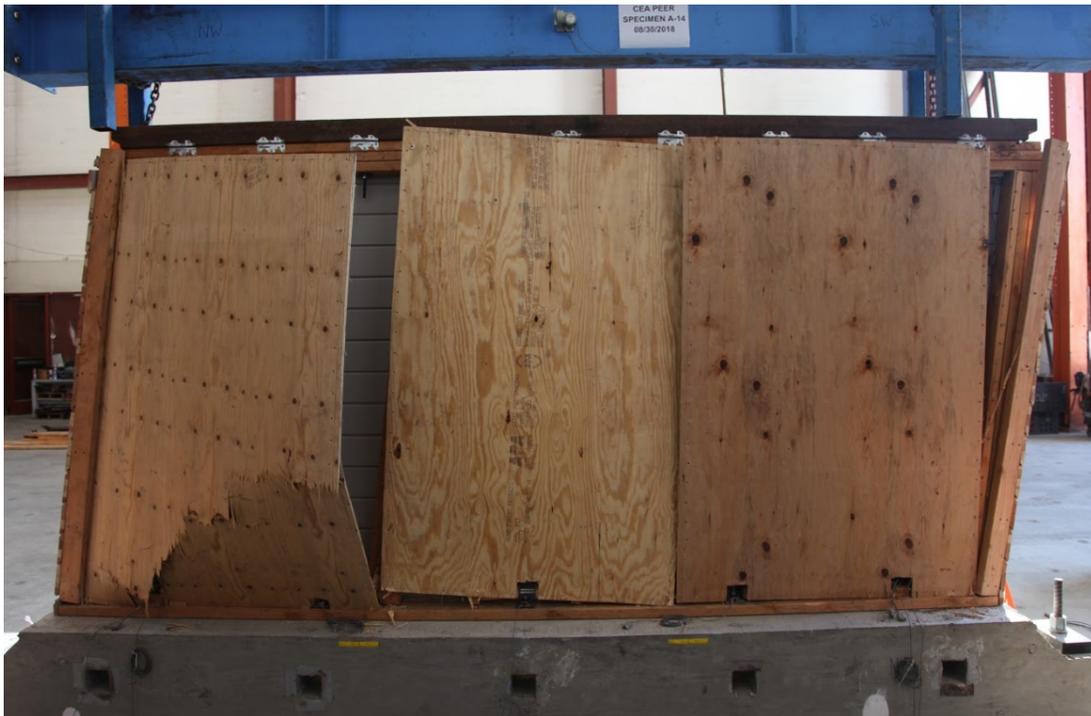
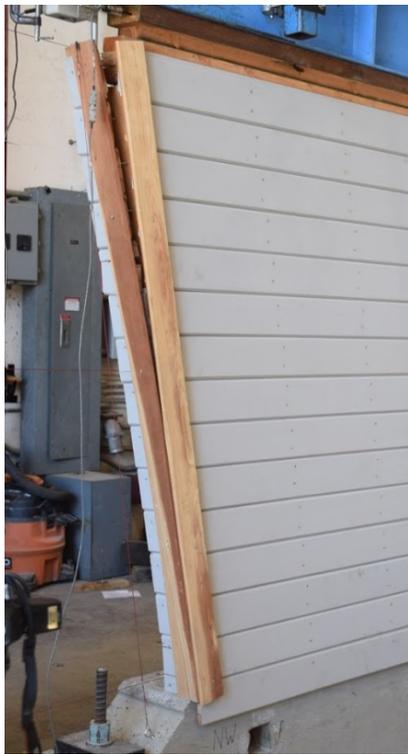
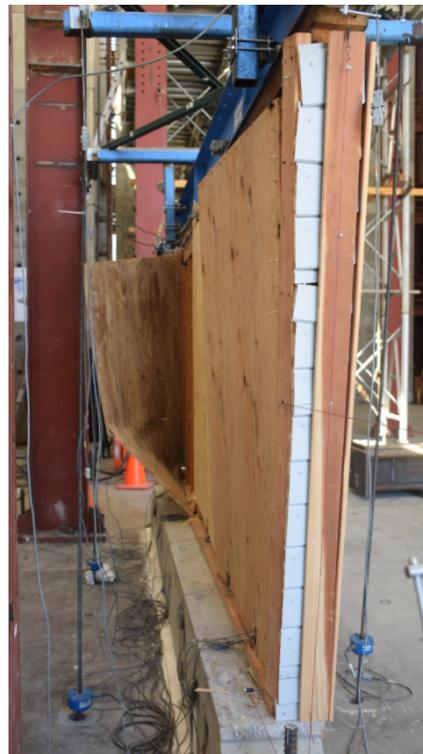
Figure 4.61 Specimen A-14 post-test photographs with lateral load = 0 kips at residual displacement = +11.42 in. @ +14.9% drift after monotonic push to +13.0 in. @ +18.1% drift: (a) exterior elevation; (b) interior elevation; (c) south-end exterior of wall corner view; and (d) south-end interior of wall corner view.

Figure 4.61 (continued).

Figure 4.61 shows photographs of the cripple wall in the residual state after a monotonic push to +13.0 in. (+18.1% drift ratio). The monotonic push was initiated after the 10% drift ratio cycle group, which is where an 80% drop in strength occurred. The residual state of the cripple wall had a displacement of +11.42 in. (+14.9% drift ratio).

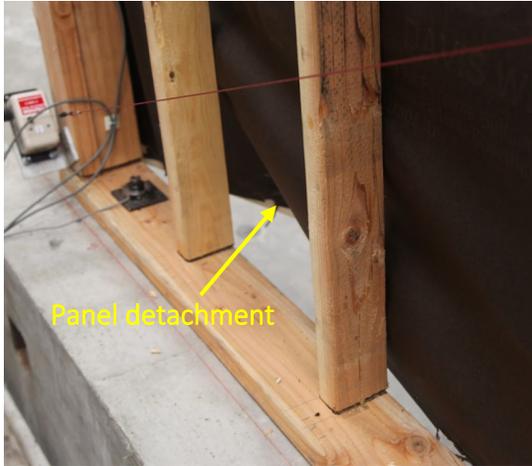
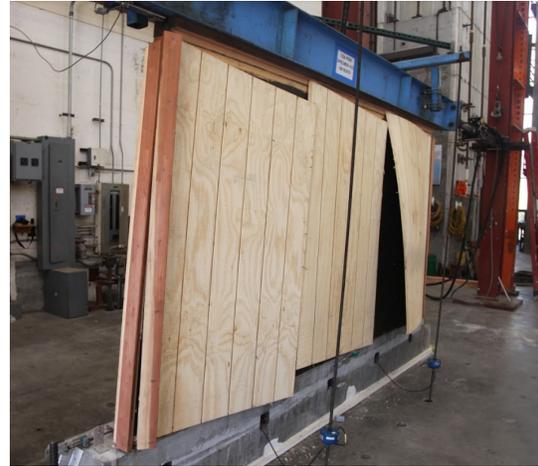
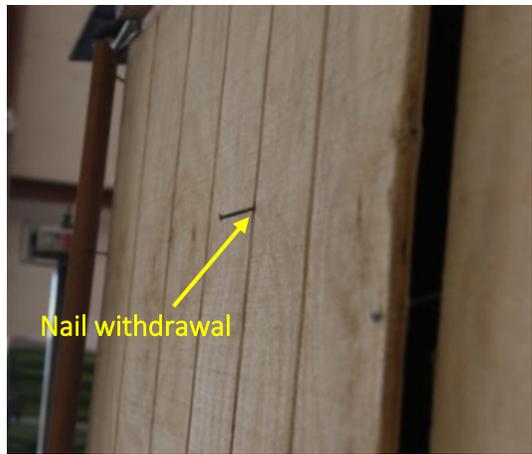
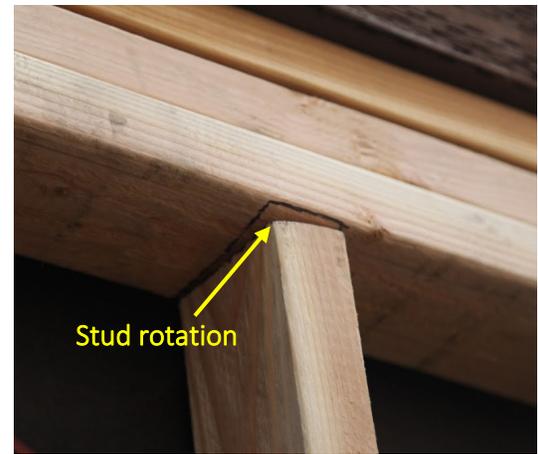
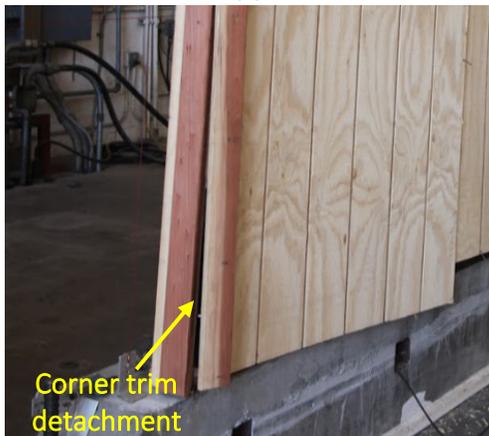
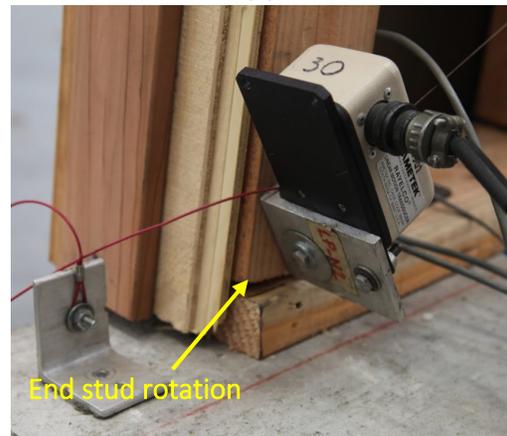
Figure 4.62 Specimen A-23 damage details for post-strength drift ratio levels: (a) bottom interior of wall view at +10% drift (south and middle panels); (b) exterior isometric view of wall at -10% drift; (c) top exterior of wall view at -10% drift (south panel); (d) top of middle interior of wall view at -10% drift; (e) bottom of south-end of wall corner view at +10% drift; and (f) bottom of north-end interior of wall at +10% drift.

The lateral strength occurred at 3% drift in the push direction and 2% drift in the pull direction. From 3% drift to 10% drift, the loss in strength was nearly constant in each subsequent drift cycle group. After the 6% drift ratio level, less than 40% of the capacity of the wall remained. Figure 4.62 shows details of the damage accumulated post peak strength. All drift ratio levels are at 10% unless otherwise noted. Initially, the panels detached from the sill plate and then continued to detach up the studs. Eventually the detachment of the panels on the studs was far enough that the underlying panel had almost no contact with the overlying panel; see Figure 4.62(b). Most of the nails at the sill plate and near the base of the studs pulled through or were torn through the edges of the T1-11 panel. Higher up on the wall, more nails remained attached to the panels and had pulled out from the framing, as seen in Figure 4.62(c). The rotation of the studs at the interface with both the top plates and the sill plates had rotated heavily, both in and out of plane; see Figure 4.62(d). The trim boards at the finish face of the corner had almost fully detached from the framing and only remained partially fastened to the T1-11 panels; see Figure 4.62(e). There was no uplift of the sill plate due to the lack of connection between the sill plate and the panels; see Figure 4.62(f).

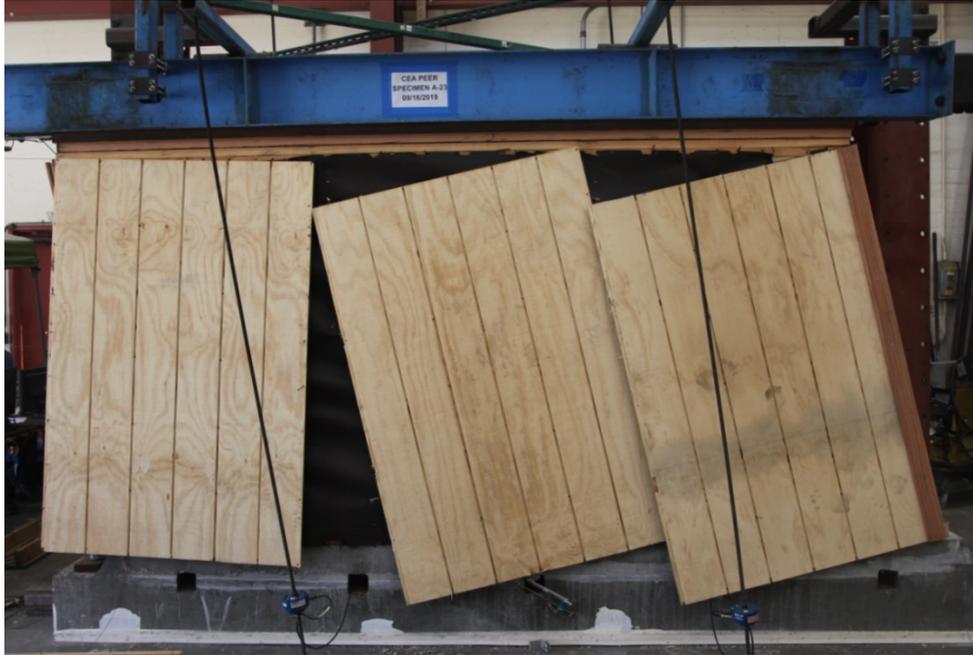
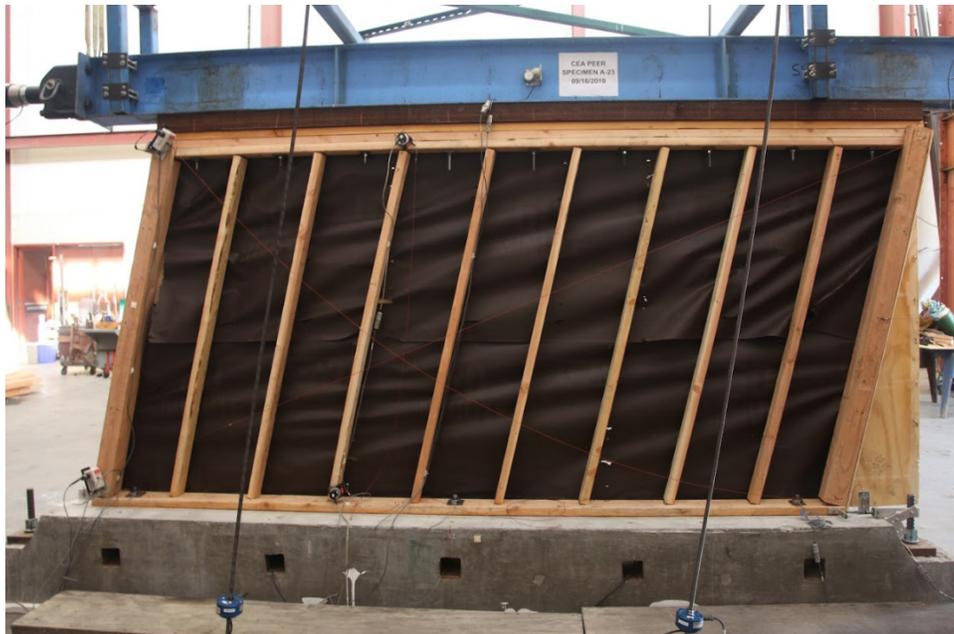
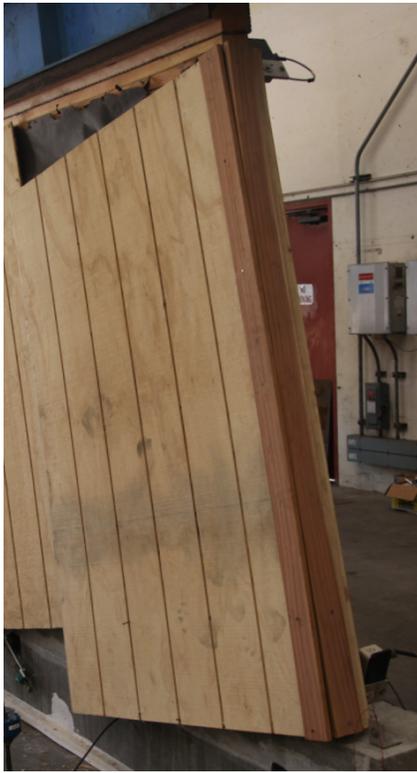
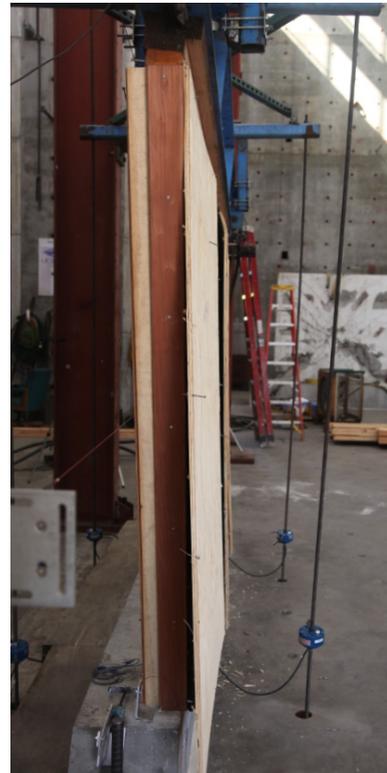
Figure 4.63 Specimen A-23 post-test photographs with lateral load = 0 kips at residual displacement = +14.33 in. @ +19.9% drift ratio after monotonic push to +15.0 in. @ +20.8% drift ratio: (a) exterior elevation; (b) interior elevation; (c) north-end exterior of wall corner view; and (d) south-end of wall corner view.

Figure 4.63 (continued).

Figure 4.63 shows photographs of the cripple wall in the residual state after a monotonic push to +15.0" (+20.8% drift ratio). The monotonic push was initiated after the 10% drift ratio cycle group, which is where an 80% drop in strength occurred. The residual state of the cripple wall had a displacement of +14.33 in. (+19.9% drift ratio).

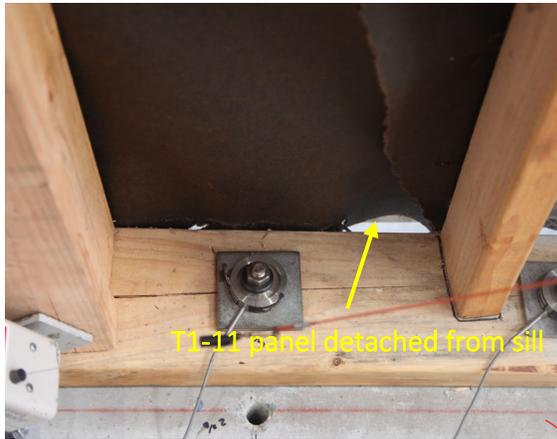
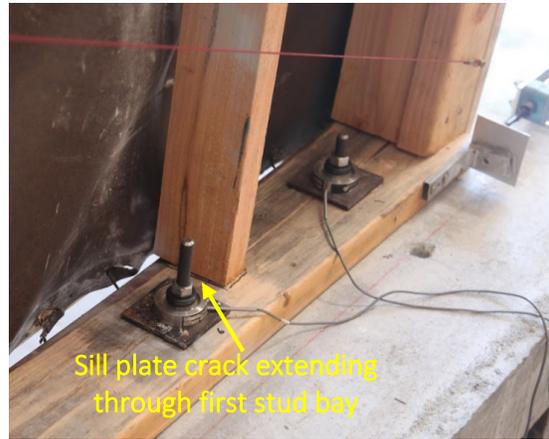
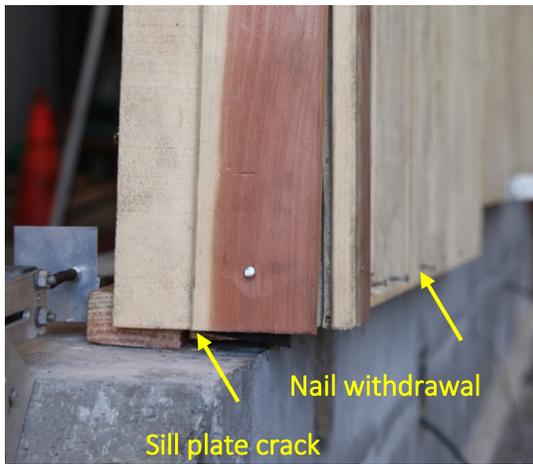
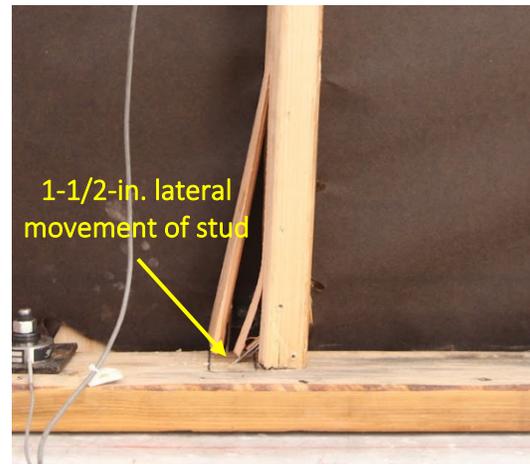
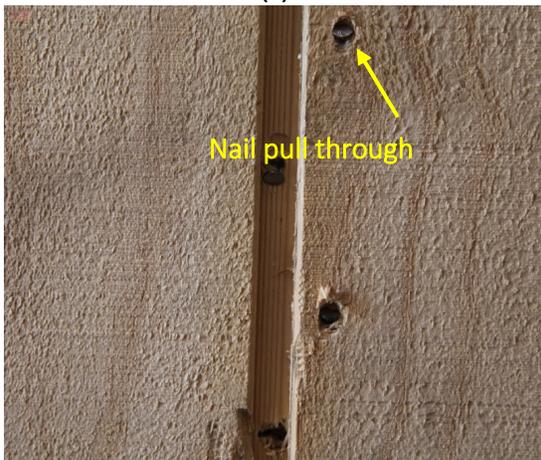
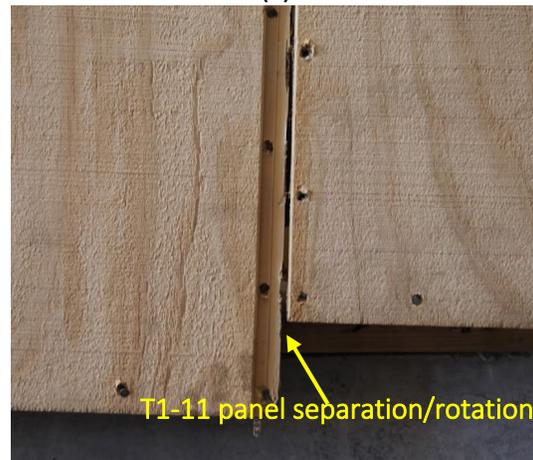
Figure 4.64 Specimen A-24 damage details for post-strength drift ratio levels: (a) bottom of south-end interior of wall view at +6% drift; (b) bottom of north-end interior of wall view at +6% drift; (c) bottom of south-end exterior of wall corner view at -6% drift; (d) bottom of middle interior of wall view at -6% drift; (e) middle exterior of wall view at -6% drift (south and middle panels); and (f) bottom exterior of wall view at -6% drift (north and middle panels).

By 10% drift, the panels were heavily rotated and had lost most of their attachment to the framing. On the interior face, the building paper had large tears. The lateral strength occurred at 3% global drift in the push direction and 2% global drift in the pull direction. The response was fairly symmetric in subsequent drift cycles. After the 4% drift ratio level, there were large drops in capacity until 6% drift, where only 40% of the capacity of the cripple wall remained. By 8% drift, less than 15% of capacity remained in the push direction and less than 10% in the pull direction. Figure 4.64 shows close-up photographs of the cripple wall at various post-strength drift ratio levels. All drift ratio levels are at 8% unless otherwise noted. Cracking of the sill plate extended to nearly two studs bays on both ends of the wall, as shown in Figure 4.64(a) and (b), where the separation of T1-11 panels from the sill plate is evident. The nails attached through the 5/8-in. sections of the panels generally pulled out from the framing while the nails attached through the 5/16-in. sections generally pulled through the panels or tore through the edges of the panels. At the panel overlaps, the T1-11 has thin sections where the fasteners had pulled through or torn through the panels in most instances, especially near the bottom of the wall; see Figure 4.64(f). Splitting of one of the studs occurred at 6% drift; see Figure 4.64(d). Previously, there had been visible bending of the studs, which is what led to the splitting of the stud.

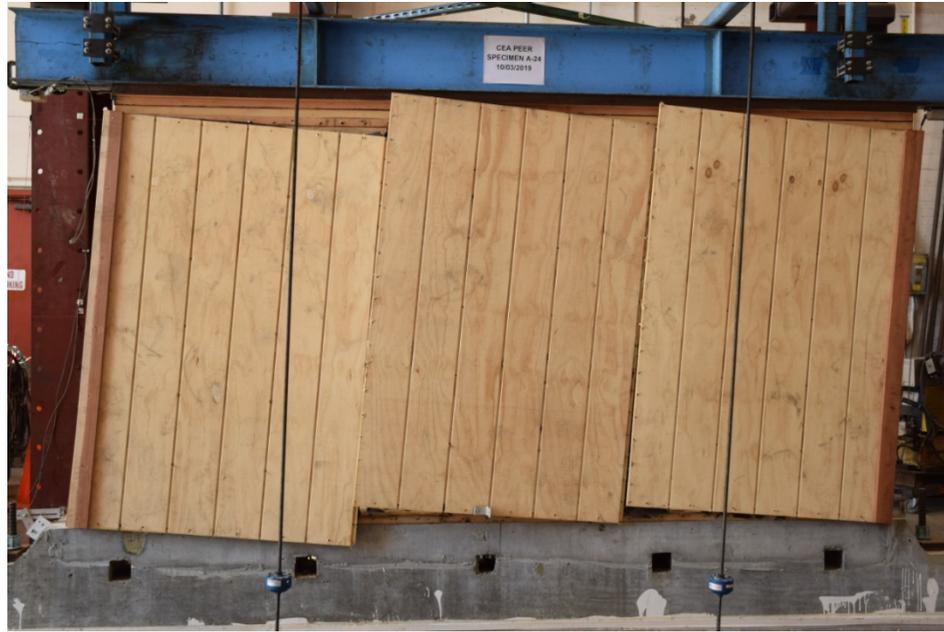
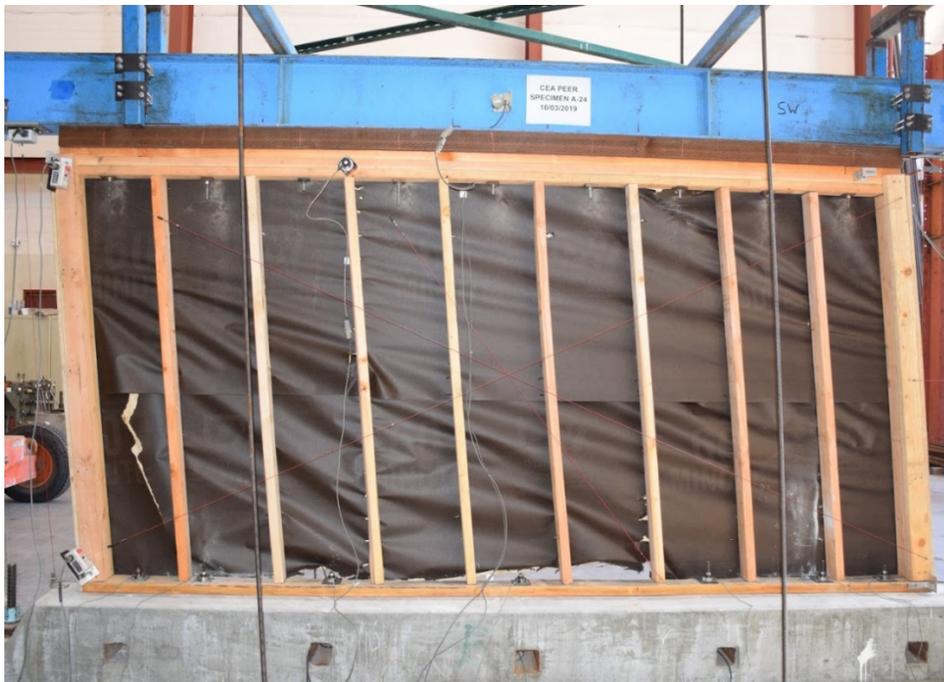
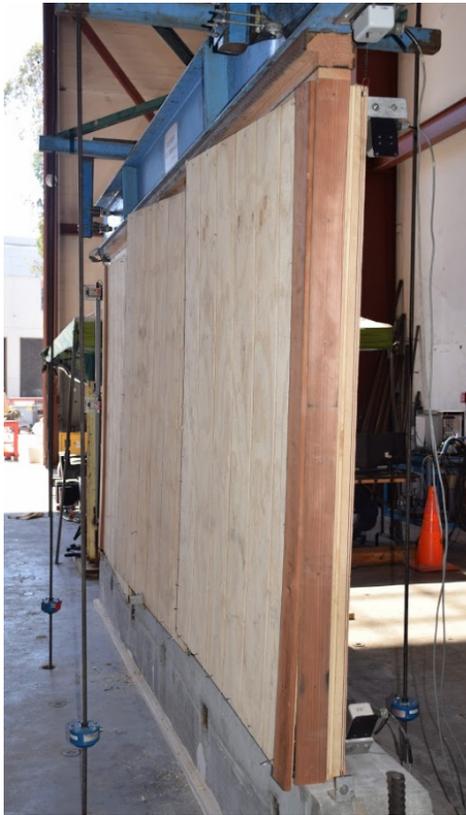
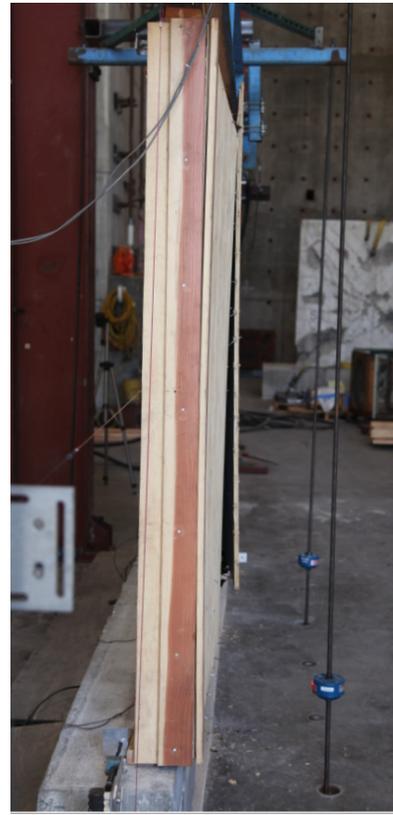
Figure 4.65 Specimen A-24 post-test photographs with lateral load = 0 kips at residual displacement = -5.63 in. @ -7.8% drift ratio after finishing the first cycle of the -8% drift ratio cycle group: (a) exterior elevation; (b) interior elevation; (c) north-end exterior of wall corner view; and (d) south-end of wall corner view.

Figure 4.65 (continued).

Figure 4.65 shows photographs of the cripple wall in the residual state reaching the target drift in the pull direction of the 8% drift ratio cycle group. The decision was made to stop the test

at this point as an 80% drop in strength had already occurred and sufficient post-strength behavior had been recorded. The residual state of the cripple wall had a displacement of -5.63 in. (-7.8% drift ratio).
