Cripple Wall Small-Component Test Program: Dry Specimens

**A Report for the “Quantifying the Performance of
Retrofit of Cripple Walls and Sill Anchorage in Single-
Family Wood-Frame Buildings” Project**

PEER Report 2020/17

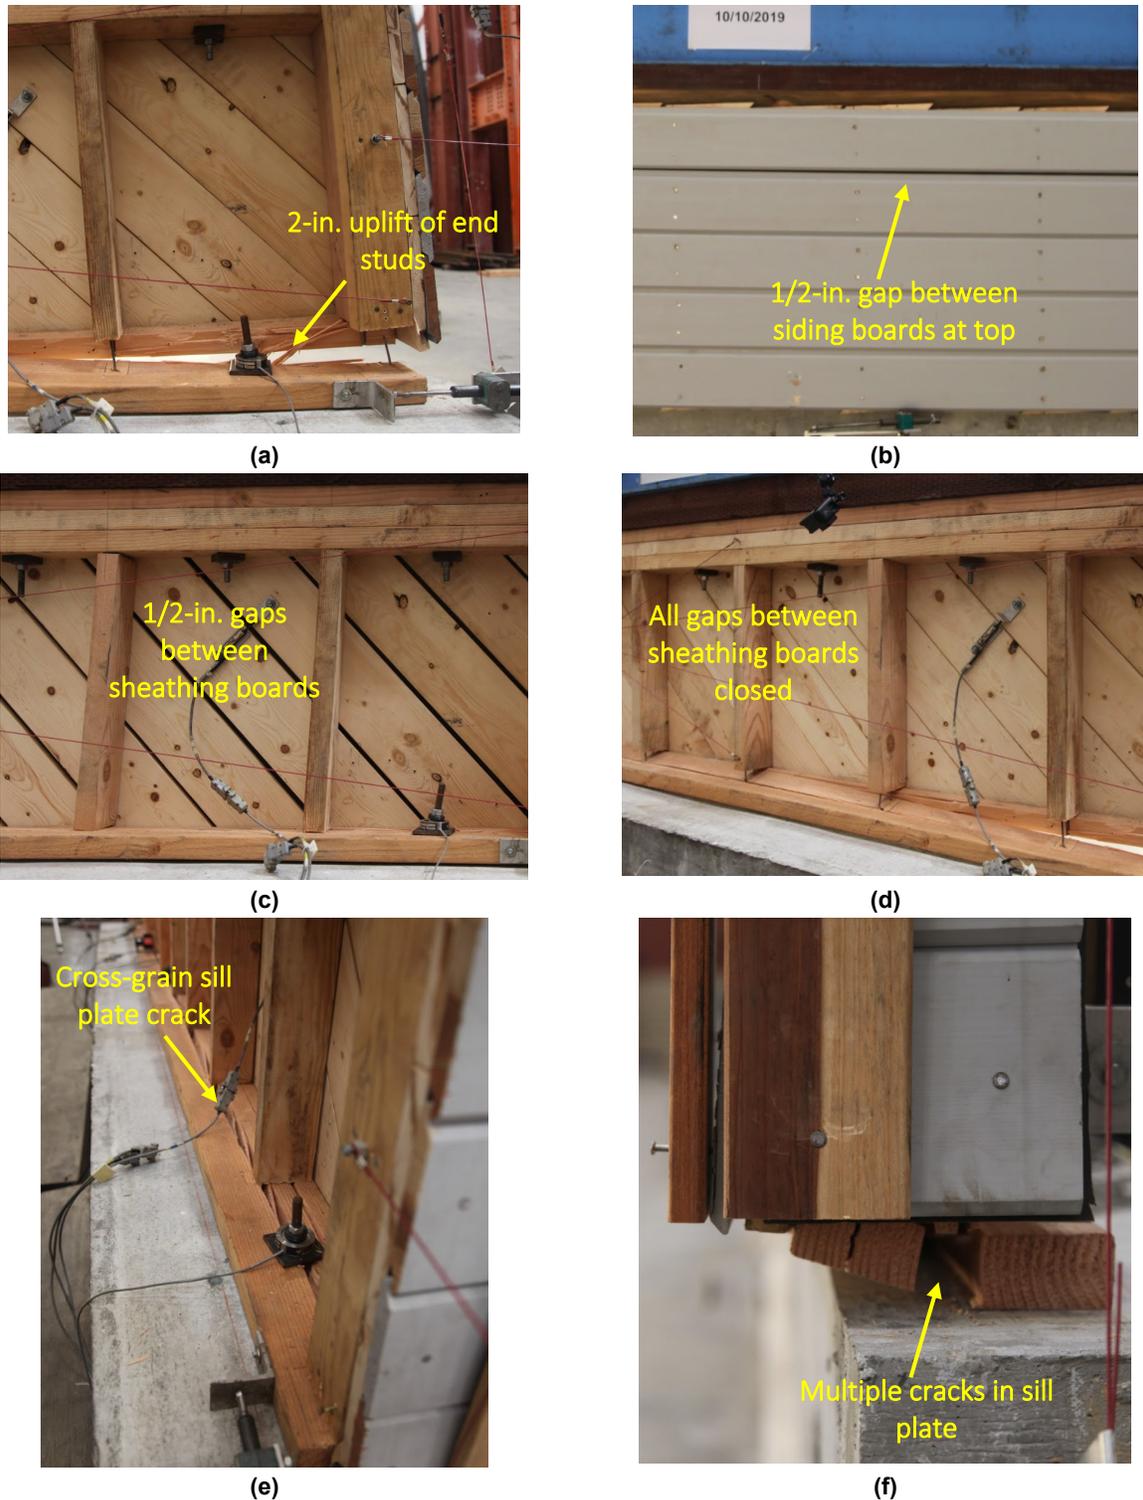
Figure 4.66 Specimen A-28 damage state details post-strength drift ratio levels: (a) bottom of south-end interior of wall view at -9% drift; (b) top of middle exterior of wall view at +10% drift; (c) middle interior of wall view at +8% drift; (d) middle interior of wall view at -8% drift; (e) bottom of south-end interior of wall view at -10% drift; and (f) bottom of north-end of wall corner view at -10% drift.

Figure 4.66 shows close-up photographs of the cripple wall at various post-strength drift ratio levels. After achieving strength in the push direction (5% global drift ratio), the cripple wall consistently had small drops in capacity. During these cycles, the strength of the wall continued to increase in the pull direction, until it peaked at 7% drift. After 7% drift, drops in capacity began to occur due to damage accumulating in the sill plate. Figure 4.66(a) shows major uplift at the corner and cracking of the sill plate. More damage to the sill plate can be seen in Figures 4.66(e) and (f). At 10% drift, the entire sill plate was nearly split in half, resulting in major drops in capacity that eventually ended the test. Like all other cripple walls with horizontal siding over diagonal sheathing, the key factors contributing to loss of strength was not attributed the finish materials detaching from the framing. On the finish face of the specimen, a large gap formed between the top two siding boards, as shown in Figure 4.66(b).

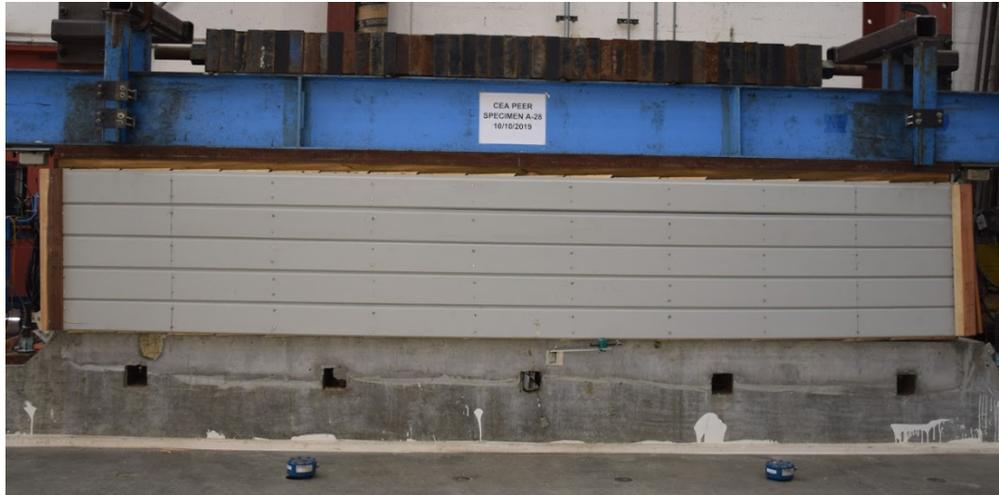
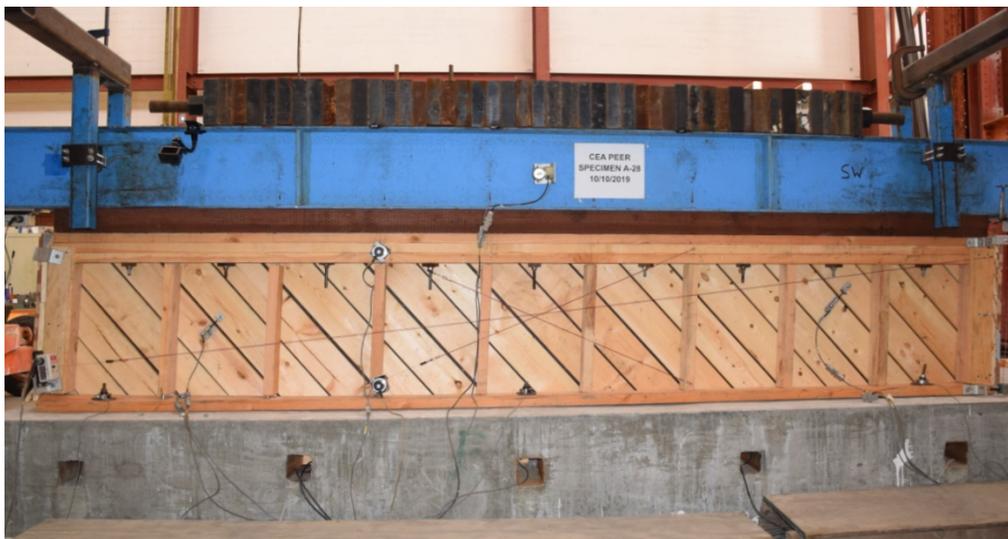
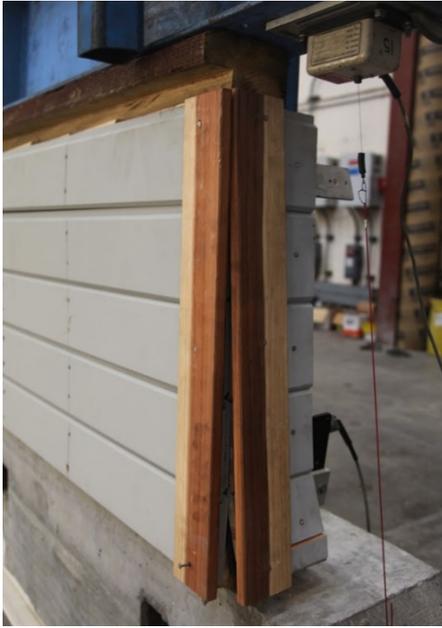
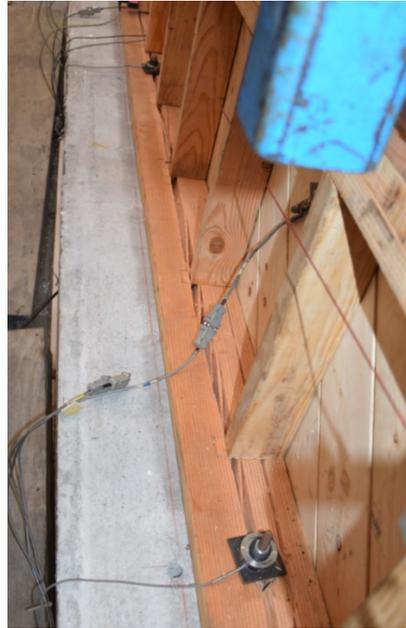
Figure 4.67 Specimen A-28 post-test photographs with lateral load = 0 kips at residual displacement = +2.49 in. @ +10.4% drift ratio after a monotonic push to +3.12 in. @ +13.0% drift ratio: (a) exterior elevation; (b) interior elevation; (c) north-end exterior of wall corner view; and (d) south-end of interior of wall view.

Figure 4.67 (continued).

Figure 4.67 shows photographs of the cripple wall in the residual state after a monotonic push to +3.12 in. (+13.0% drift ratio). At this point an 80% drop in strength had occurred. From the exterior face, the sheathing boards were visible at the top of cripple wall. From the interior face, the gaps between the sheathing boards had all closed, and there was visible bending of the sill plate. The residual state of the cripple wall had a displacement of +2.49 in. (+10.4% drift ratio).

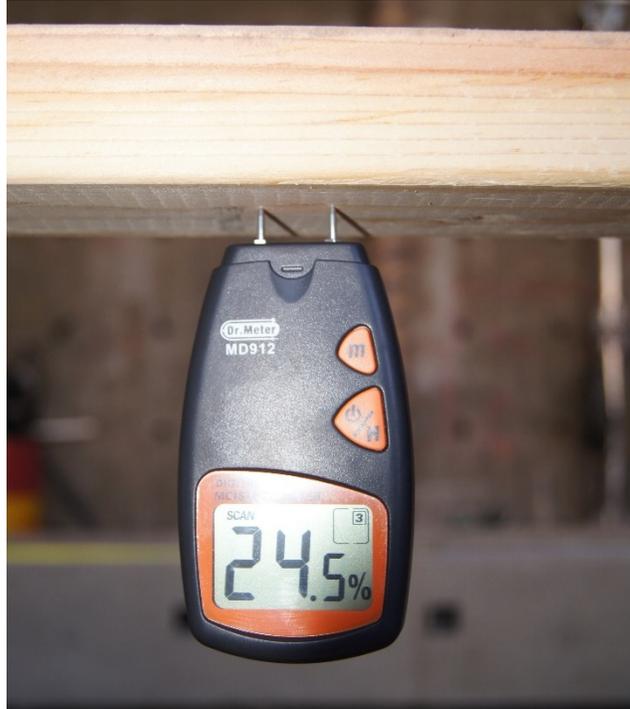
Figure A.1 MD912 digital moisture content reader in use.

The moisture content of the wood was recorded for all constructed cripple walls using an MD912 digital moisture meter, which is a pin meter with a resolution of 0.5% and accuracy of +/- 0.5%. A picture of the moisture content reader used for the project can be seen in Figure A.1. Understanding the moisture content of wood is important as drier wood has higher strength properties than fresh or moist wood. For all cripple walls, the moisture content was from 4–12% immediately prior to testing. The moisture content was read on five various places on a piece of lumber—top, bottom, middle, and sides—and then repeated on four additional pieces of the same type of lumber. The results were recorded and are displayed in Table A.1 for Phase 2 specimens and Table A.2 for Phase 4 specimens, along with the date of recording and averages for each type of lumber.

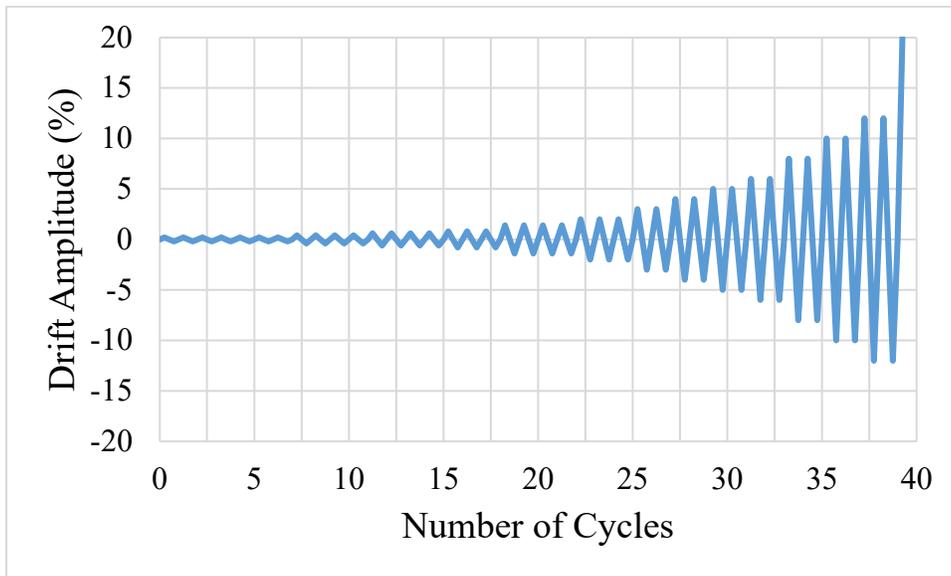
Figure A.2 Specimen A-7 loading protocol.

The following section presents a graph and table of the loading protocol for the specimens considered in this report. Overall, the loading protocol started the same for each specimen. Variations occurred at later drift ratio levels depending on the rate of post-peak strength degradation of the individual specimen. As noted in Section 2.4, all cripple walls underwent the same loading protocol up until the specimen realized a loss greater than 60% of its measured lateral strength. At this point in the protocol, the following and each subsequent drift ratio level was increased by 2%, rather than 1%. If the 60% loss in strength did not occur, each drift ratio level would remain at an increase of 1% per cycle grouping. The loading protocol would progress until an 80% loss in strength was realized. At this point, a monotonic push would be conducted, typically to a global drift of 20%. The amplitude of the monotonic push might vary slightly depending on instrumentation constraints.

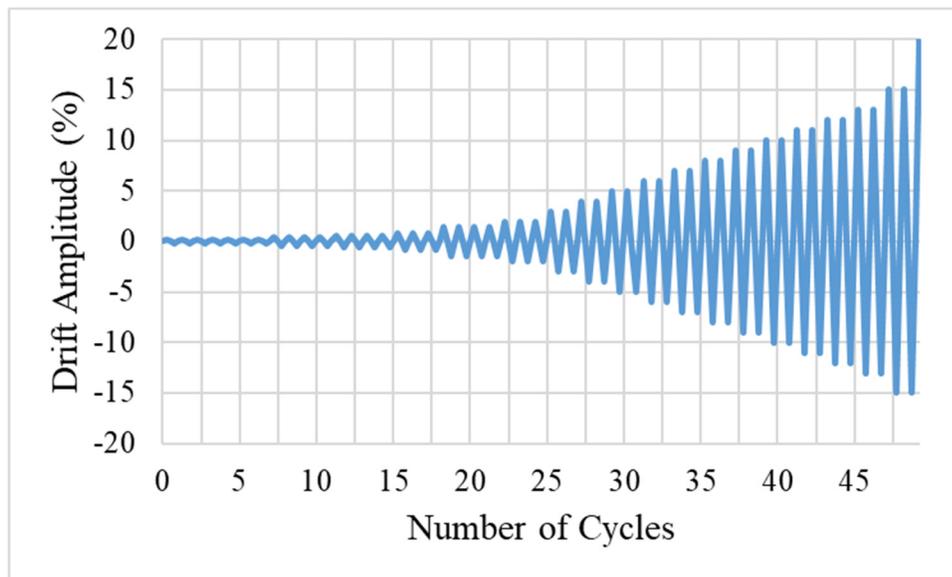
Figure A.3 Specimen A-8 loading protocol.

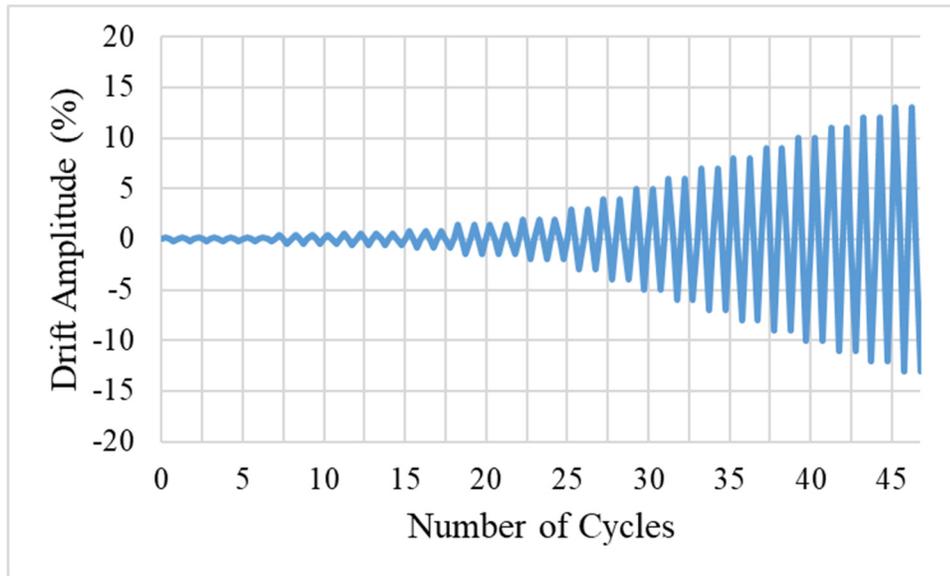
Figure A.4 Specimen A-9 loading protocol.

Table A.6 Specimen A-9 loading protocol.

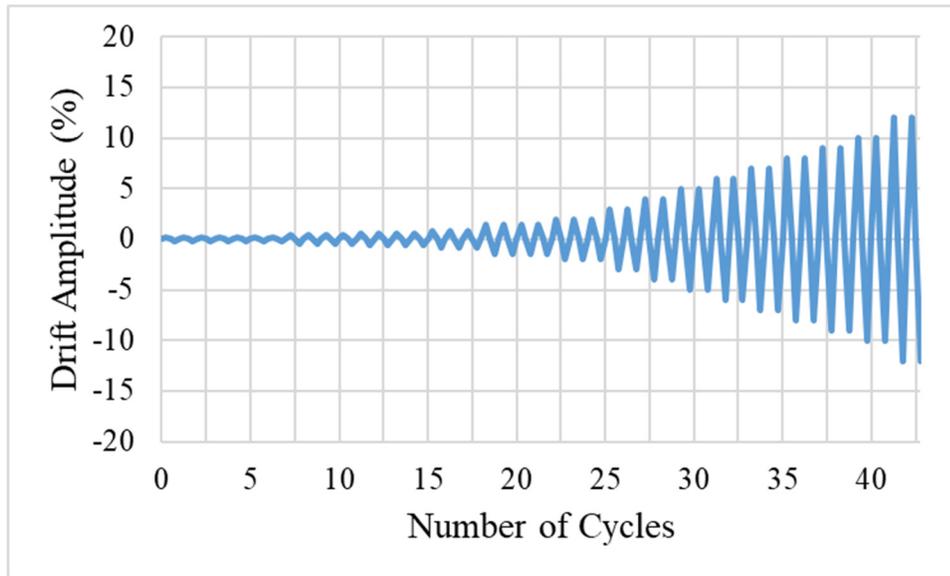
Figure A.5 Specimen A-10 loading protocol.

Table A.7 Specimen A-10 loading protocol.

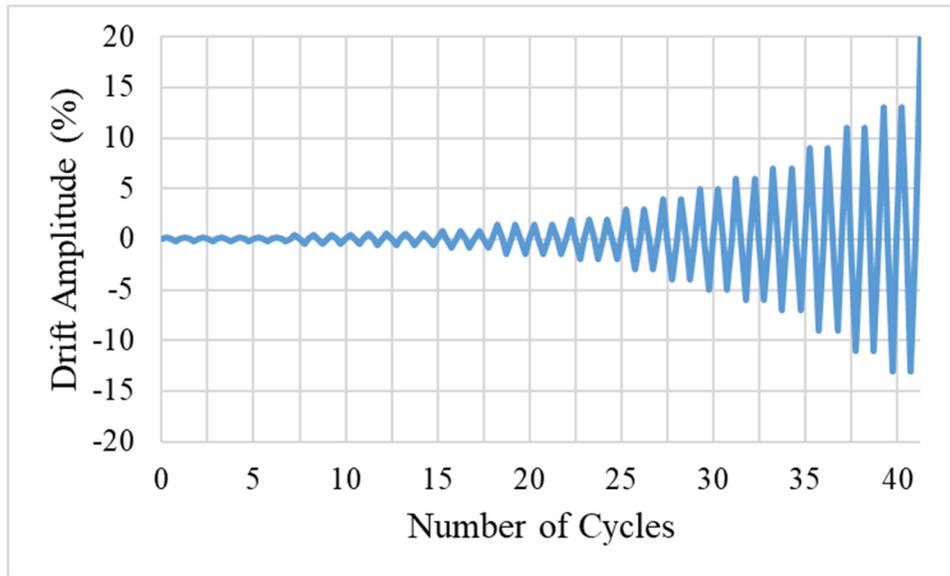
Figure A.6 Specimen A-11 loading protocol.

Table A.8 Specimen A-11 loading protocol.

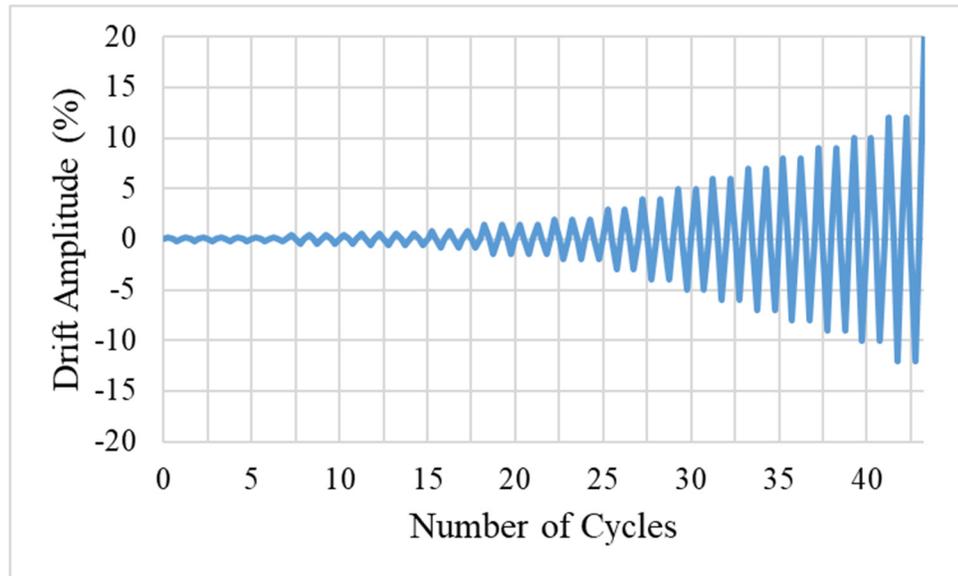
Figure A.7 Specimen A-12 loading protocol.

Table A.9 Specimen A-12 loading protocol.

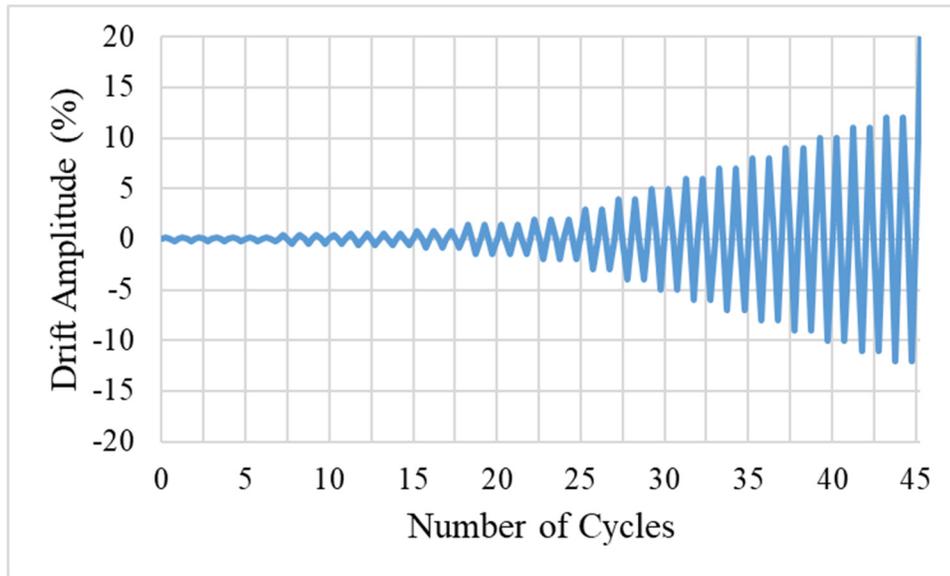
Figure A.8 Specimen A-13 loading protocol.

Table A.10 Specimen A-13 loading protocol.

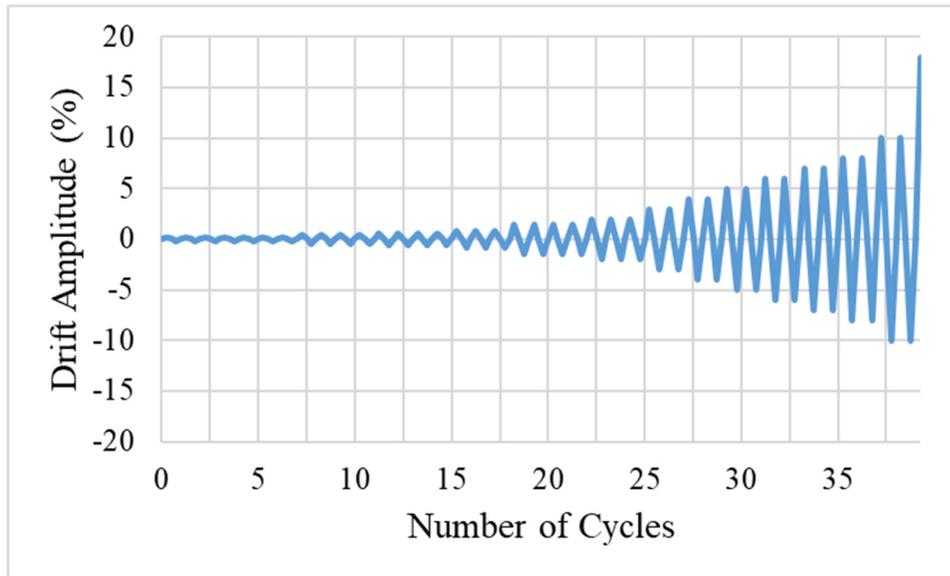
Figure A.9 Specimen A-14 loading protocol.

Table A.11 Specimen A-14 loading protocol.

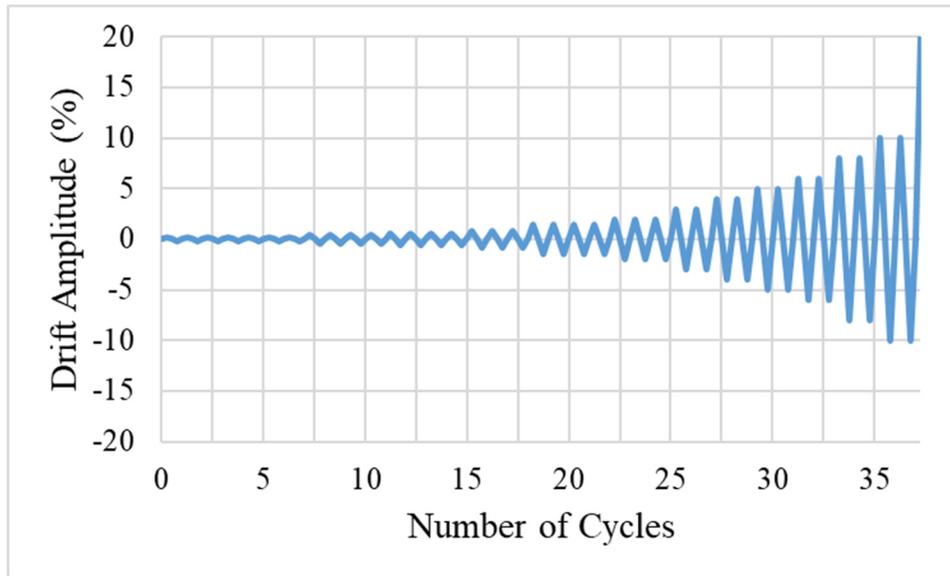
Figure A.10 Specimen A-23 loading protocol.

Table A.12 Specimen A-23 loading protocol.

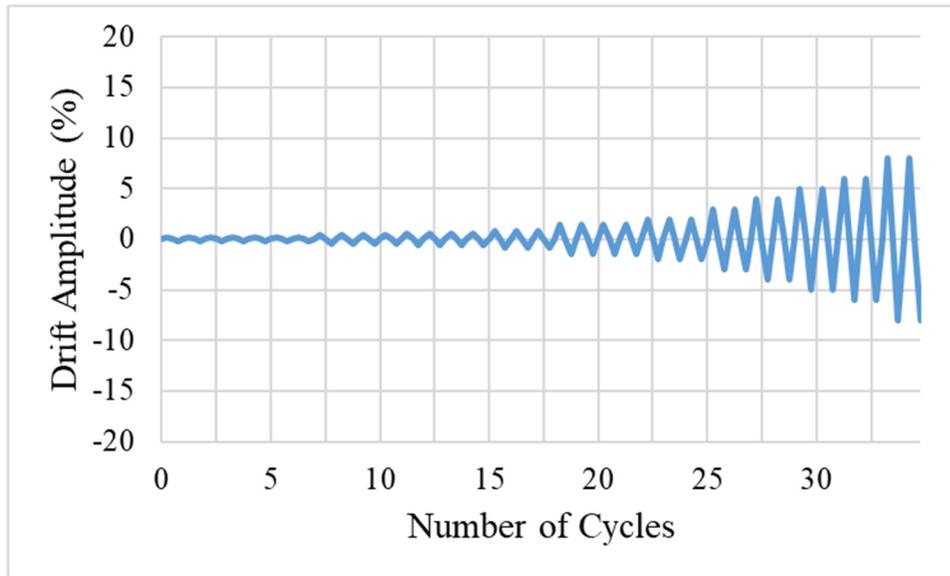
Figure A.11 Specimen A-24 loading protocol.

Table A.13 Specimen A-24 loading protocol.

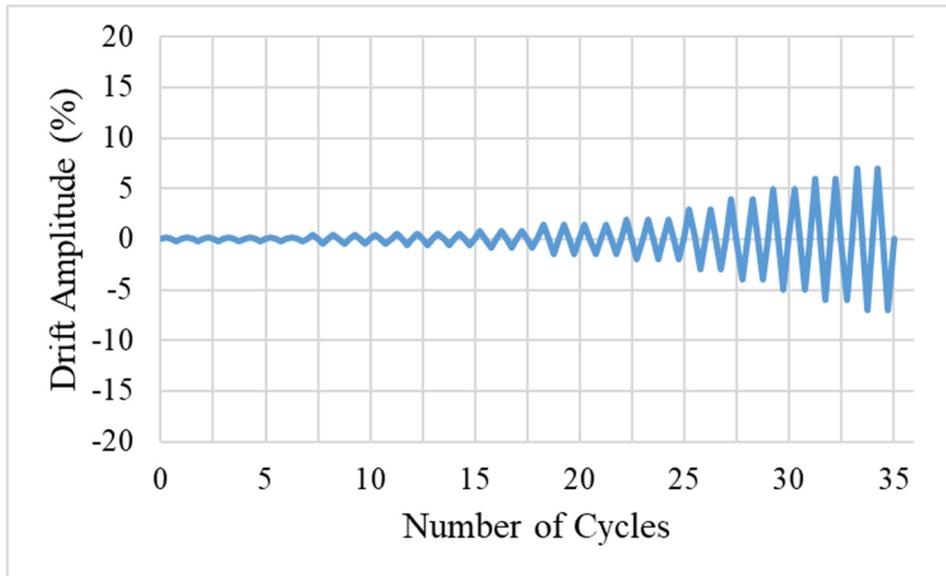
Figure A.12 Specimen A-28 loading protocol.

Table A.14 Specimen A-28 loading protocol.

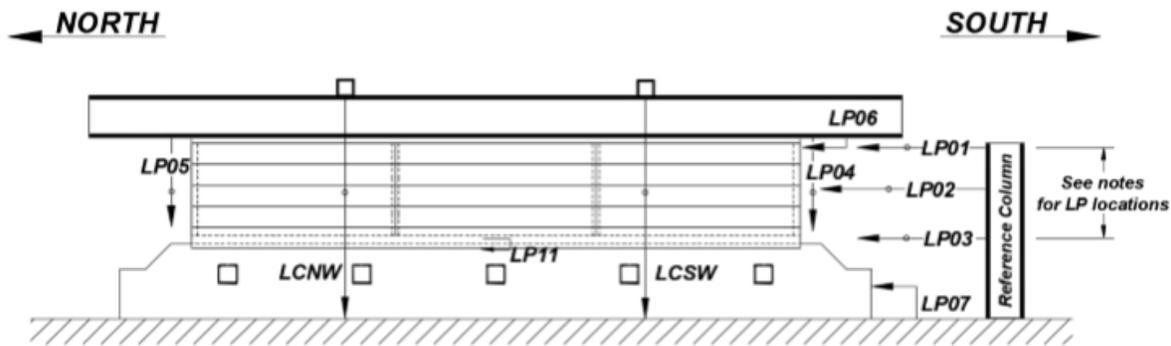
1. LP01, LP02, and LP03 measure lateral displacement with LP01 attached to middle of upper top plate, LP02 attached to middle of stud, and LP03 attached to middle of sill plate.
2. LP04 and LP05 measure the uplift at each end of the wall.
3. LP06 monitors the slip between the horizontal transfer beam and the upper top plate.
4. LP07 monitors the slip of the footing.
5. LCNW and LCSW monitor the axial load on the East Side of the wall.
6. LP11 monitors displacement of siding relative to the footing.

Instrumentation Elevation (E1)
Siding Face
2' Tall Cripple Wall

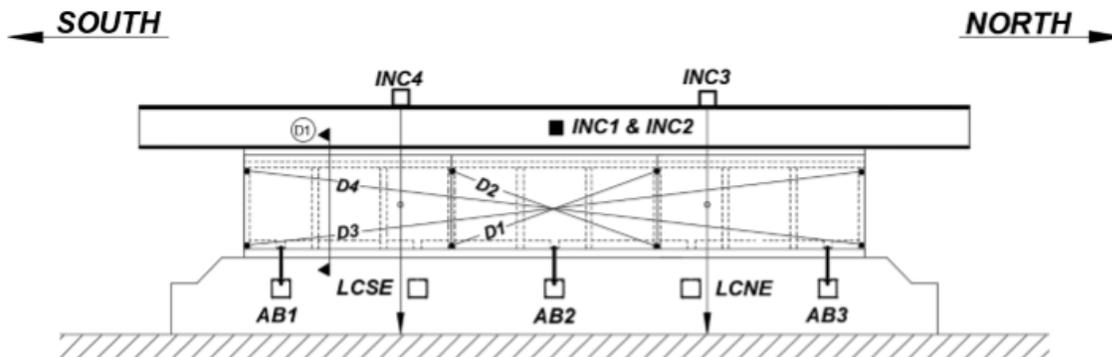
1. AB1-AB5 are instrumented with 2" Ø Donut Load Cells measuring uplift loads.
2. Pairs of strength potentiometers are mounted on framing studs or plywood panels for retrofit cases.
3. INC1 measures longitudinal rotation of load transfer beam. INC2 measures the transverse rotation of the load transfer beam.
4. INC3 and INC4 measure the rotation of the transverse beams where axial load is applied.
5. LCNE and LCSE monitor the axial load on the West Side of the wall.

Tension in anchor bolts were measured with 10-kip donut load cells placed on top of the square plate washers. A spherical washer was placed on top of the load cell and fastened with a nut. For unretrofitted cripple walls, three anchor bolts were used, spaced at 64 in. on center. For retrofitted cripple walls, additional anchor bolts were added as per the *FEMA P-1100* prescriptive retrofit guidelines. Anchor bolts were tensioned to around 0.2 kips, which is meant to mimic a hand-tightened amount of tension and representative of what would commonly be observed in the field for older homes.

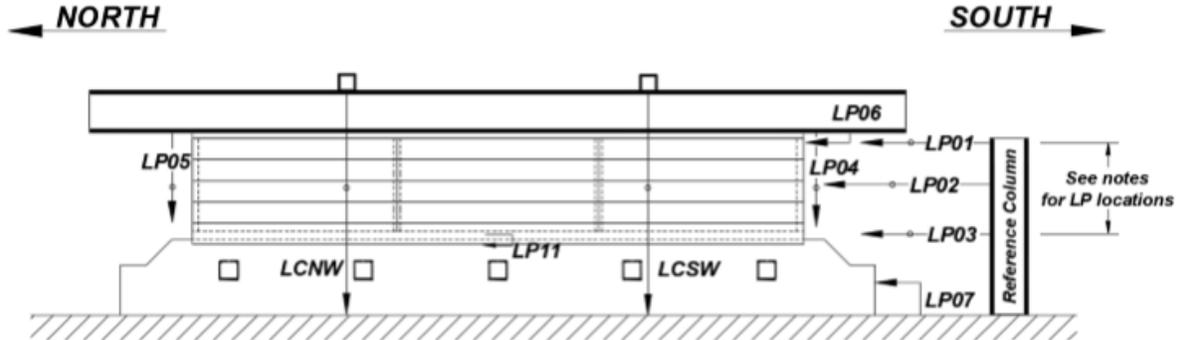
1. LP01, LP02, and LP03 measure lateral displacement with LP01 attached to middle of upper top plate, LP02 attached to middle of stud, and LP03 attached to middle of sill plate.
2. LP04 and LP05 measure the uplift at each end of the wall.
3. LP06 monitors the slip between the horizontal transfer beam and the upper top plate.
4. LP07 monitors the slip of the footing.
5. LCNW and LCSW monitor the axial load on the East Side of the wall.
6. LP11 monitors displacement of siding relative to the footing.

Instrumentation Elevation (E1) Siding Face 2' Tall Cripple Wall

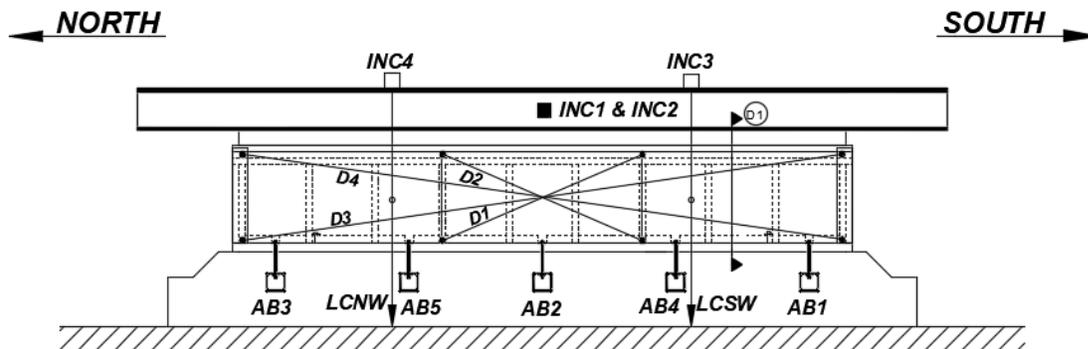
1. AB1-AB5 are instrumented with 2" \varnothing Donut Load Cells measuring uplift loads.
2. Pairs of strength potentiometers are mounted on framing studs or plywood panels for retrofit cases.
3. INC1 measures longitudinal rotation of load transfer beam. INC2 measures the transverse rotation of the load transfer beam.
4. INC3 and INC4 measure the rotation of the transverse beams where axial load is applied.
5. LCNW and LCSW monitor the axial load on the West Side of the wall.

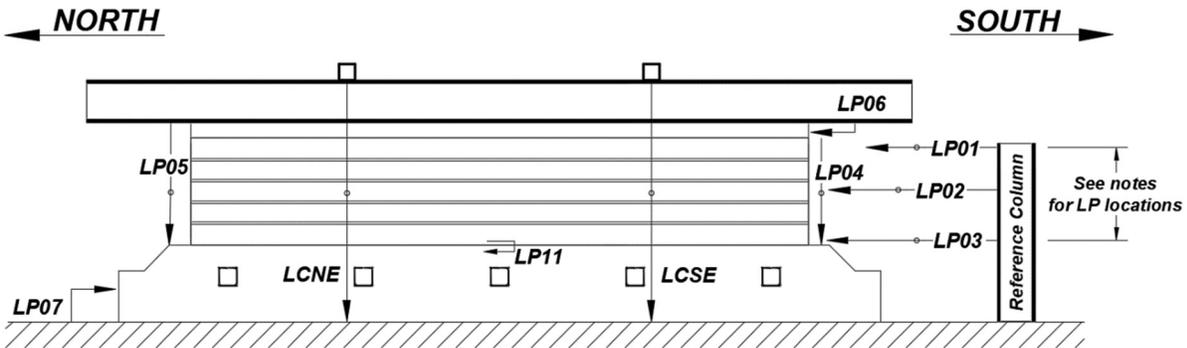
1. LP01, LP02, and LP03 measure lateral displacement with LP01 attached to middle of second top plate, LP02 attached to middle of stud, and LP03 attached to middle of sill plate.
2. LP04 and LP05 measure the uplift at each end of the wall.
3. LP06 monitors the slip between the horizontal transfer beam and the upper top plate.
4. LP07 monitors the slip of the footing.
5. LCNE and LCSE monitor the axial load on the East Side of the wall.
6. LP11 monitors displacement of siding relative to the footing.

Instrumentation Elevation (E1)

Finish Face 2' Tall Cripple Wall

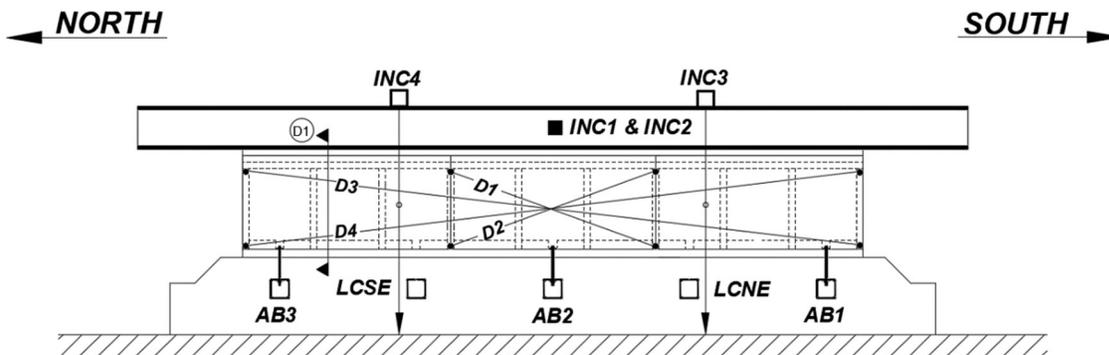
Figure B.3 Specimen A-9 instrumentation.

1. AB1-AB5 are instrumented with 2" Ø Donut Load Cells measuring uplift loads.
2. Pairs of strength potentiometers are mounted on framing studs or plywood panels for retrofit cases.
3. INC1 measures longitudinal rotation of load transfer beam. INC2 measures the transverse rotation of the load transfer beam.
4. INC3 and INC4 measure the rotation of the transverse beams where axial load is applied.
5. LCNE and LCSE monitor the axial load on the East Side of the wall.

Framing Face 2' Tall Cripple Wall

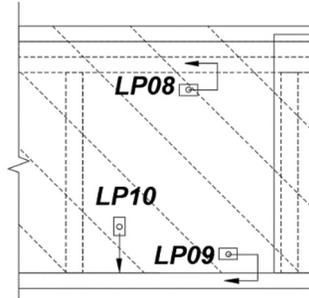
1. LP08 and LP09 monitor the sheathing slip.
2. LP10 monitors the sheathing uplift

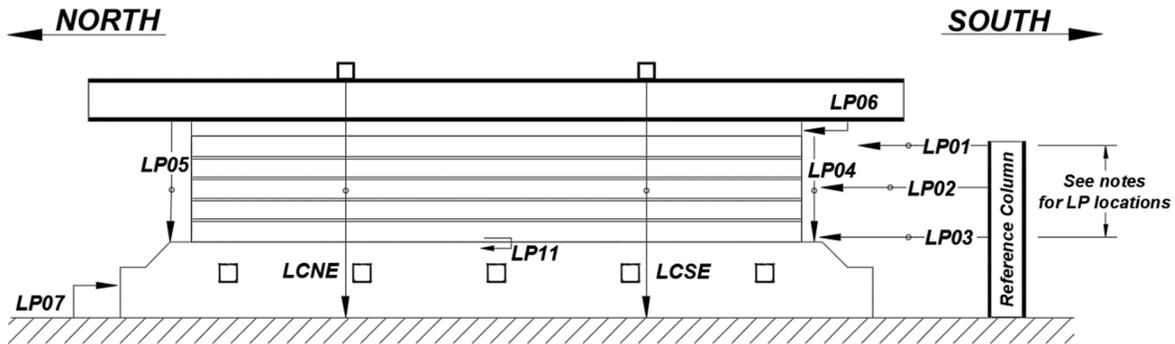
1. LP01, LP02, and LP03 measure lateral displacement with LP01 attached to middle of second top plate, LP02 attached to middle of stud, and LP03 attached to middle of sill plate.
2. LP04 and LP05 measure the uplift at each end of the wall.
3. LP06 monitors the slip between the horizontal transfer beam and the upper top plate.
4. LP07 monitors the slip of the footing.
5. LCNE and LCSE monitor the axial load on the East Side of the wall.
6. LP11 monitors displacement of siding relative to the footing.

Instrumentation Elevation (E1) Finish Face 2' Tall Cripple Wall

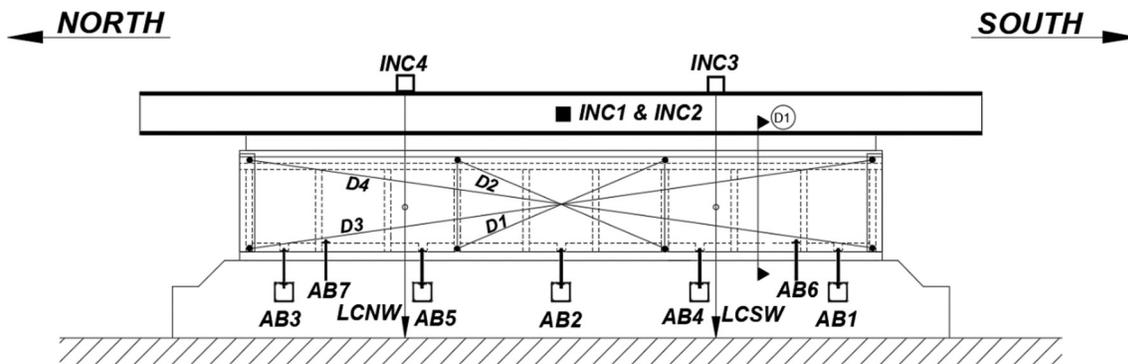
Figure B.4 Specimen A-10 instrumentation.

1. AB1-AB7 are instrumented with 2" Ø Donut Load Cells measuring uplift loads.
2. Pairs of strength potentiometers are mounted on framing studs or plywood panels for retrofit cases.
3. INC1 measures longitudinal rotation of load transfer beam. INC2 measures the transverse rotation of the load transfer beam.
4. INC3 and INC4 measure the rotation of the transverse beams where axial load is applied.
5. LCNW and LCSW monitor the axial load on the West Side of the wall.

Instrumentation Elevation (E2) Framing Face 2' Tall Cripple Wall

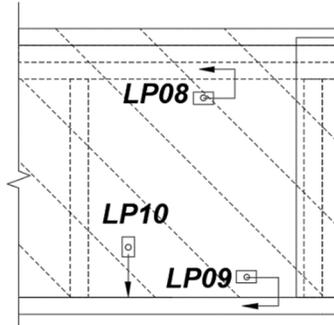
1. LP08 and LP09 monitor the sheathing slip.
2. LP10 monitors the sheathing uplift

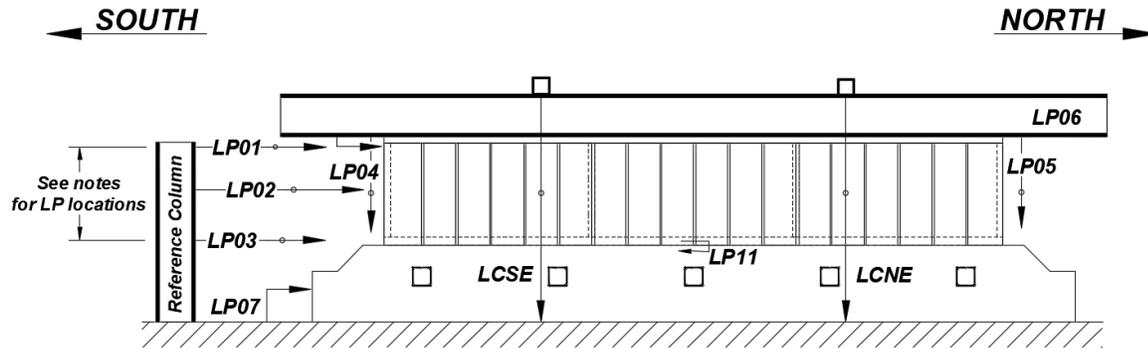
1. LP01, LP02, and LP03 measure lateral displacement with LP01 attached to middle of upper top plate, LP02 attached to middle of stud, and LP03 attached to middle of sill plate.
2. LP04 and LP05 measure the uplift at each end of the wall.
3. LP06 monitors the slip between the horizontal transfer beam and the upper top plate.
4. LP07 monitors the slip of the footing.
5. LCNW and LCSW monitor the axial load on the West Side of the wall.
6. LP11 monitors displacement of siding relative to the footing.

Instrumentation Elevation (E1)

Panel Face 2' Tall Cripple Wall

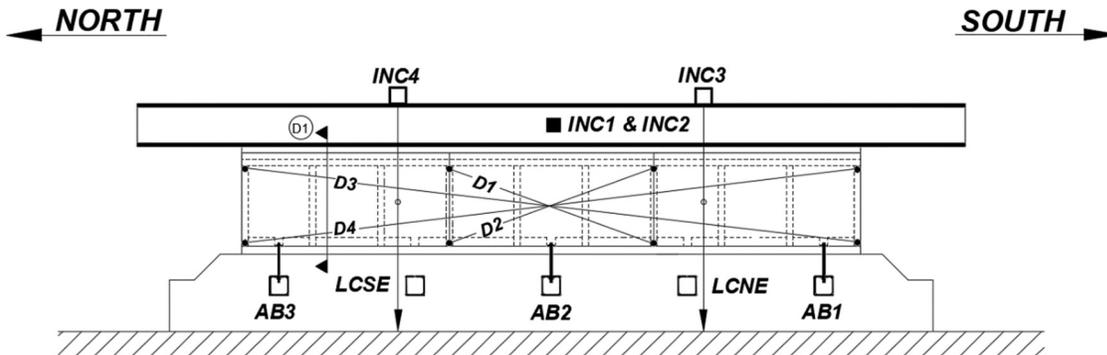
Figure B.6 Specimen A-11 instrumentation.

1. AB1-AB5 are instrumented with 2" Ø Donut Load Cells measuring uplift loads.
2. Pairs of strength potentiometers are mounted on framing studs or plywood panels for retrofit cases.
3. INC1 measures longitudinal rotation of load transfer beam. INC2 measures the transverse rotation of the load transfer beam.
4. INC3 and INC4 measure the rotation of the transverse beams where axial load is applied.
5. LCNE and LCSE monitor the axial load on the East Side of the wall.

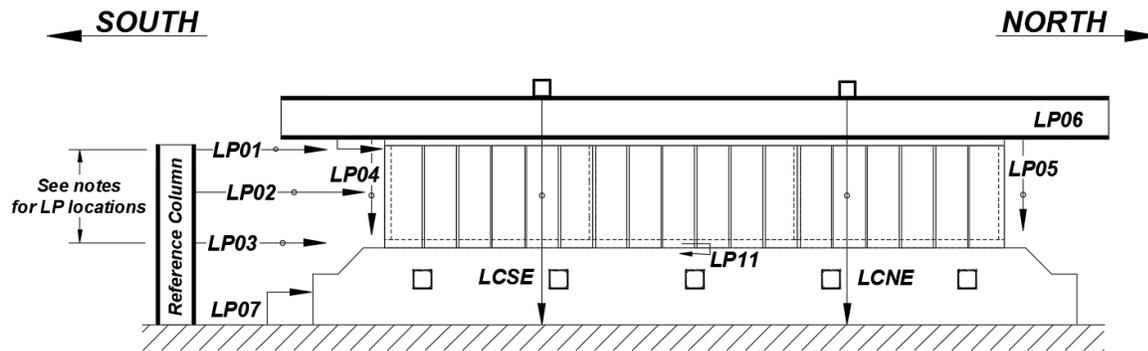
1. LP01, LP02, and LP03 measure lateral displacement with LP01 attached to middle of upper top plate, LP02 attached to middle of stud, and LP03 attached to middle of sill plate.
2. LP04 and LP05 measure the uplift at each end of the wall.
3. LP06 monitors the slip between the horizontal transfer beam and the upper top plate.
4. LP07 monitors the slip of the footing.
5. LCNW and LCSW monitor the axial load on the West Side of the wall.
6. LP11 monitors displacement of siding relative to the footing.

Instrumentation Elevation (E1) Panel Face 2' Tall Cripple Wall

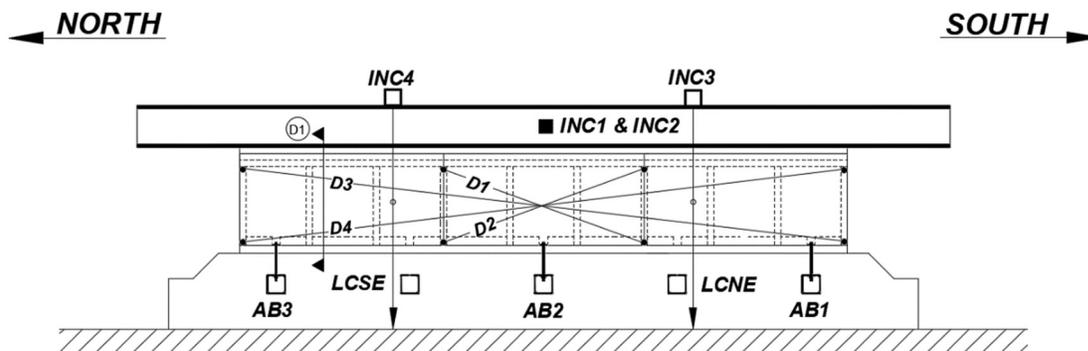
Figure B.7 Specimen A-12 instrumentation.

1. AB1-AB5 are instrumented with 2" \varnothing Donut Load Cells measuring uplift loads.
2. Pairs of strength potentiometers are mounted on framing studs or plywood panels for retrofit cases.
3. INC1 measures longitudinal rotation of load transfer beam. INC2 measures the transverse rotation of the load transfer beam.
4. INC3 and INC4 measure the rotation of the transverse beams where axial load is applied.
5. LCNE and LCSE monitor the axial load on the East Side of the wall.

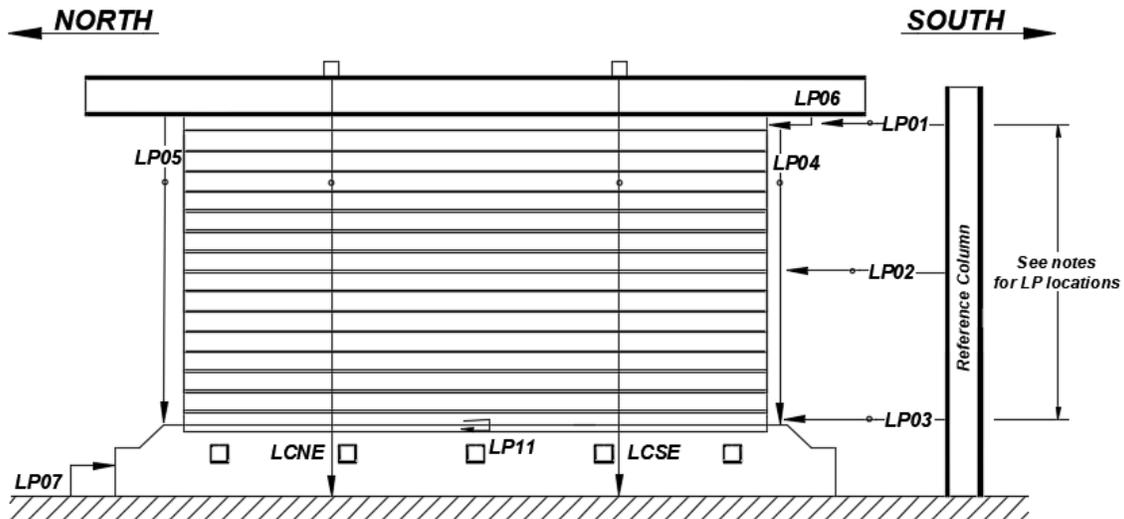
Figure B.8 Specimen A-13 instrumentation.

1. LP01, LP02, and LP03 measure lateral displacement with LP01 attached to middle of second top plate, LP02 attached to middle of stud, and LP03 attached to middle of sill plate.
2. LP04 and LP05 measure the uplift at each end of the wall.
3. LP06 monitors the slip between the horizontal transfer beam and the upper top plate.
4. LP07 monitors the slip of the footing.
5. LCNE and LCSE monitor the axial load on the East Side of the wall.
6. LP11 monitors displacement of siding relative to the footing.

Instrumentation Elevation (E1) Finish Face 6' Tall Cripple Wall

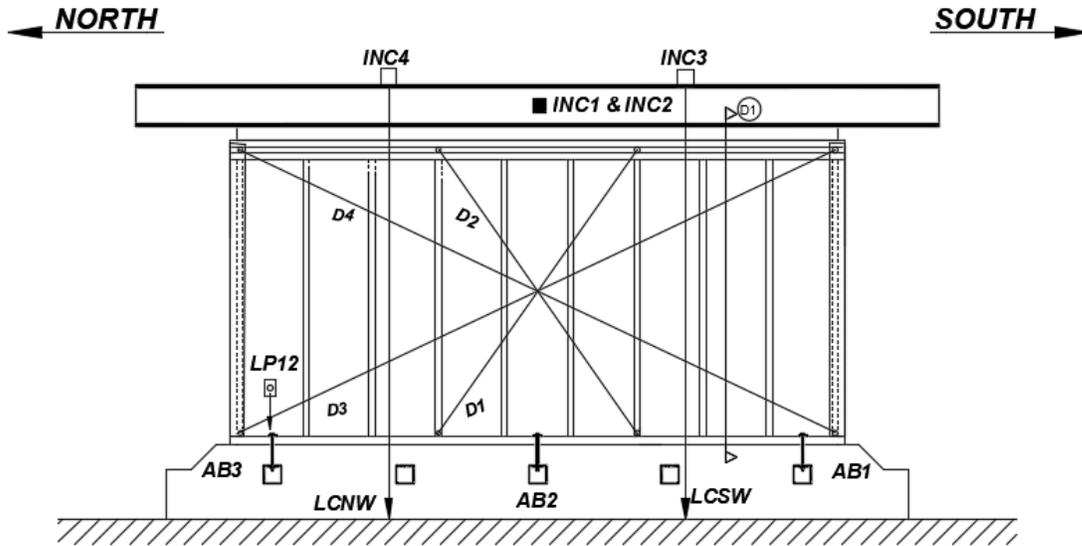
1. AB1-AB3 are instrumented with 2" Ø Donut Load Cells measuring uplift loads.
2. Pairs of strength potentiometers are mounted on framing studs or plywood panels for retrofit cases.
3. INC1 measures longitudinal rotation of load transfer beam. INC2 measures the transverse rotation of the load transfer beam.
4. INC3 and INC4 measure the rotation of the transverse beams where axial load is applied.
5. LCNW and LCSW monitor the axial load on the West Side of the wall.
6. LP12 monitors the uplift of the bottom siding board relative to the sill plate.

Instrumentation Elevation (E2)
Framing Face
6' Tall Cripple Wall

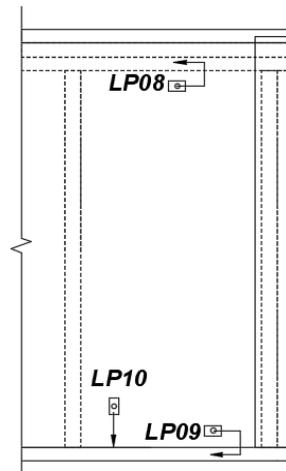
1. LP08 and LP09 monitor the sheathing slip.
2. LP10 monitors the sheathing uplift

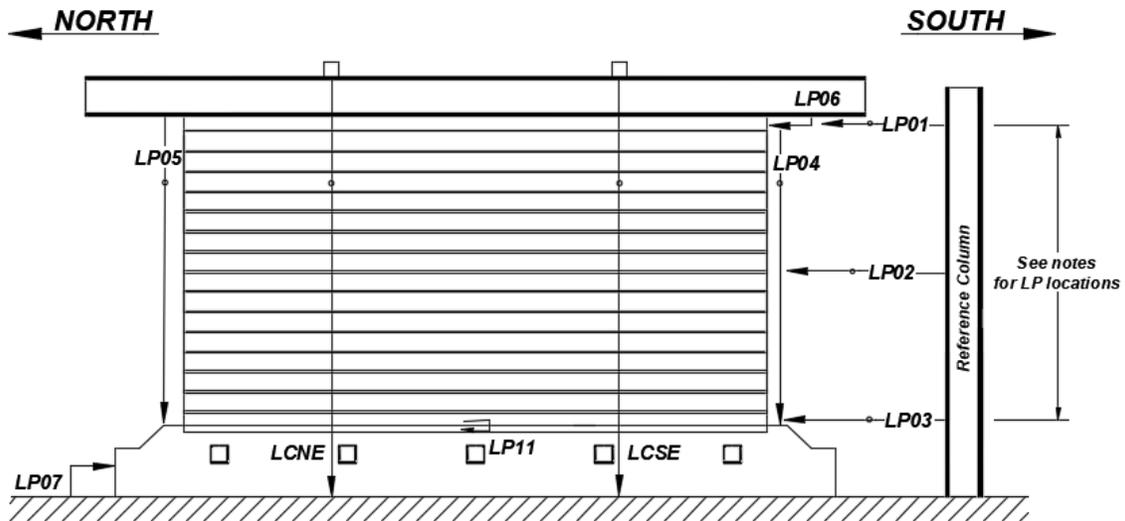
1. LP01, LP02, and LP03 measure lateral displacement with LP01 attached to middle of second top plate, LP02 attached to middle of stud, and LP03 attached to middle of sill plate.
2. LP04 and LP05 measure the uplift at each end of the wall.
3. LP06 monitors the slip between the horizontal transfer beam and the upper top plate.
4. LP07 monitors the slip of the footing.
5. LCNE and LCSE monitor the axial load on the East Side of the wall.
6. LP11 monitors displacement of siding relative to the footing.

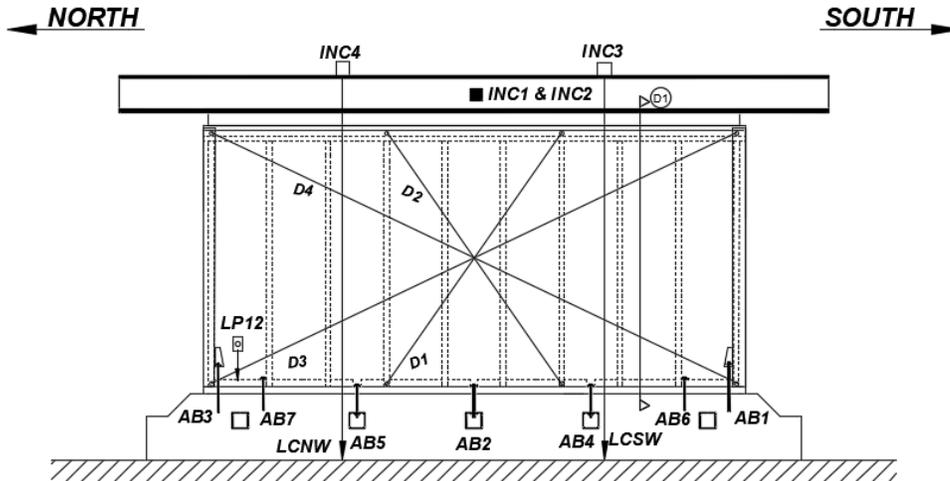
Figure B.9 Specimen A-14 instrumentation

1. AB1-AB7 are instrumented with 2" Ø Donut Load Cells measuring uplift loads.
2. Pairs of strength potentiometers are mounted on framing studs or plywood panels for retrofit cases.
3. INC1 measures longitudinal rotation of load transfer beam. INC2 measures the transverse rotation of the load transfer beam.
4. INC3 and INC4 measure the rotation of the transverse beams where axial load is applied.
5. LCNW and LCSW monitor the axial load on the West Side of the wall.

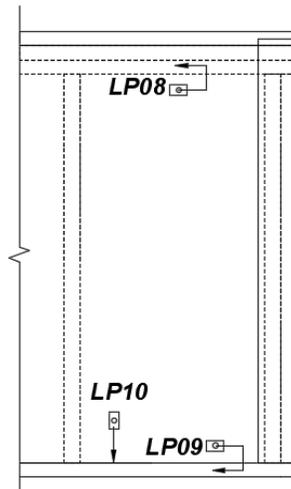
**Framing Face
6' Tall Cripple Wall**

1. LP08 and LP09 monitor the sheathing slip.
2. LP10 monitors the sheathing uplift
