Cripple Wall Small-Component Test Program: Dry Specimens

**A Report for the “Quantifying the Performance of
Retrofit of Cripple Walls and Sill Anchorage in Single-
Family Wood-Frame Buildings” Project**

PEER Report 2020/17

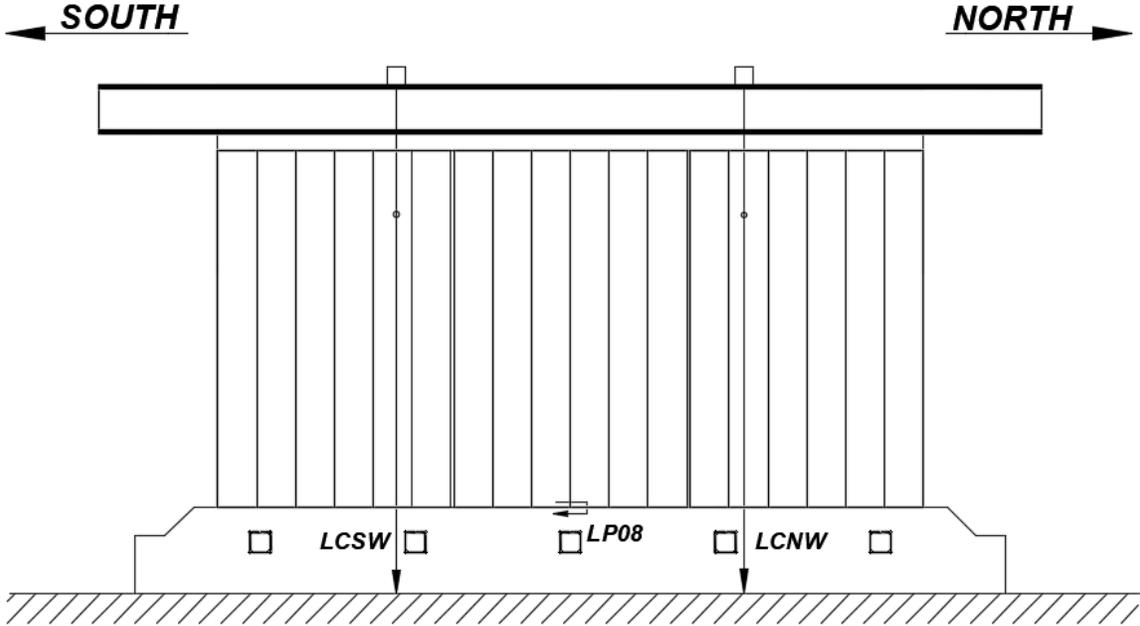
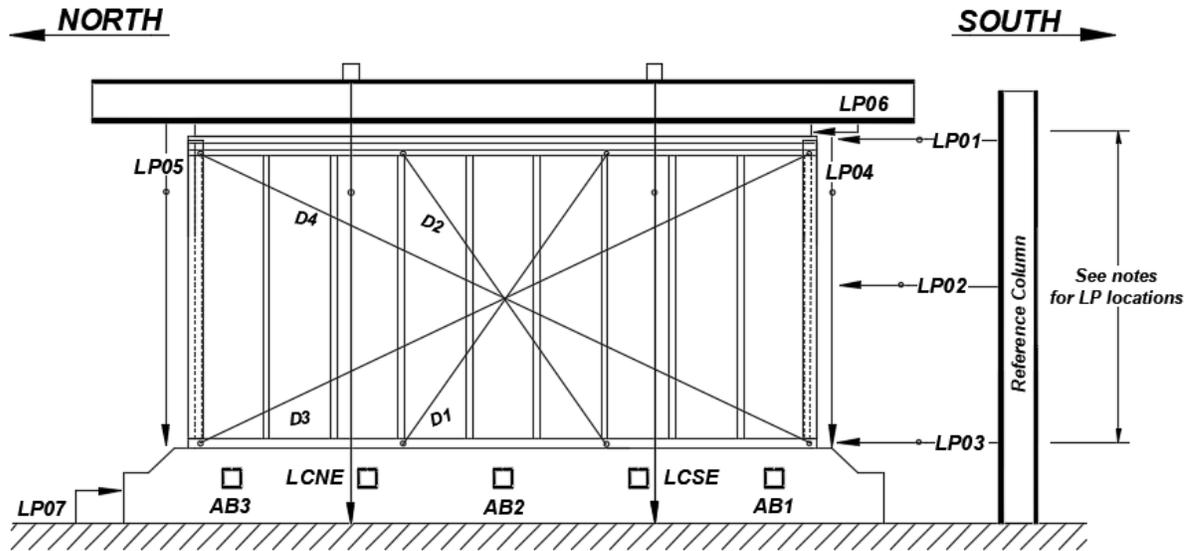
Figure B.9 Specimen A-23 instrumentation.

- 1. LP08 monitors the out-of-plane displacement of the middle T1-11 panel.
- 2. LCNE and LCSE monitor the axial load on the East Side of the wall.

Instrumentation Elevation (E1)
Finish Face
T1-11 6' Tall Cripple Wall

1. LP01, LP02, and LP03 measure lateral displacement with LP01 attached to middle of second top plate, LP02 attached to middle of stud, and LP03 attached to middle of sill plate.
2. LP04 and LP05 measure the uplift at each end of the wall.
3. LP06 monitors the slip between the horizontal transfer beam and the upper top plate.
4. LP07 monitors the slip of the footing.
5. LCNE and LCSE monitor the axial load on the East Side of the wall.

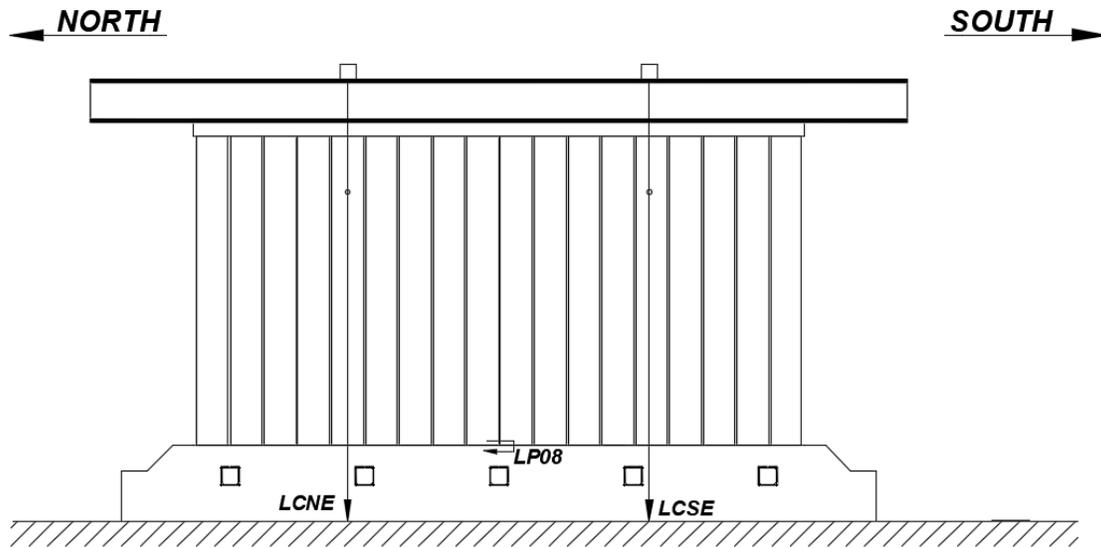
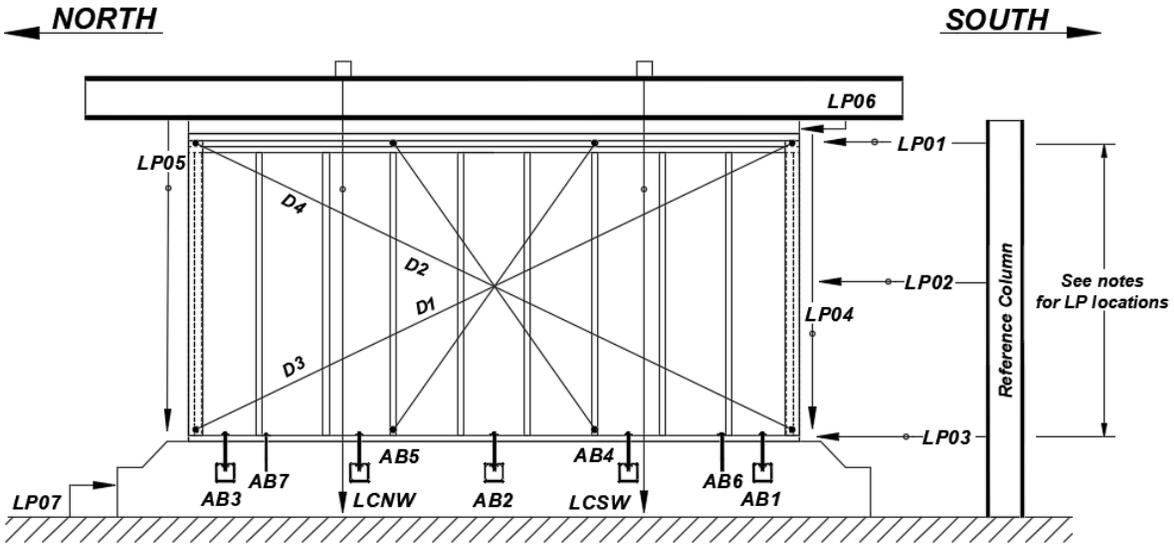
Figure B.10 Specimen A-24 instrumentation.

1. LCNE and LCSE monitor the axial load on the East Side of the wall.
2. LP08 monitors displacement of siding relative to the footing.

**Finish Face
6' T1-11 Retrofitted
Cripple Wall**

1. LP01, LP02, and LP03 measure lateral displacement with LP01 attached to middle of second top plate, LP02 attached to middle of stud, and LP03 attached to middle of sill plate.
2. LP04 and LP05 measure the uplift at each end of the wall.
3. LP06 monitors the slip between the horizontal transfer beam and the upper top plate.
4. LP07 monitors the slip of the footing.
5. LCNW and LCSW monitor the axial load on the East Side of the wall.

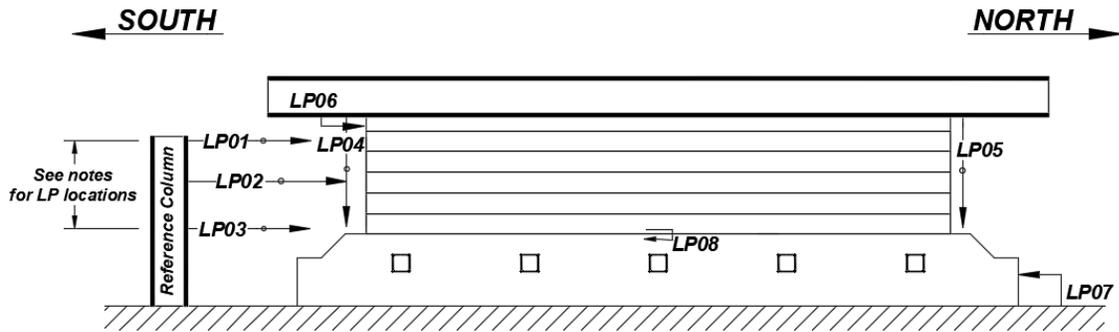
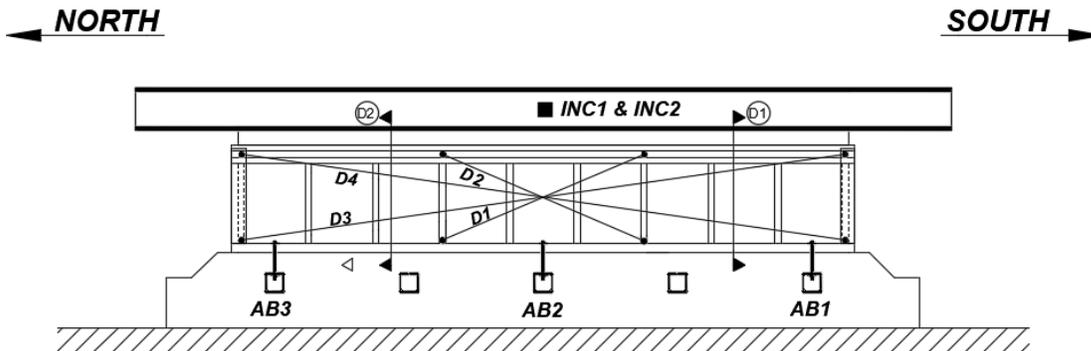
Figure B.11 Specimen A-28 instrumentation.

1. LP01, LP02, and LP03 measure lateral displacement with LP01 attached to middle of upper top plate, LP02 attached to middle of stud, and LP03 attached to middle of sill plate.
2. LP04 and LP05 measure the uplift at each end of the wall.
3. LP06 monitors the slip between the horizontal transfer beam and the upper top plate.
4. LP07 monitors the slip of the footing.
5. LP08 monitors displacement of bottom siding board relative to the footing.

Instrumentation Elevation (E1) Finish Face 2' Tall Cripple Wall

1. AB1-AB3 are instrumented with 2" Ø Donut Load Cells measuring uplift loads.
2. Pairs of strength potentiometers are mounted on framing studs or plywood panels for retrofit cases.
3. INC1 measures longitudinal rotation of load transfer beam. INC2 measures the transverse rotation of the load transfer beam.

Instrumentation Elevation (E2) Framing Face 2' Tall Cripple Wall

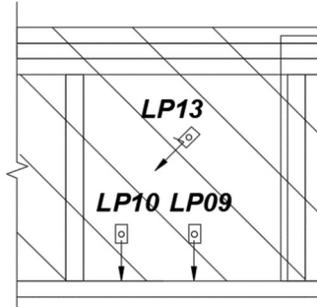
Instrumentation Detail (D1)
Sheathing

1. LP09 and LP10 monitor the sheathing uplift.
2. LP13 monitors sheathing board gap.

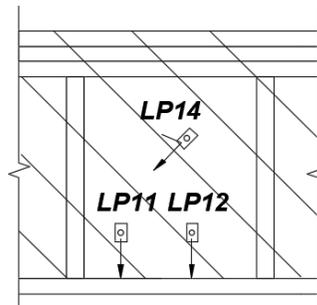
1. LP11 and LP12 monitor the sheathing uplift.
2. LP14 monitors sheathing board gap.

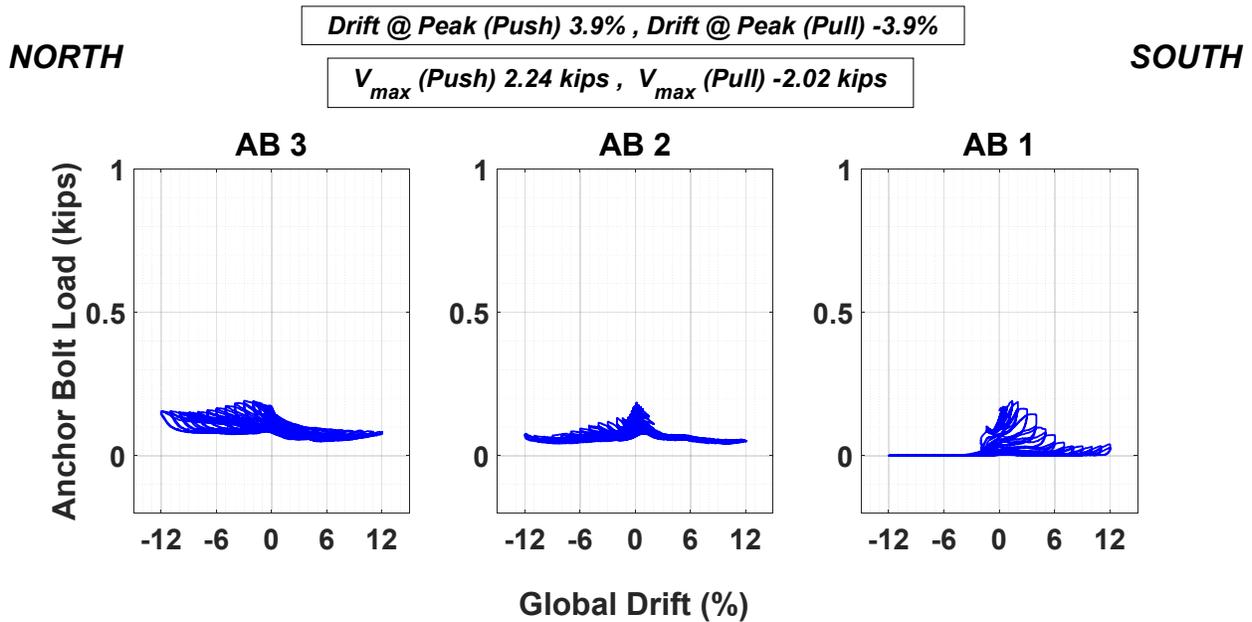
Figure C.1 Specimen A-7 anchor bolt loads versus global drift for the existing 2-ft-tall cripple wall with horizontal siding.

Tension in anchor bolts were measured with 10-kip donut load cells placed on top of the square plate washers. A spherical washer was placed on top of the load cell and fastened with a nut. For unretrofitted cripple walls, three anchor bolts were used, spaced at 64 in. on center. For retrofitted cripple walls, additional anchor bolts were added as per the *FEMA P-1100* prescriptive retrofit guidelines. Anchor bolts were tensioned to around 0.2 kips, which is meant to mimic a hand-tightened amount of tension and representative of what would commonly be observed in the field for older homes.

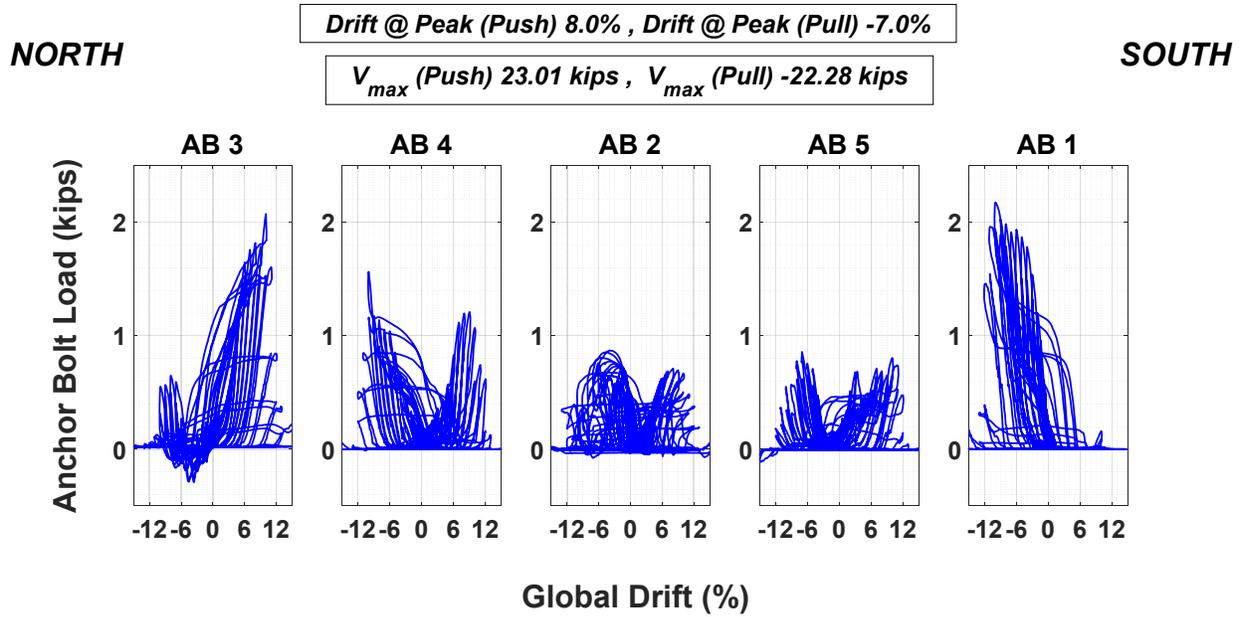
Figure C.2 Specimen A-8 anchor bolt loads versus global drift for the retrofitted 2-ft-tall cripple wall with horizontal siding.

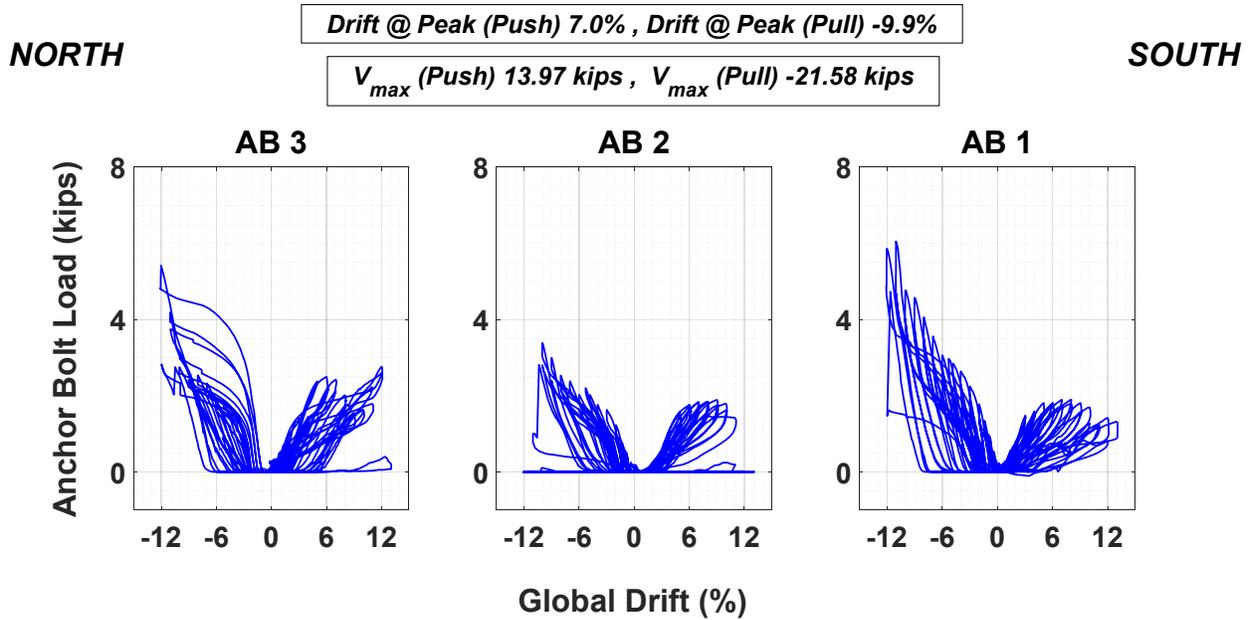
Figure C.3 Specimen A-9 anchor bolt loads versus global drift for the existing 2-ft-tall cripple wall with horizontal siding or diagonal sheathing.

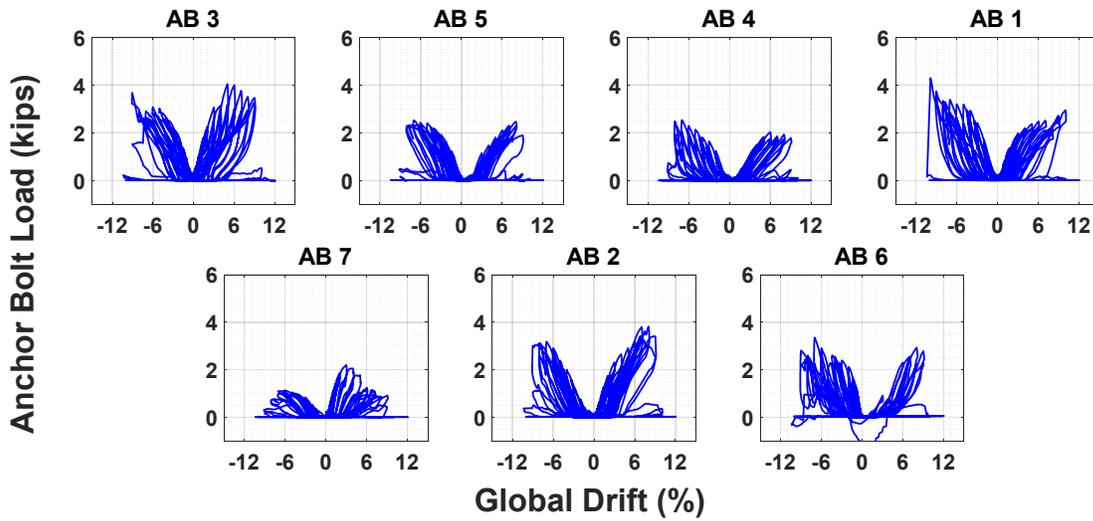
Figure C.4 Specimen A-10 anchor bolt loads versus global drift for the retrofitted 2-ft-tall cripple wall with horizontal siding or diagonal sheathing.

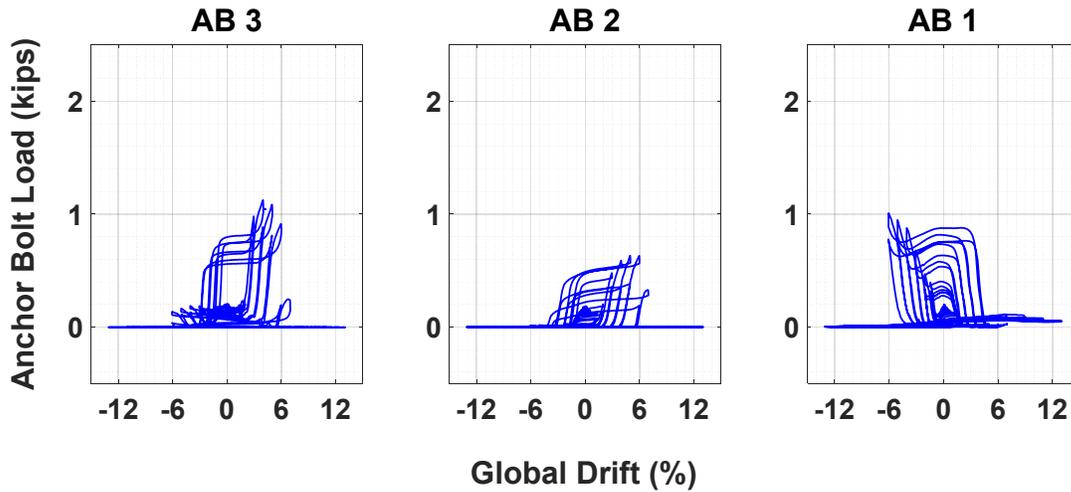
Figure C.5 Specimen A-11 anchor bolt loads versus global drift for the existing 2-ft-tall cripple wall with T1-11 wood structural panels.

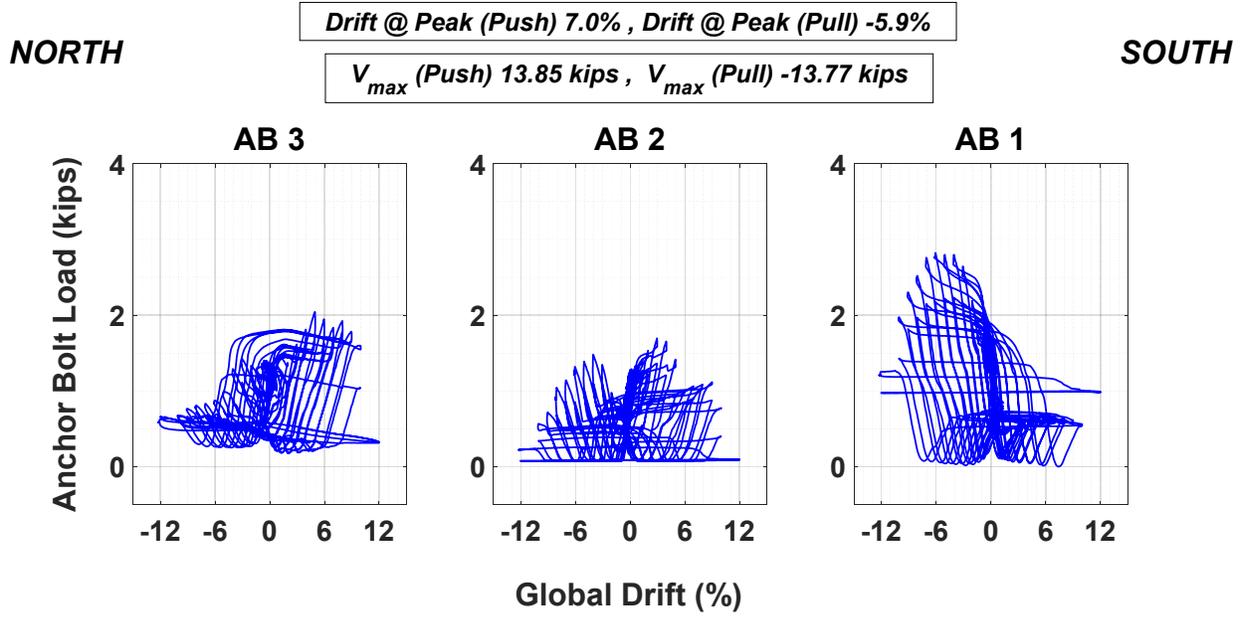
Figure C.6 Specimen A-12 anchor bolt loads versus global drift for the retrofitted 2-ft-tall cripple wall with T1-11 wood structural panels.

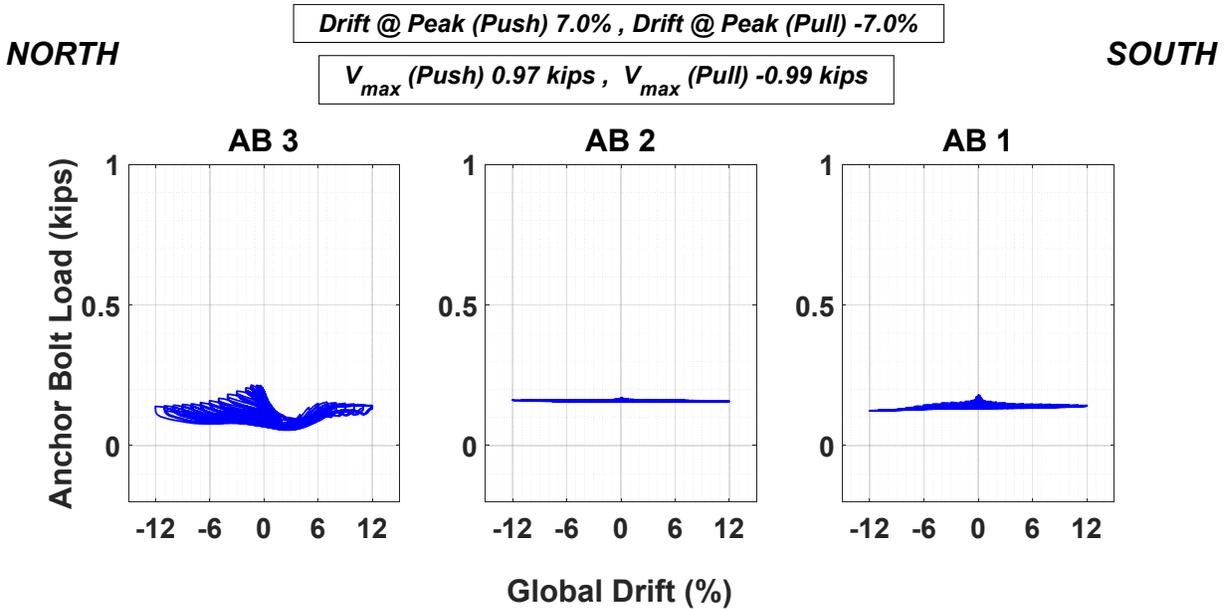
Figure C.7 Specimen A-13 anchor bolt loads versus global drift for the existing 6-ft-tall cripple wall with horizontal siding.

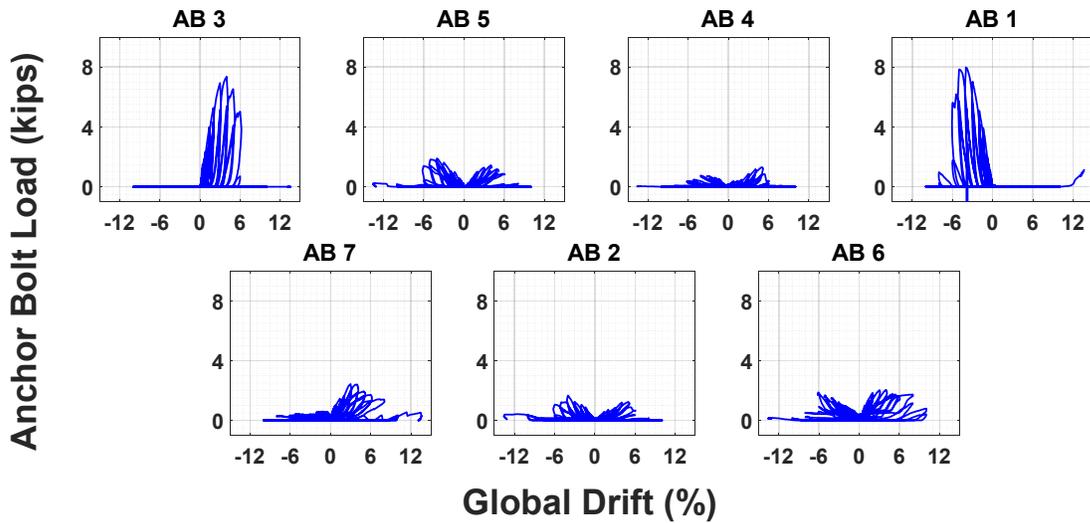
Figure C.8 Specimen A-14 anchor bolt loads versus global drift for existing 6-ft-tall cripple wall with horizontal siding.

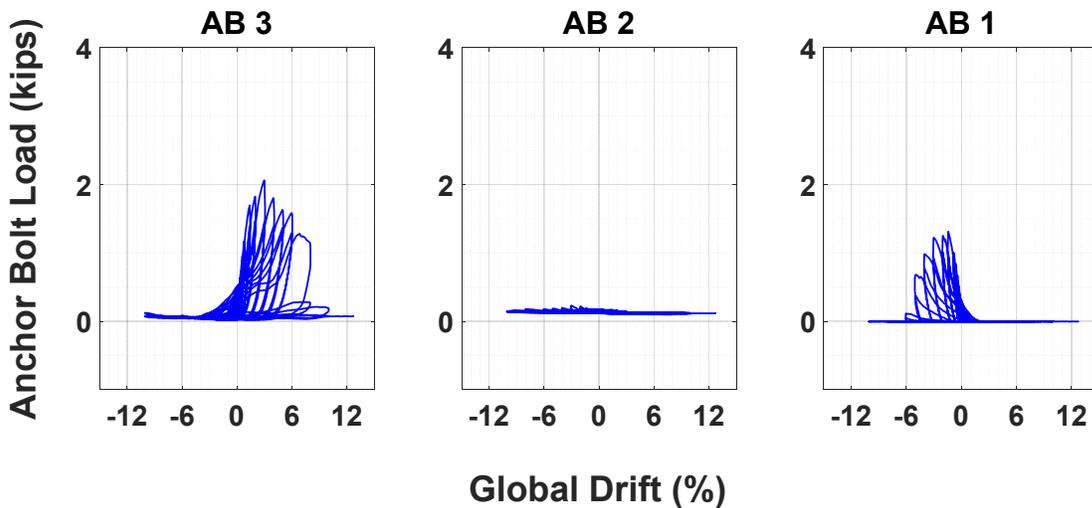
Figure C.9 Specimen A-23 anchor bolt loads versus global drift for existing 6-ft-tall cripple wall with T1-11 wood structural panels.

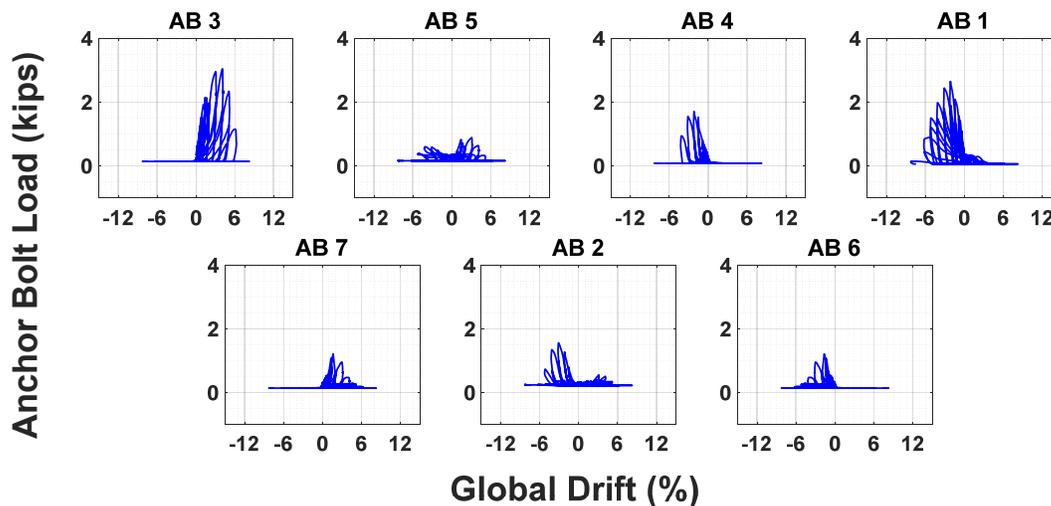
Figure C.10 Specimen A-24 anchor bolt loads versus global drift for the retrofitted 6-ft-tall cripple wall with T1-11 wood structural panels.

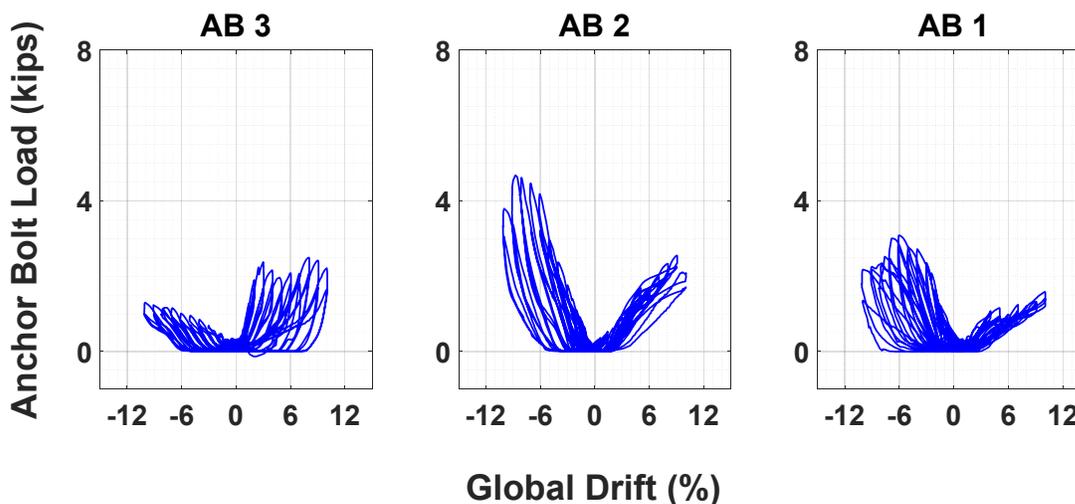
Figure C.11 Specimen A-28 anchor bolt loads versus global drift for the existing 2-ft-tall cripple wall with horizontal siding over diagonal sheathing and light vertical load.

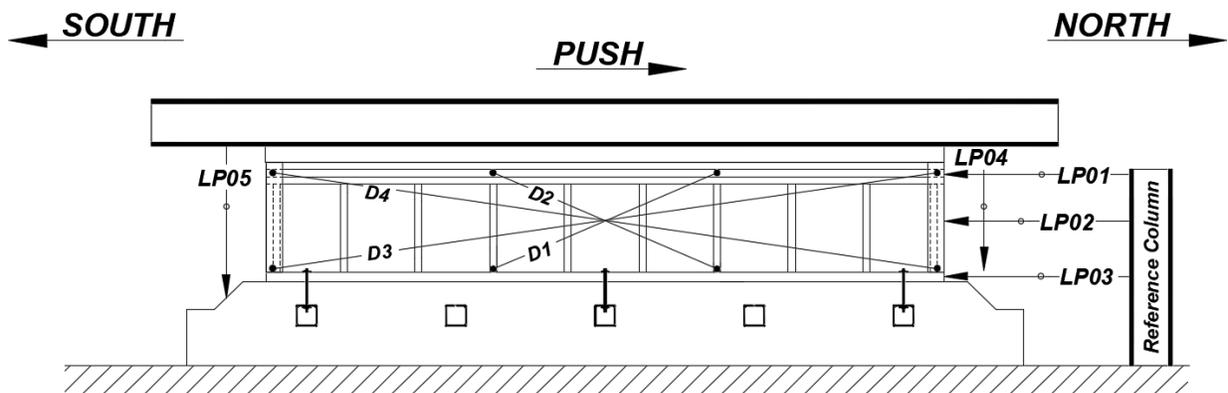
Figure C.12 Diagonal, end uplift, and lateral displacement potentiometer schematic.

Two pairs of linear displacement potentiometers were used to measure the diagonal distortion of the cripple walls during testing. One pair, shown in Figure C.12 and denoted as D1 and D2, measured the distortion of the middle third of the cripple wall. These are referred to as the inner diagonal measurements. The other pair, denoted as D3 and D4, measured the distortion across the entire cripple wall. These are referred to as the outer diagonal measurements. The diagonal measurements are useful in determining the amount of shear distortion experienced by the cripple wall during testing. When coupled with the uplift measurements, LP04 and LP05, the amount of lateral displacement of the cripple wall can be resolved and compared to the measured lateral displacement. Figure C.13 gives a schematic for the how the resolved lateral displacements from diagonal and uplift measurements were derived.

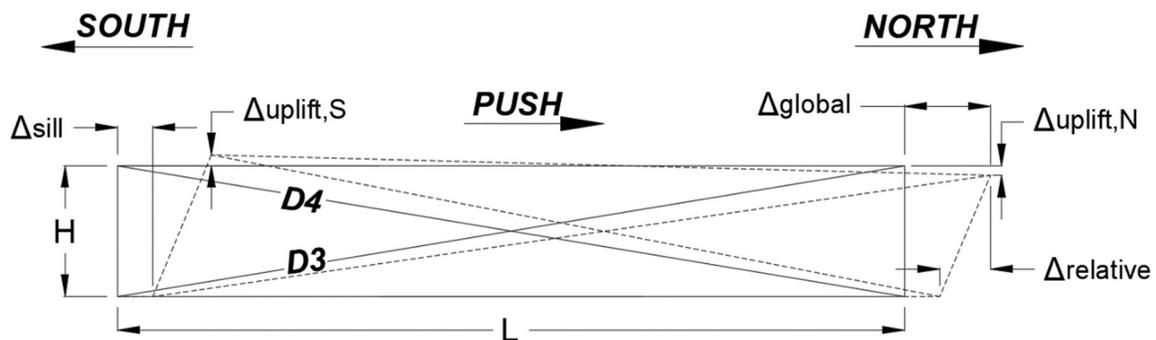
Figure C.13 Deformed cripple wall with measurements used for resolving lateral displacement from diagonal and uplift measurements.

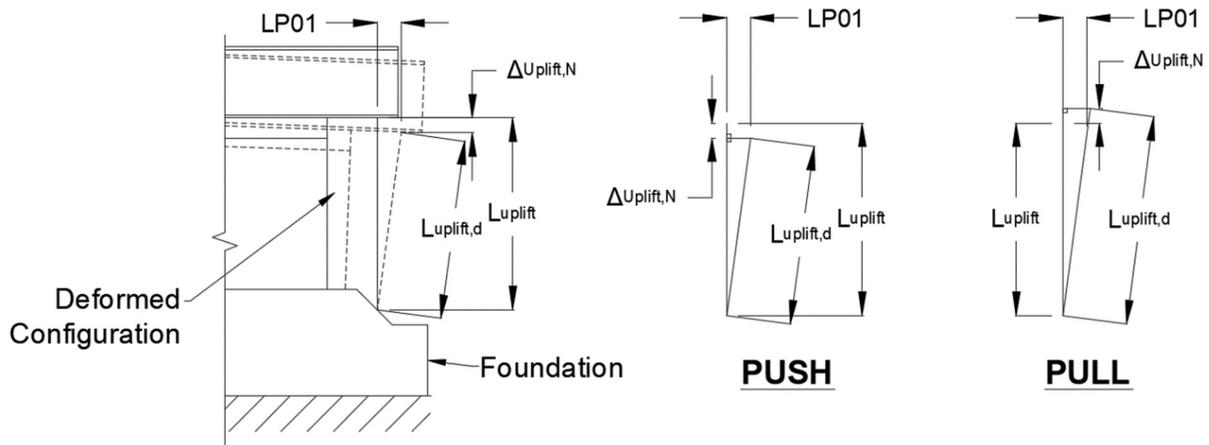
Figure C.14 Schematic for resolving end of wall uplift

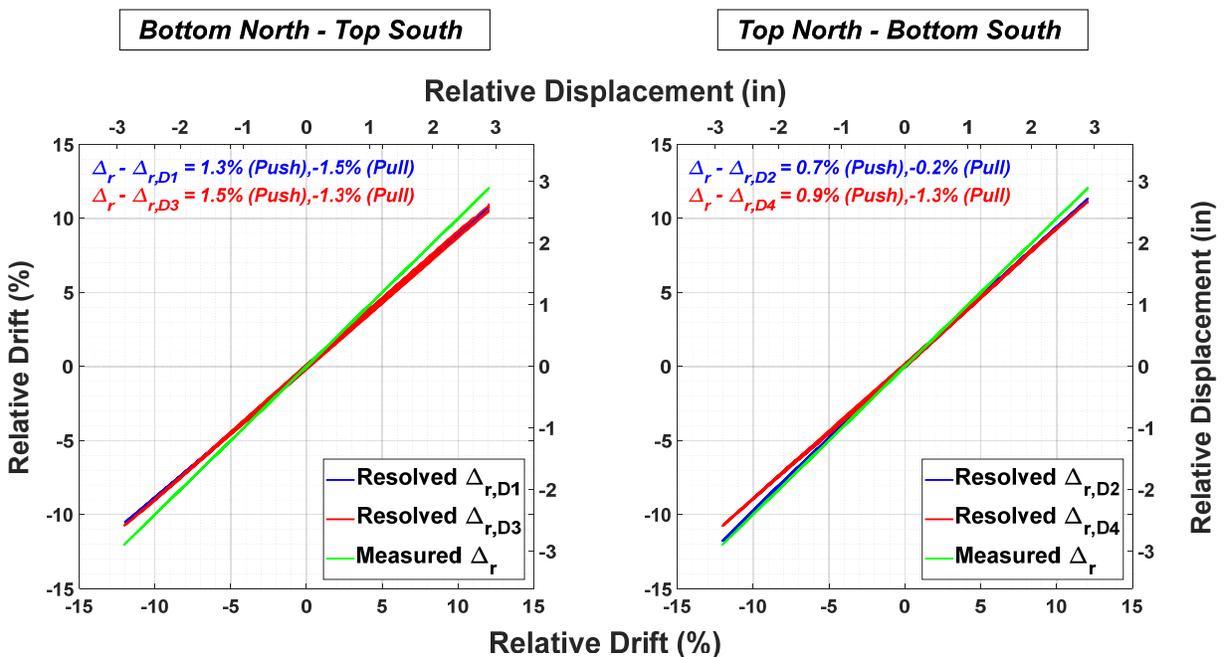
Figure C.15 Specimen A-7 resolved relative drift from diagonal measurements in one direction versus measured relative drift for the existing 2-ft-tall cripple wall with horizontal siding.

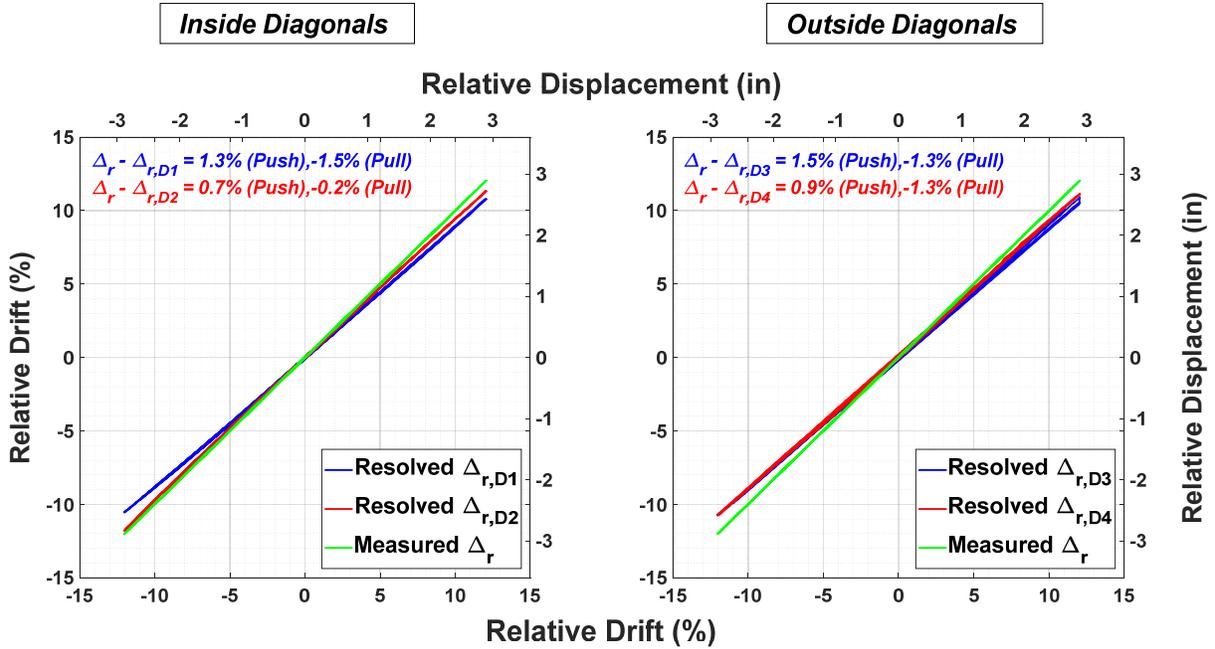
Figure C.16 Specimen A-7 resolved relative drift from diagonal measurements (outside and inside diagonals) versus measured relative drift for existing 2-ft-tall cripple wall with horizontal siding.

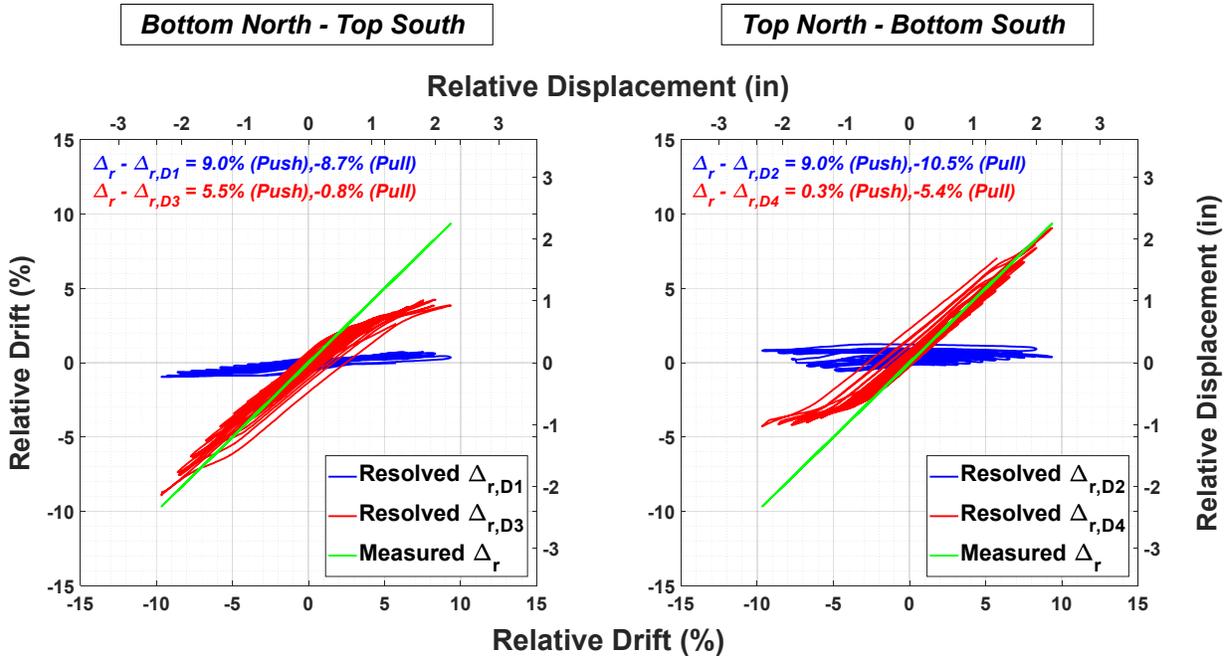
Figure C.17 Specimen A-8 resolved relative drift from diagonal measurements in one direction versus measured relative drift for 2-foot-tall, retrofitted cripple wall with horizontal siding.

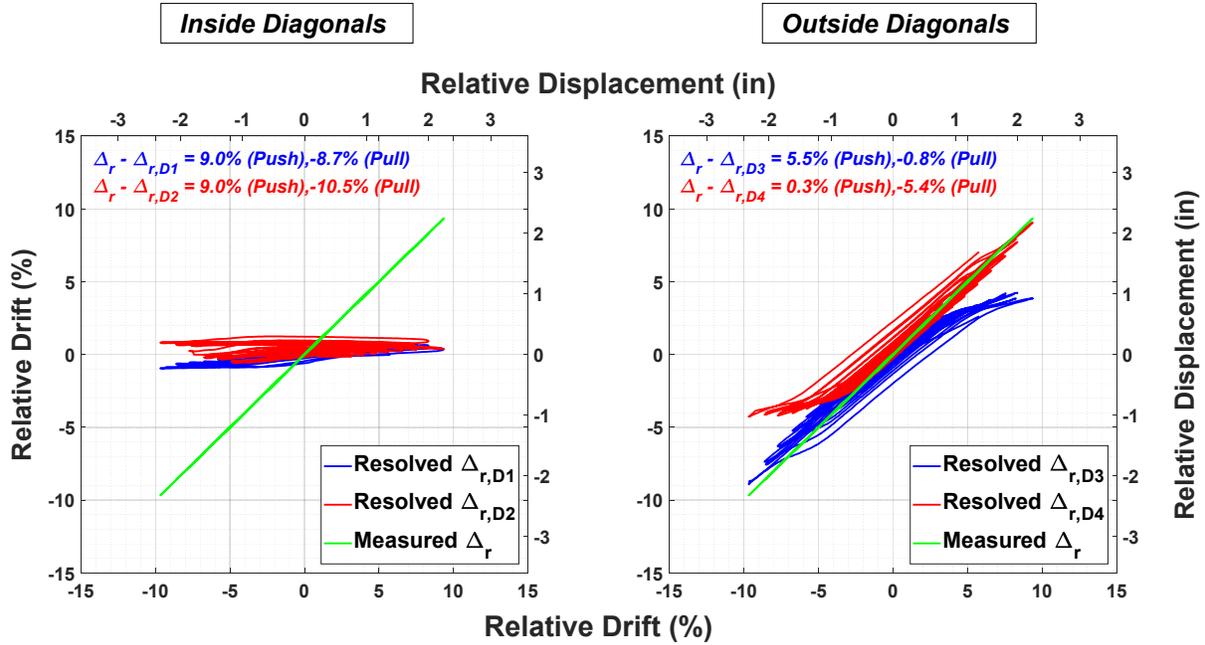
Figure C.18 Specimen A-8 resolved relative drift from diagonal measurements (outside and inside diagonals) versus measured relative drift for the retrofitted 2-ft-tall cripple wall with horizontal siding.

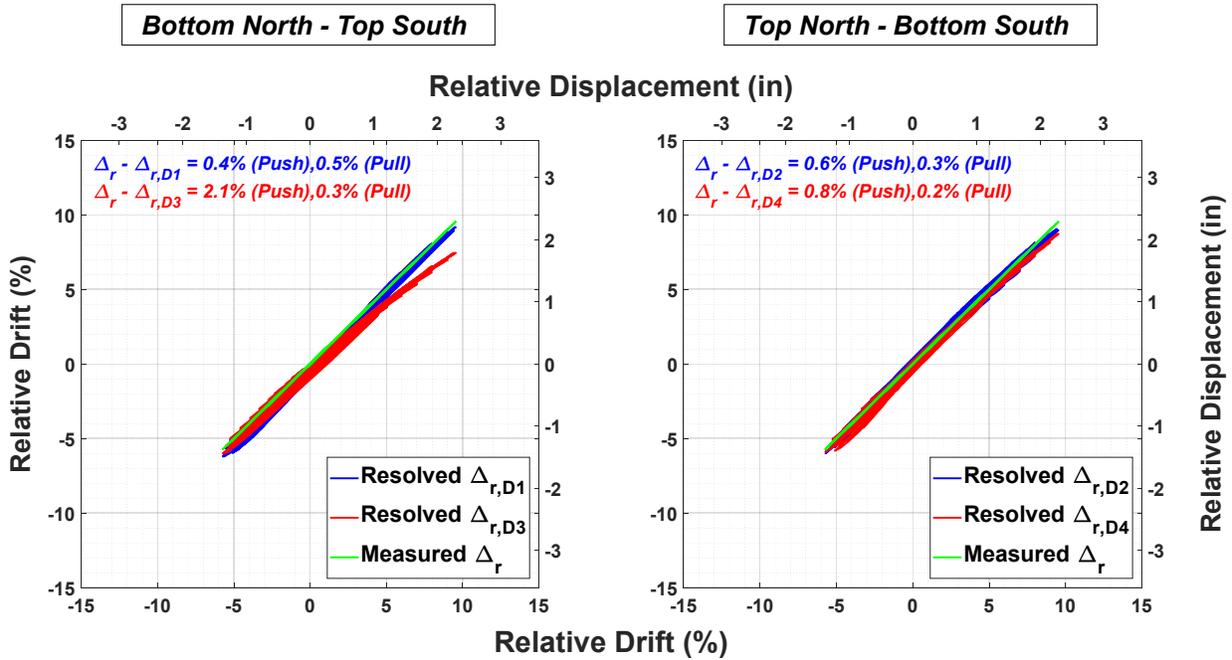
Figure C.19 Specimen A-9 resolved relative drift from diagonal measurements in one direction versus measured relative drift for the existing 2-ft-tall cripple wall with horizontal siding over diagonal sheathing.

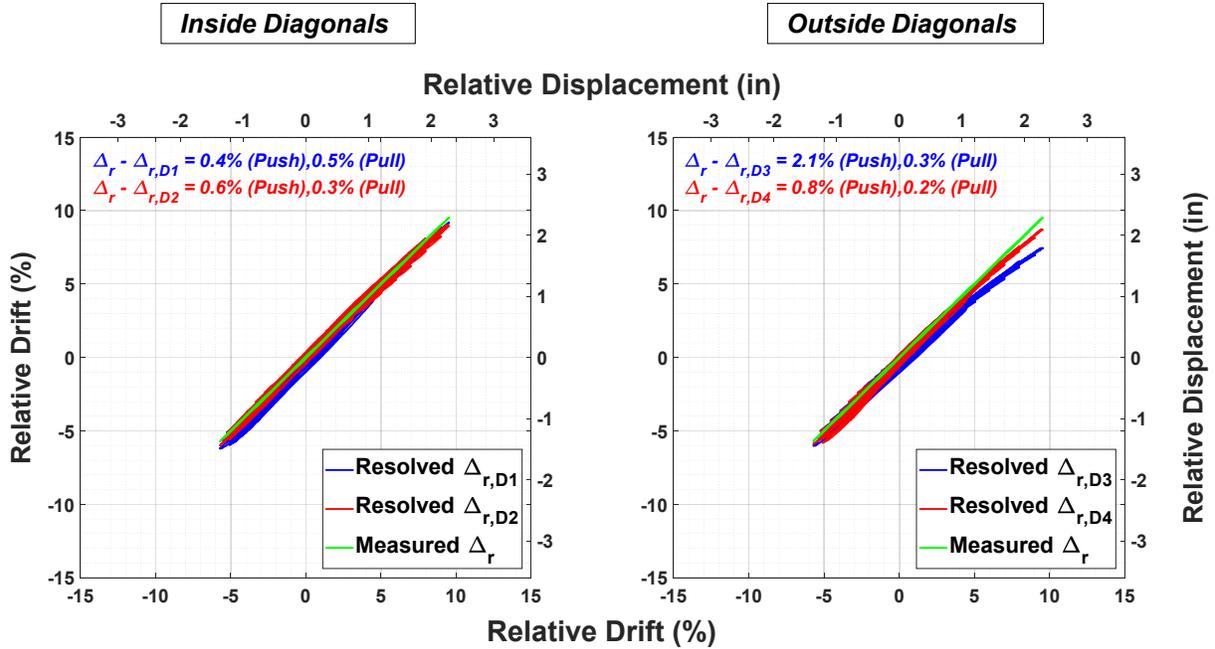
Figure C.20 Specimen A-9 resolved relative drift from diagonal measurements (outside and inside diagonals) versus measured relative drift for existing 2-ft-tall cripple wall with horizontal siding over diagonal sheathing.

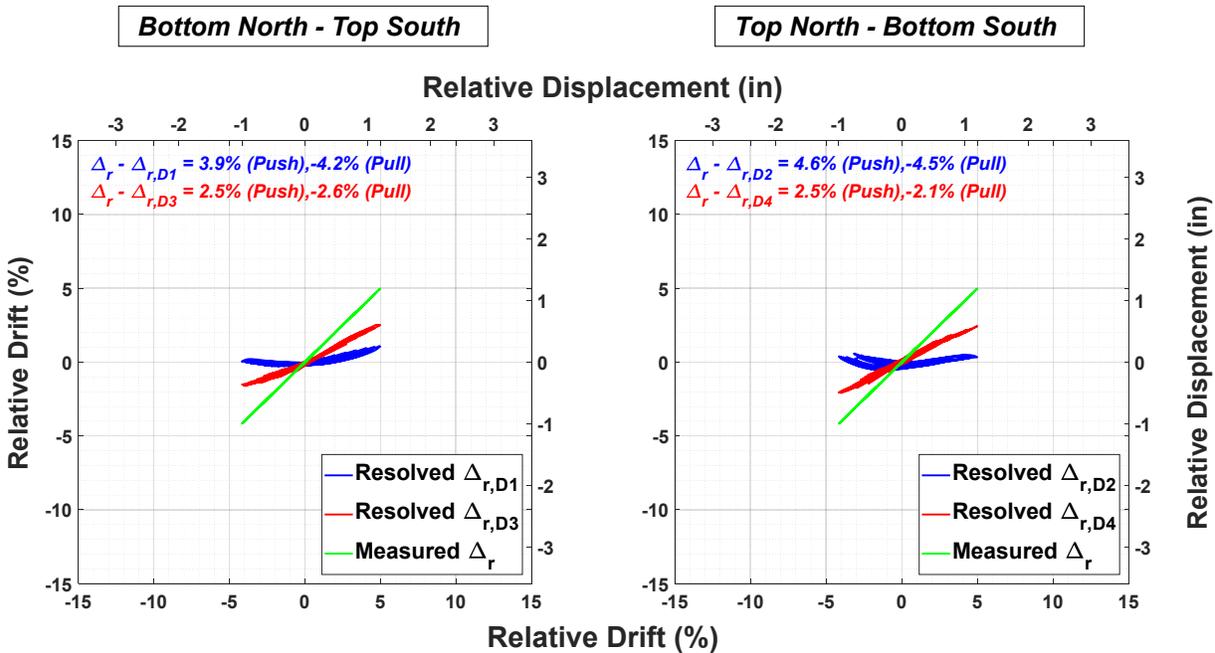
Figure C.21 Specimen A-10 resolved relative drift from diagonal measurements in one direction versus measured relative drift for the retrofitted 2-ft-tall cripple wall with horizontal siding over diagonal sheathing.

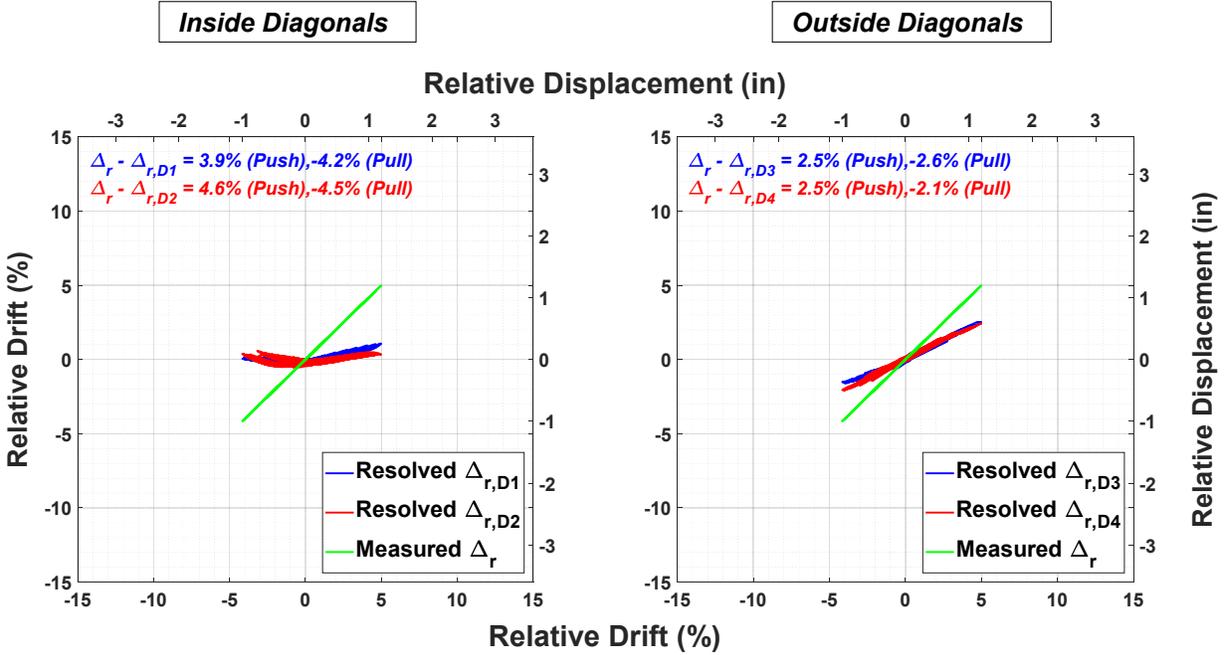
Figure C.22 Specimen A-10 resolved relative drift from diagonal measurements (outside and inside diagonals) versus measured relative drift for the retrofitted 2-ft-tall cripple wall with horizontal siding over diagonal sheathing.

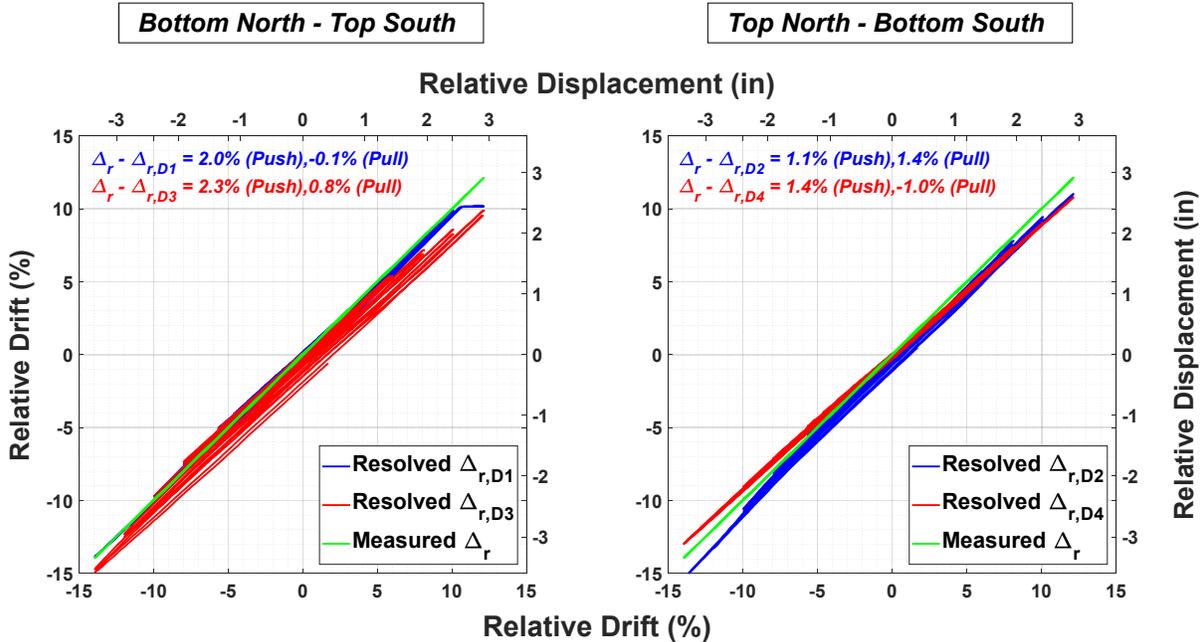
Figure C.23 Specimen A-11 resolved relative drift from diagonal measurements in one direction versus measured relative drift for the existing 2-ft-tall cripple wall with T1-11 plywood.

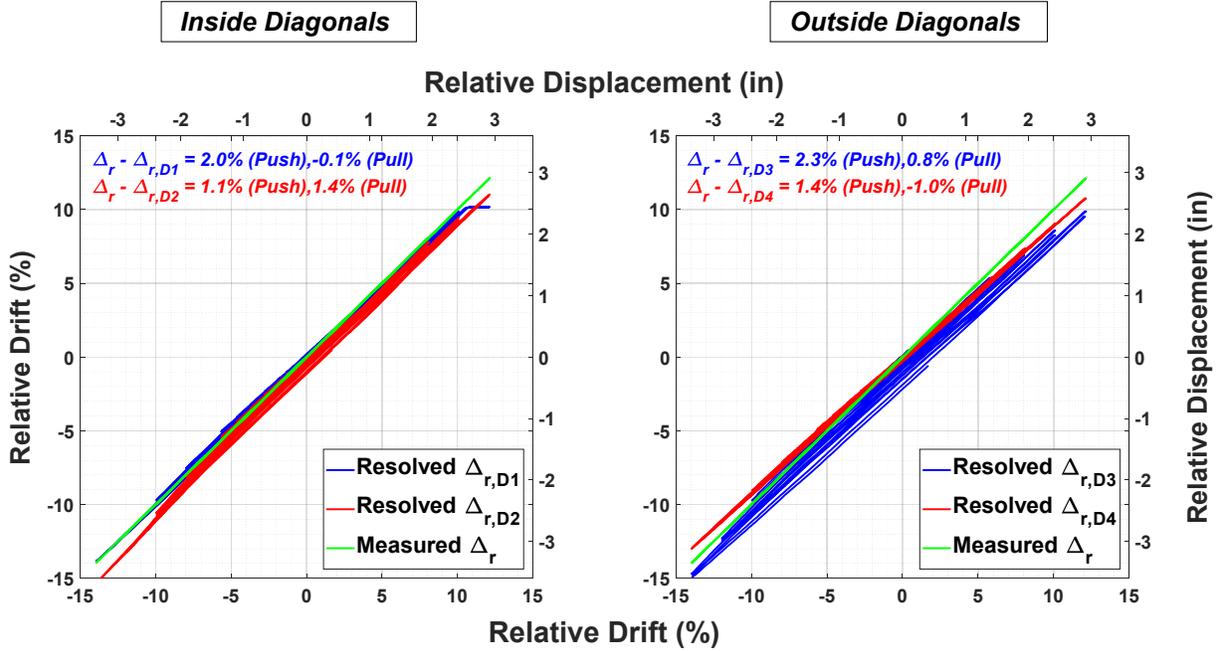
Figure C.24 Specimen A-11 resolved relative drift from diagonal measurements (outside and inside diagonals) versus measured relative drift for the existing 2-ft-tall cripple wall with T1-11 plywood.

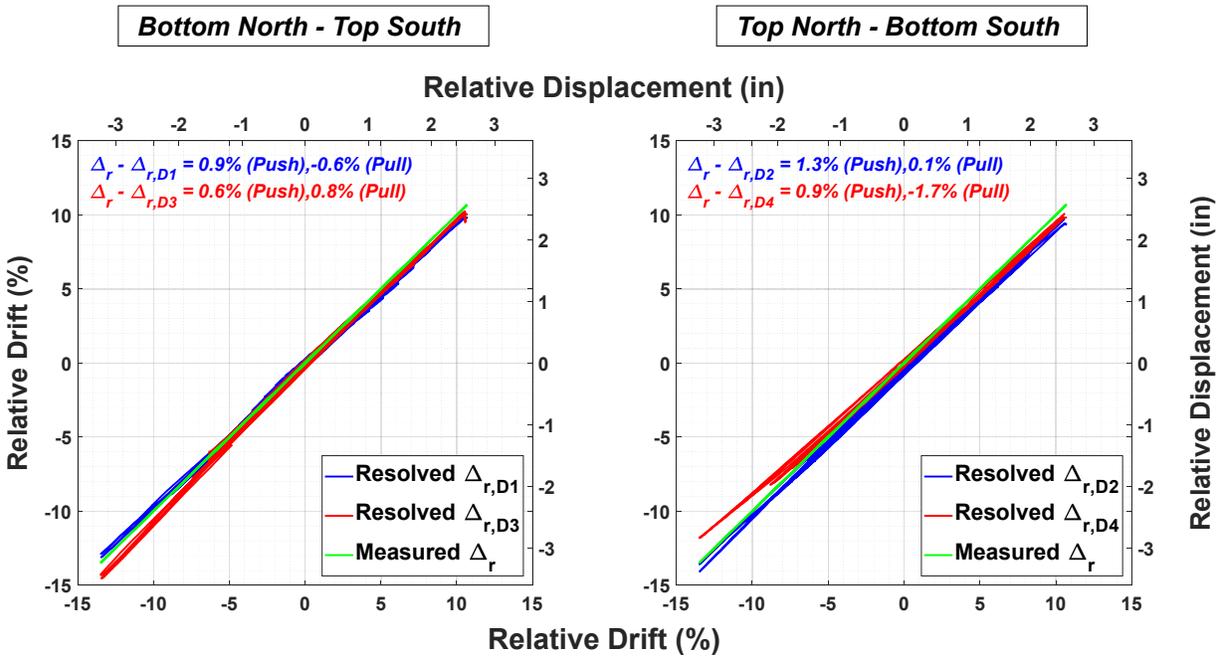
Figure C.25 Specimen A-12 resolved relative drift from diagonal measurements in one direction versus measured relative drift for the retrofitted 2-ft-tall cripple wall with T1-11 plywood.
