Cripple Wall Small-Component Test Program: Dry Specimens

**A Report for the “Quantifying the Performance of
Retrofit of Cripple Walls and Sill Anchorage in Single-
Family Wood-Frame Buildings” Project**

PEER Report 2020/17

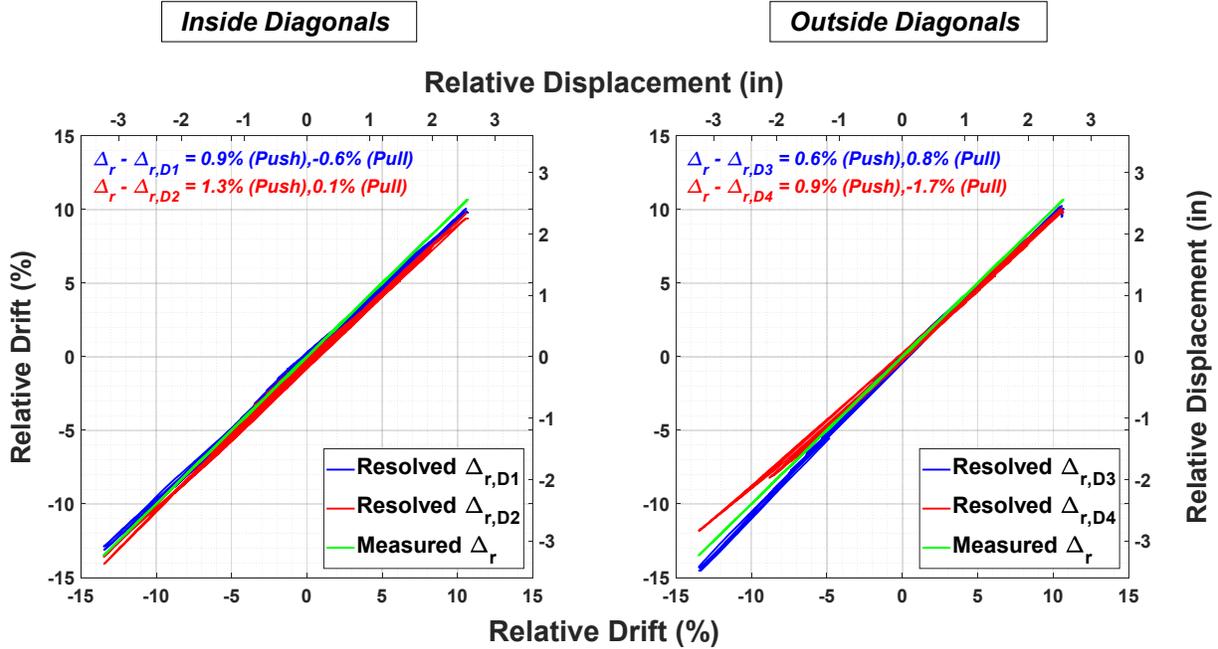
Figure C.26 Specimen A-12 resolved relative drift from diagonal measurements (outside and inside diagonals) versus measured relative drift for the retrofitted 2-ft-tall cripple wall with T1-11 plywood.

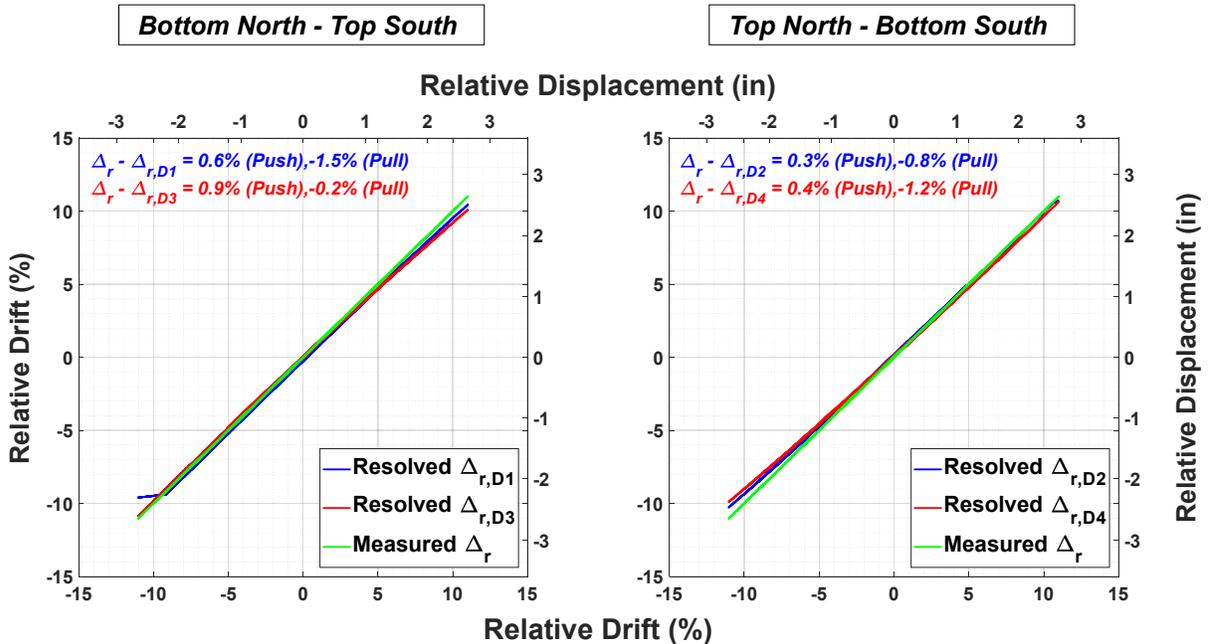
Figure C.27 Specimen A-13 resolved relative drift from diagonal measurements in one direction versus measured relative drift for the existing 6-ft-tall cripple wall with horizontal siding.

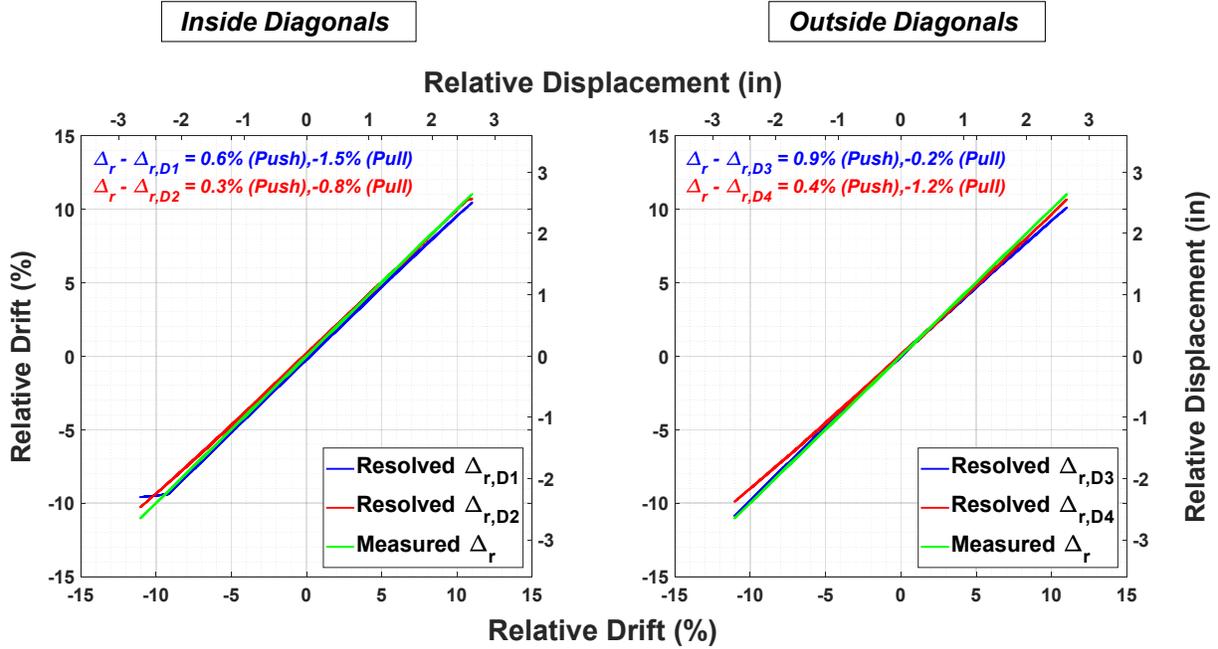
Figure C.28 Specimen A-13 resolved relative drift from diagonal measurements (outside and inside diagonals) versus measured relative drift for the existing 6-ft-tall cripple wall with horizontal siding.

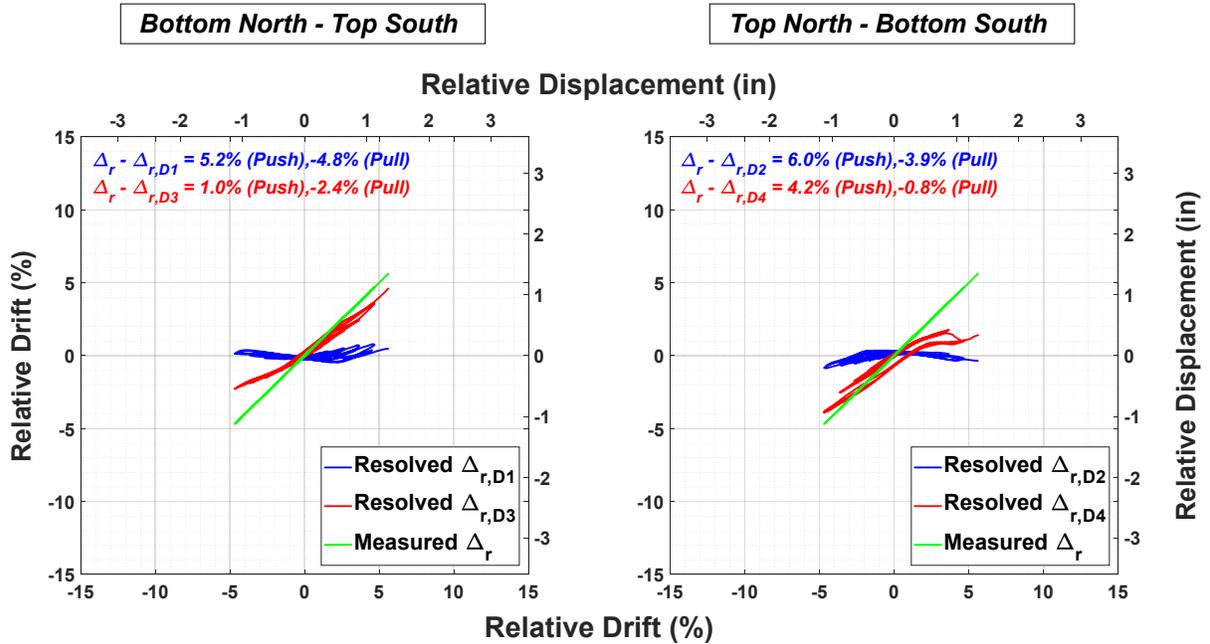
Figure C.29 Specimen A-14 resolved relative drift from diagonal measurements in one direction versus measured relative drift for the retrofitted 6-ft-tall cripple wall with horizontal siding.

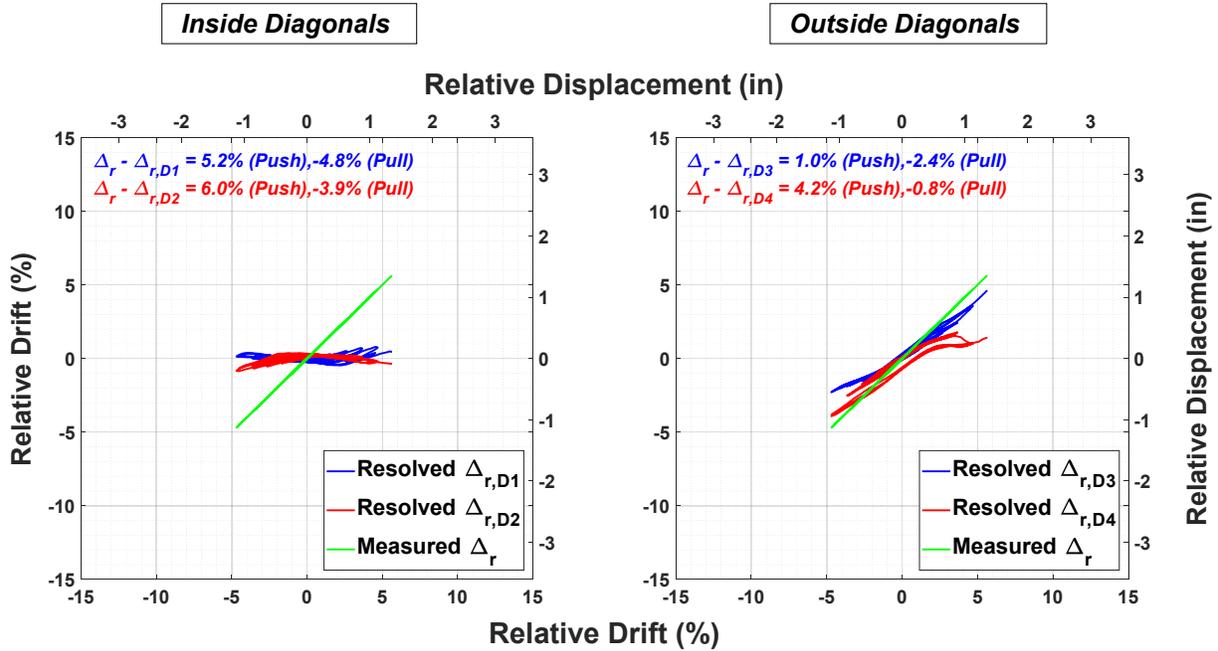
Figure C.30 Specimen A-14 resolved relative drift from diagonal measurements (outside and inside diagonals) versus measured relative drift for the retrofitted 6-ft-tall cripple wall with horizontal siding.

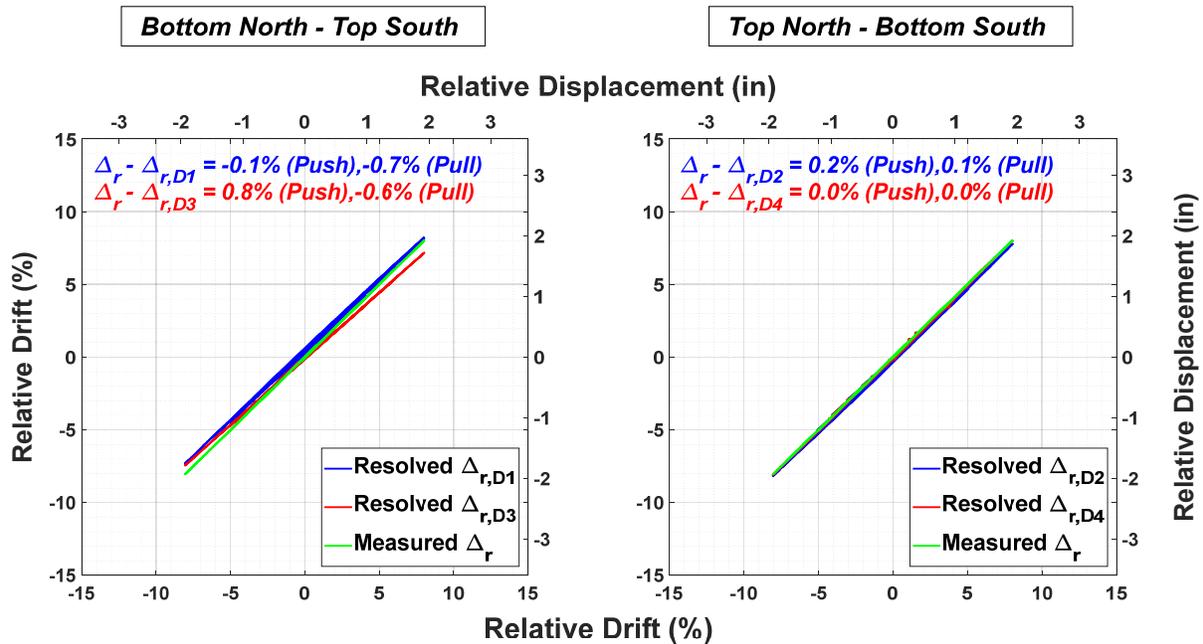
Figure C.31 Specimen A-23 resolved relative drift from diagonal measurements in one direction versus measured relative drift for the existing 6-ft-tall cripple wall with T1-11 plywood.

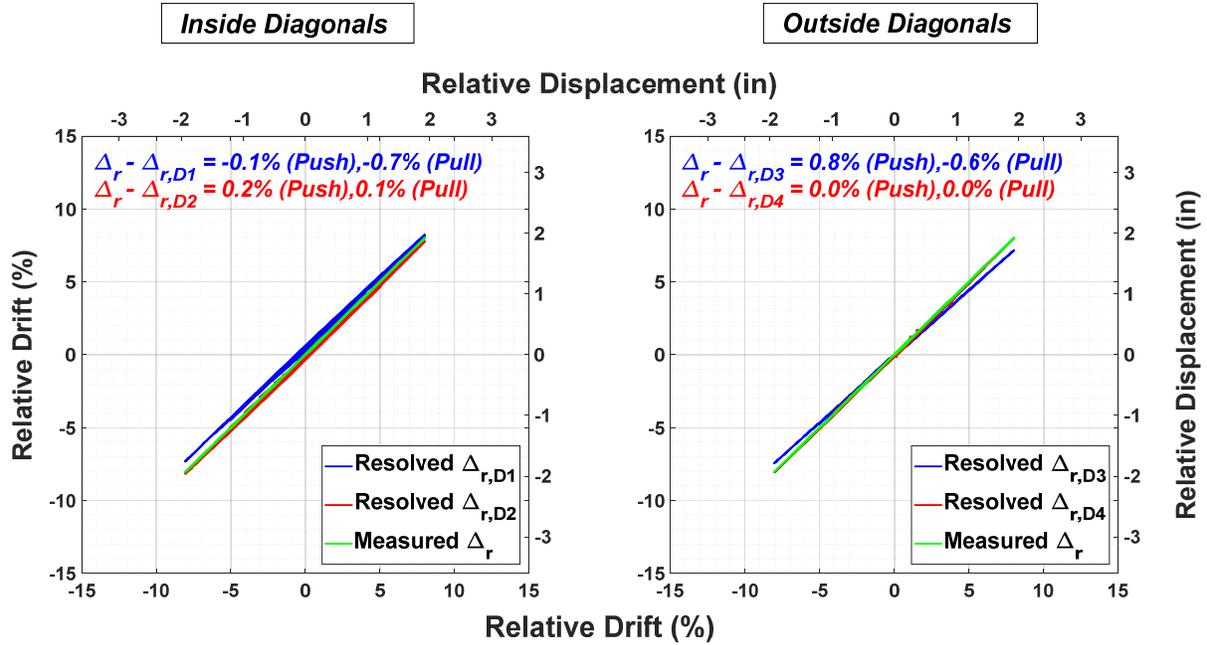
Figure C.32 Specimen A-23 resolved relative drift from diagonal measurements (outside and inside diagonals) versus measured relative drift for the existing 6-ft-tall cripple wall with T1-11 plywood (Specimen A-23)

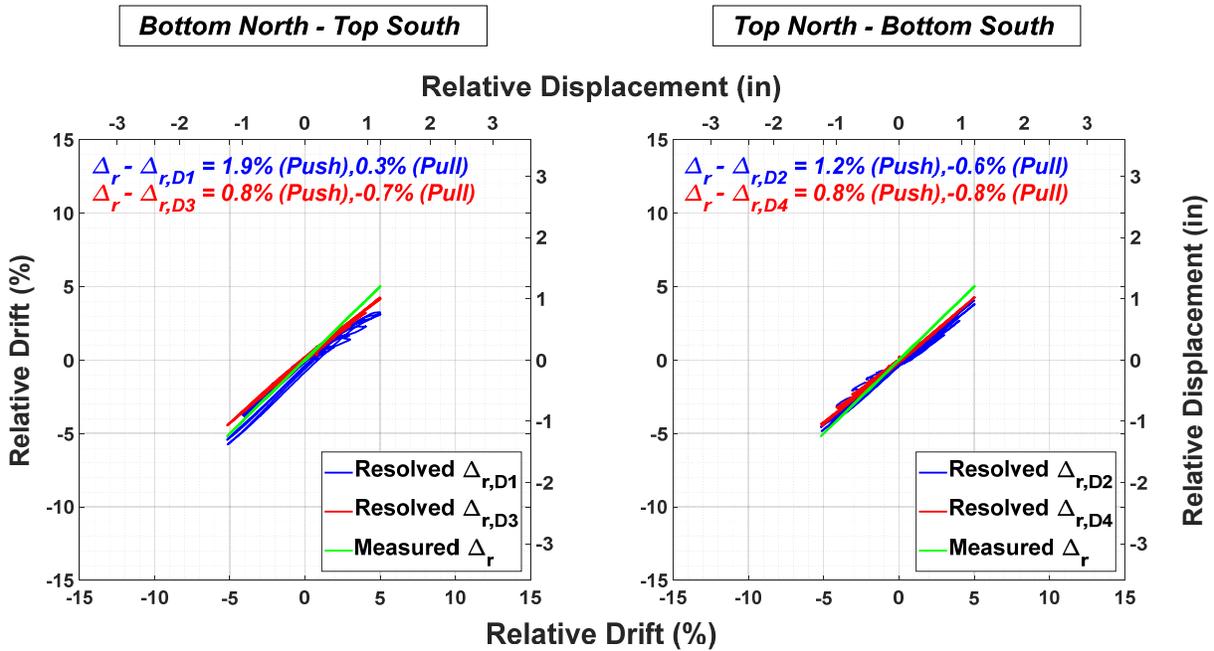
Figure C.33 Specimen A-24 resolved relative drift from diagonal measurements in one direction versus measured relative drift for 6-foot-tall, retrofitted cripple wall with T1-11 plywood.

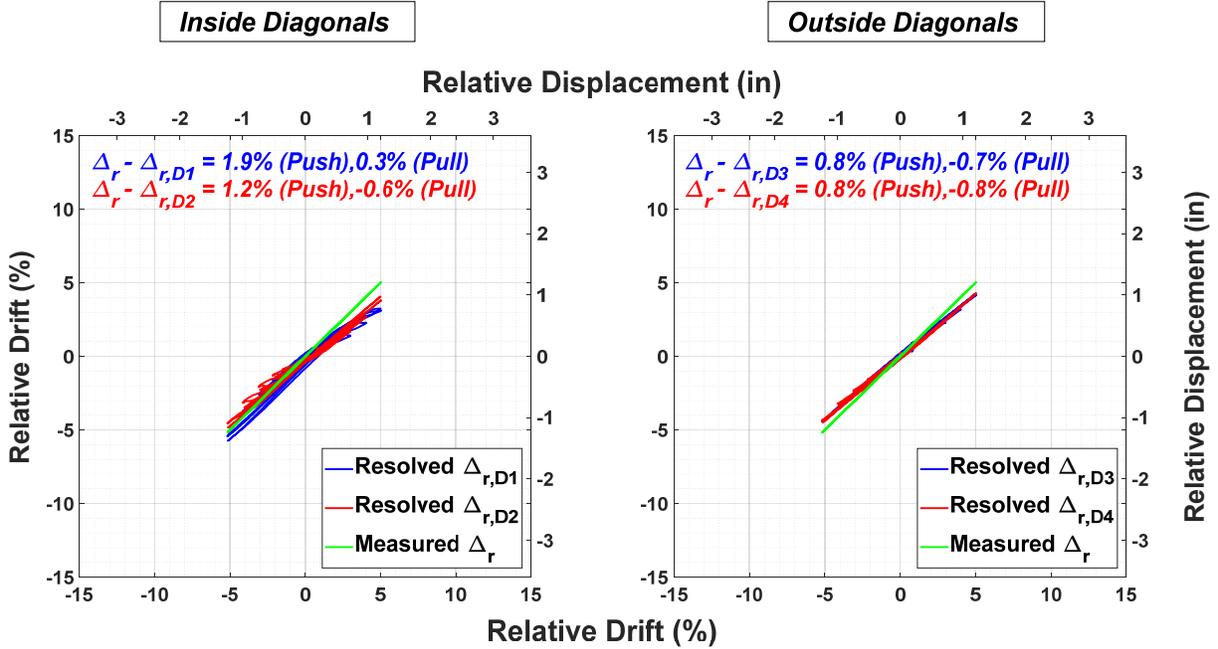
Figure C.34 Specimen A-24 resolved relative drift from diagonal measurements (outside and inside diagonals) versus measured relative drift for the retrofitted 6-ft-tall cripple wall with T1-11 plywood.

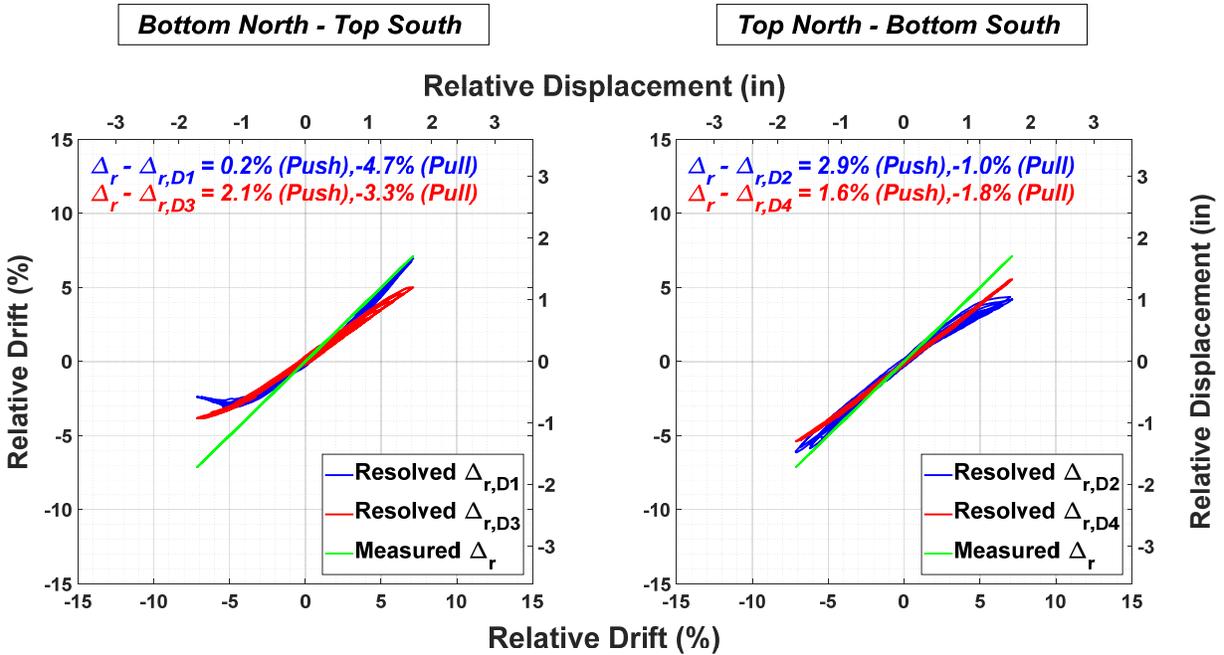
Figure C.35 Specimen A-28 resolved relative drift from diagonal measurements in one direction versus measured relative drift for the retrofitted 2-ft-tall cripple wall with horizontal siding over diagonal sheathing and low vertical load.

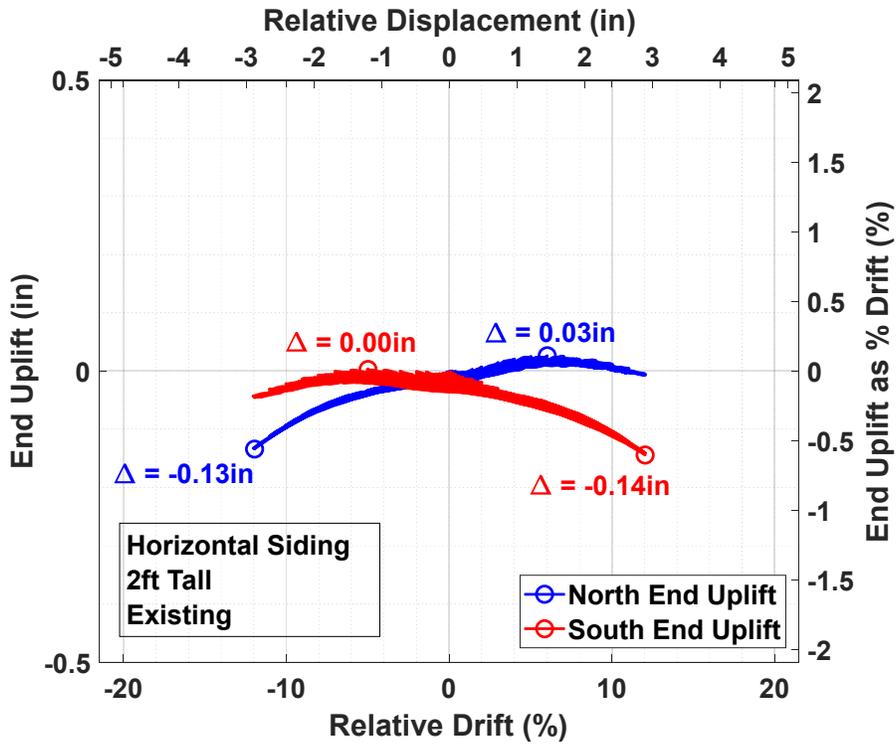
Figure C.37 Specimen A-7 end uplift versus relative drift for the existing 2-ft-tall cripple wall with horizontal siding.

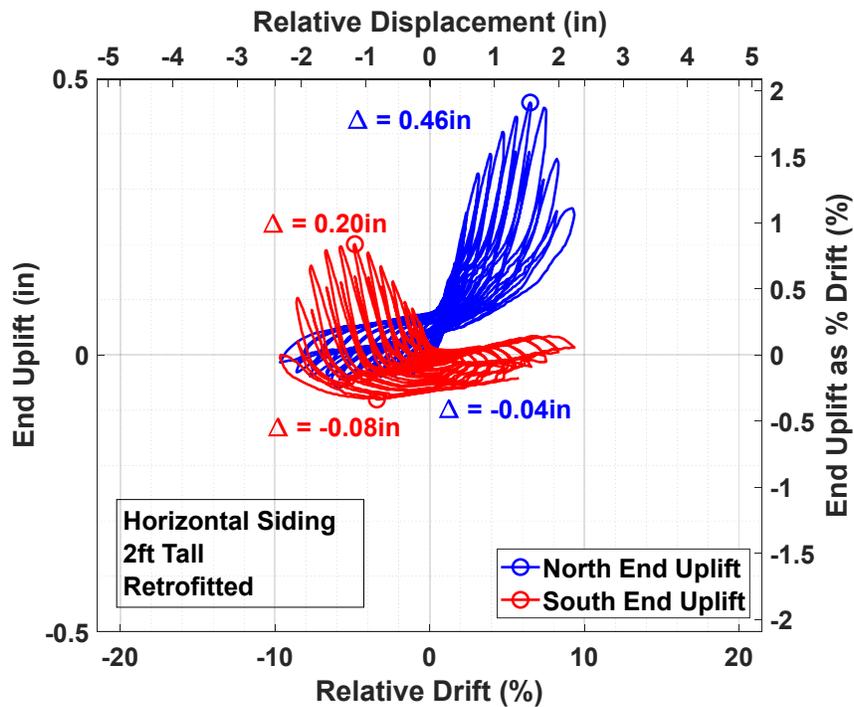
Figure C.38 Specimen A-8 end uplift versus relative drift for the retrofitted 2-ft-tall cripple wall with horizontal siding.

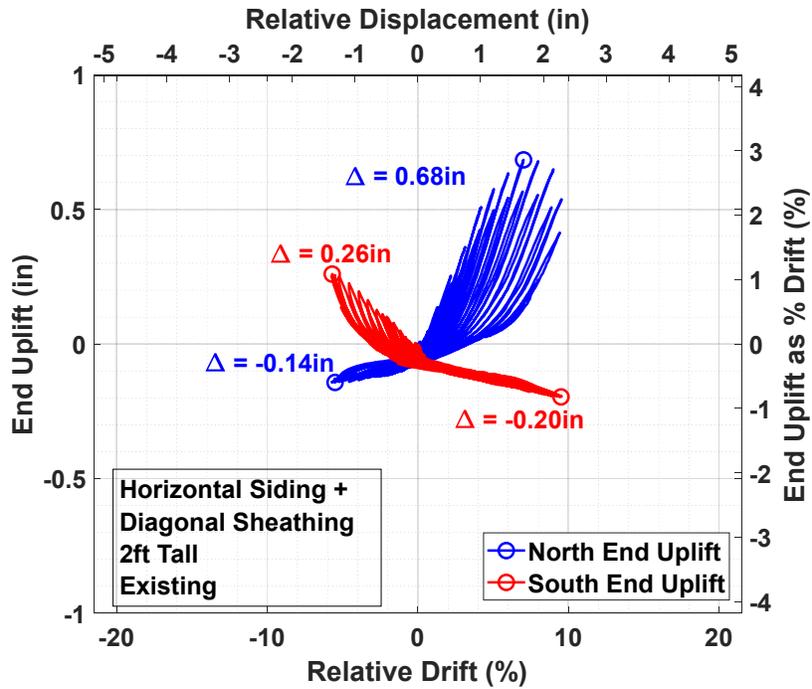
Figure C.39 Specimen A-9 end uplift versus relative drift for the existing 2-ft-tall cripple wall with horizontal siding over diagonal sheathing.

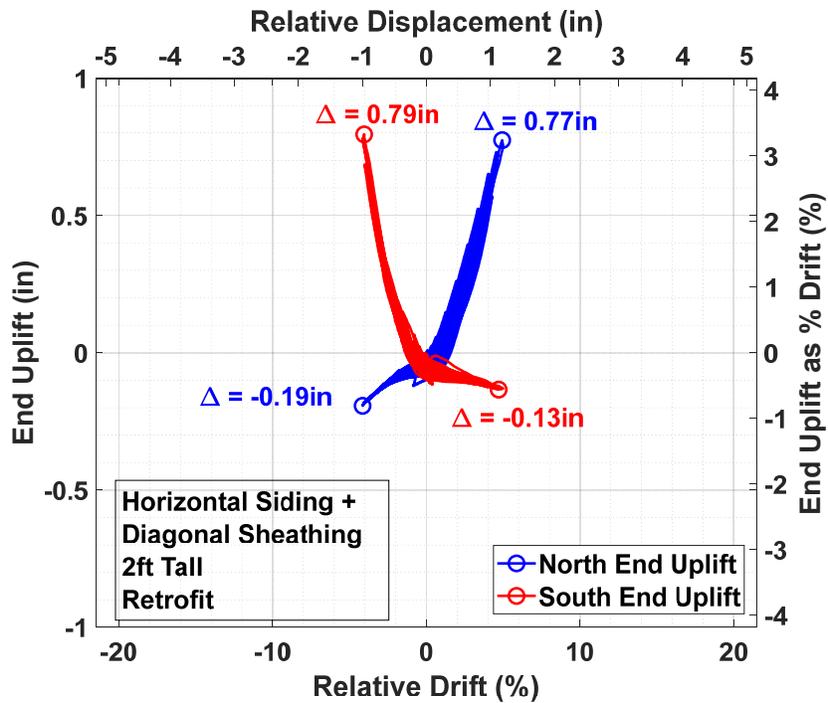
Figure C.40 Specimen A-10 end uplift versus relative drift for the retrofitted 2-ft-tall cripple wall with horizontal siding over diagonal sheathing.

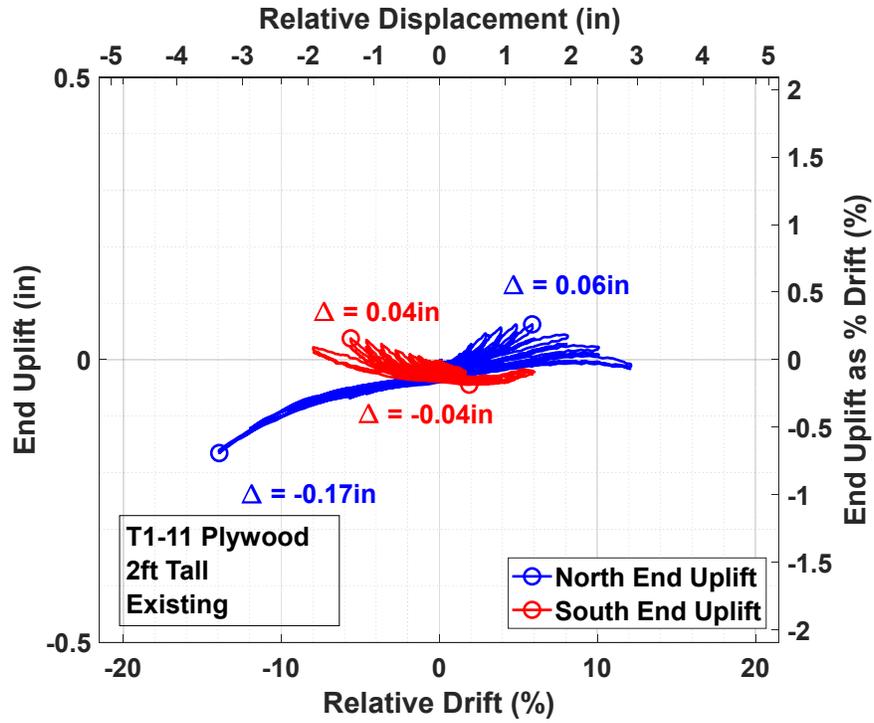
Figure C.41 Specimen A-11 end uplift versus relative drift for existing 2-ft-tall cripple wall with T1-11 plywood.

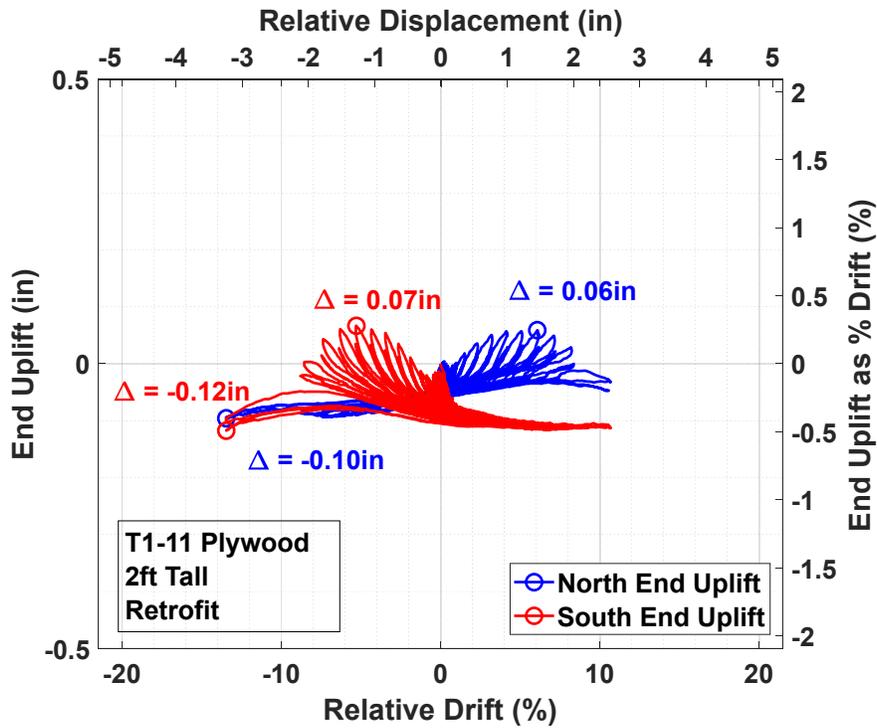
Figure C.42 Specimen A-12 end uplift versus relative drift for the retrofitted 2-ft-tall cripple wall with T1-11 plywood.

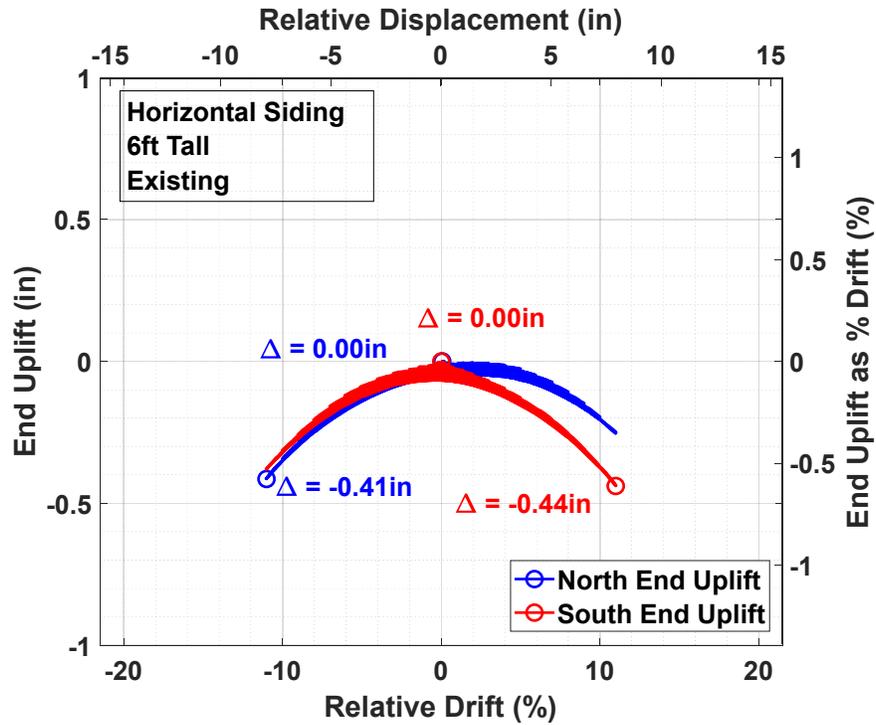
Figure C.43 Specimen A-13 end uplift versus relative drift for the existing 6-ft-tall cripple wall with horizontal siding.

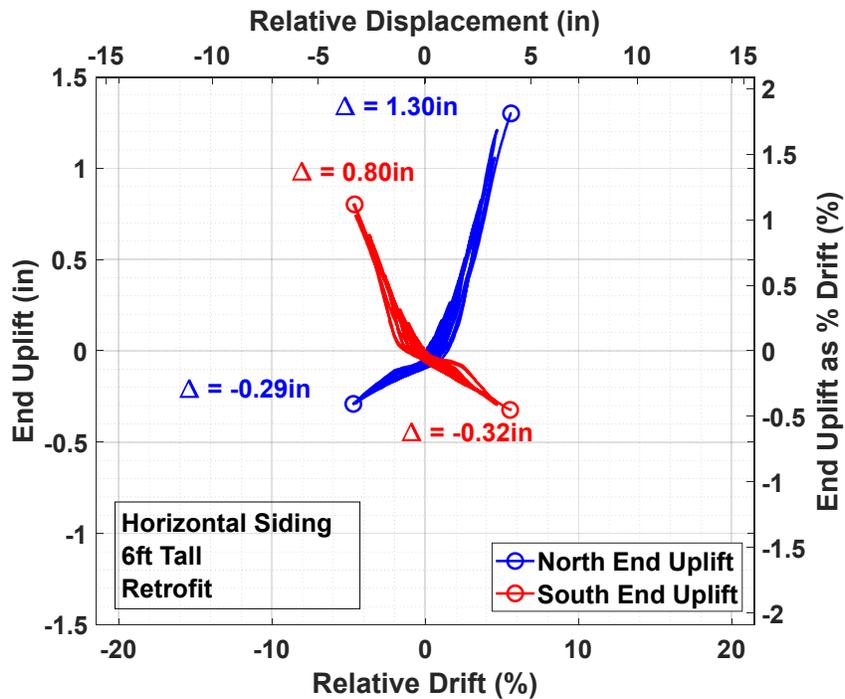
Figure C.44 Specimen A-14 end uplift versus relative drift for the retrofitted 6-ft-tall cripple wall with horizontal siding.

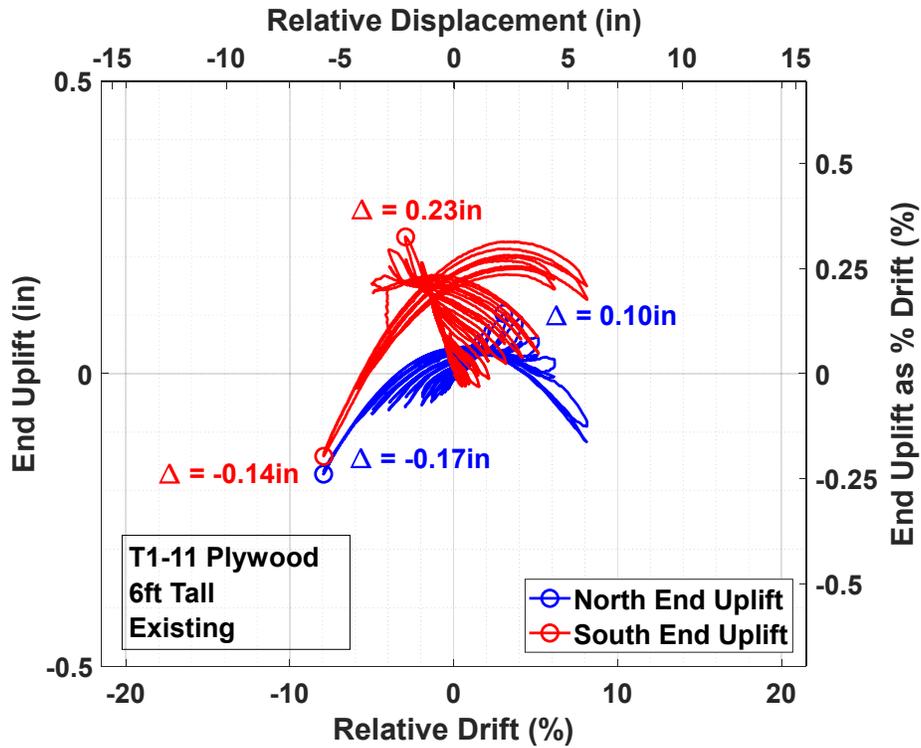
Figure C.45 Specimen A-23 end uplift versus relative drift for the existing 6-ft-tall cripple wall with T1-11 plywood.

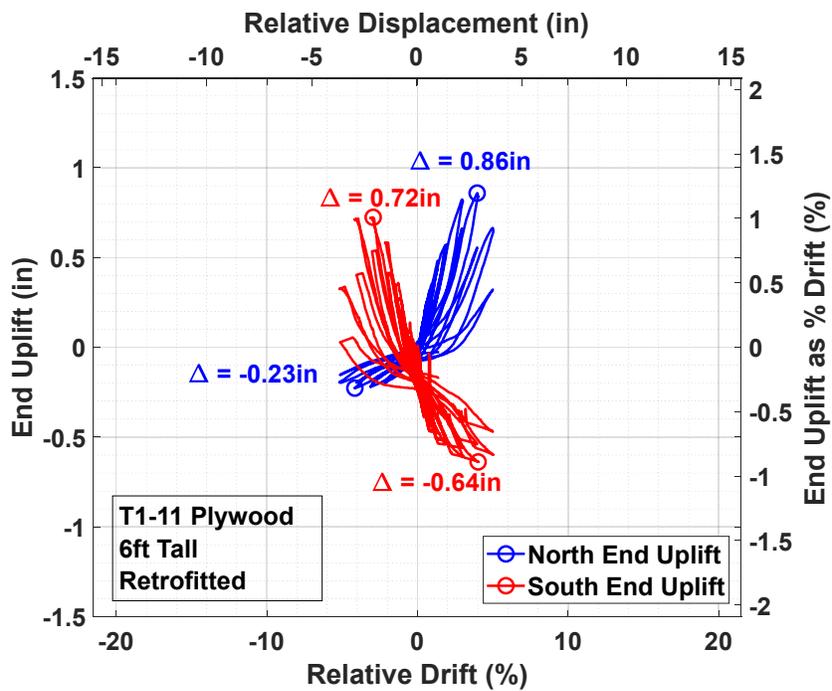
Figure C.46 Specimen A-24 end uplift versus relative drift for the retrofitted 6-ft-tall cripple wall with T1-11 plywood.

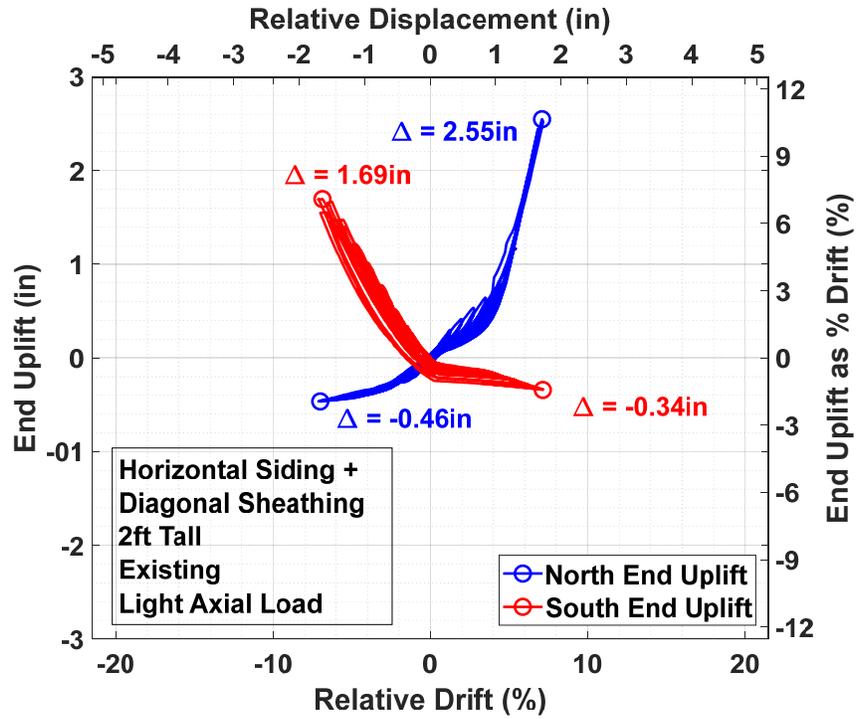
Figure C.47 Specimen A-28 end uplift versus relative drift for the existing 2-ft-tall cripple wall with horizontal siding over diagonal sheathing and light vertical load.
