Shear in Reinforced Concrete Beam –Column Joints Without Transverse Reinforcement.

J.F. Stanton¹, D.E. Lehman², S.G. Walker³, C. M. Yeargin⁴

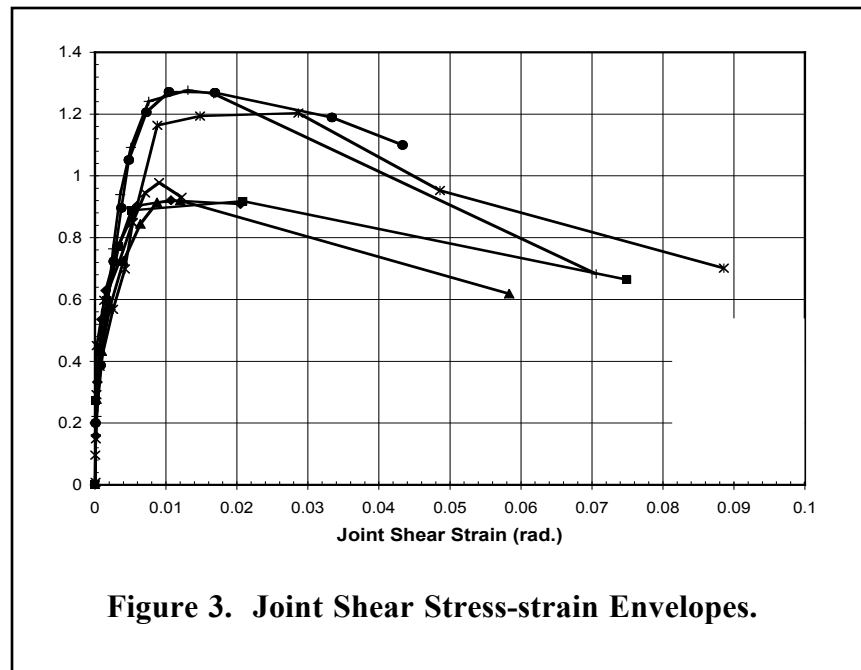
Figure 3. Joint Shear Stress-strain Envelopes.

The shear strength envelope of the joints peaked at a drift of approximately 1.5% in all cases. The peak joint shear stress depended on the beam bars, which controlled the demand. After the peak, the shear stress dropped gradually to a value of approximately

8 f'_c (psi) at a drift of 5%, regardless of the beam bar strength. (Figure 3).

The FEMA 273 model for joint shear strength shows a strength that is consistent with the test results up to a joint shear strain of about 0.5%, after which it proves very conservative (Figure 4). The Joint Shear Factor is the joint shear stress divided by f'_c (psi).
