UCB-BYU-UCLA  
ZETAŞ-SAU  
Joint Research

**Project Name:** Ground Failure and Building Performance in Adapazari, Turkey  
**Location:** Site B - Kuyudibi Av. and Yaprak Street, Karaosman District, Adapazari  
**GPS Coordinates:** 40.78513°N 30.40024°E  
**Test Number:** CPT-B1  
**Type of Cone:** ELC10 CF No. 990617 (a.p. v.d. Berg)

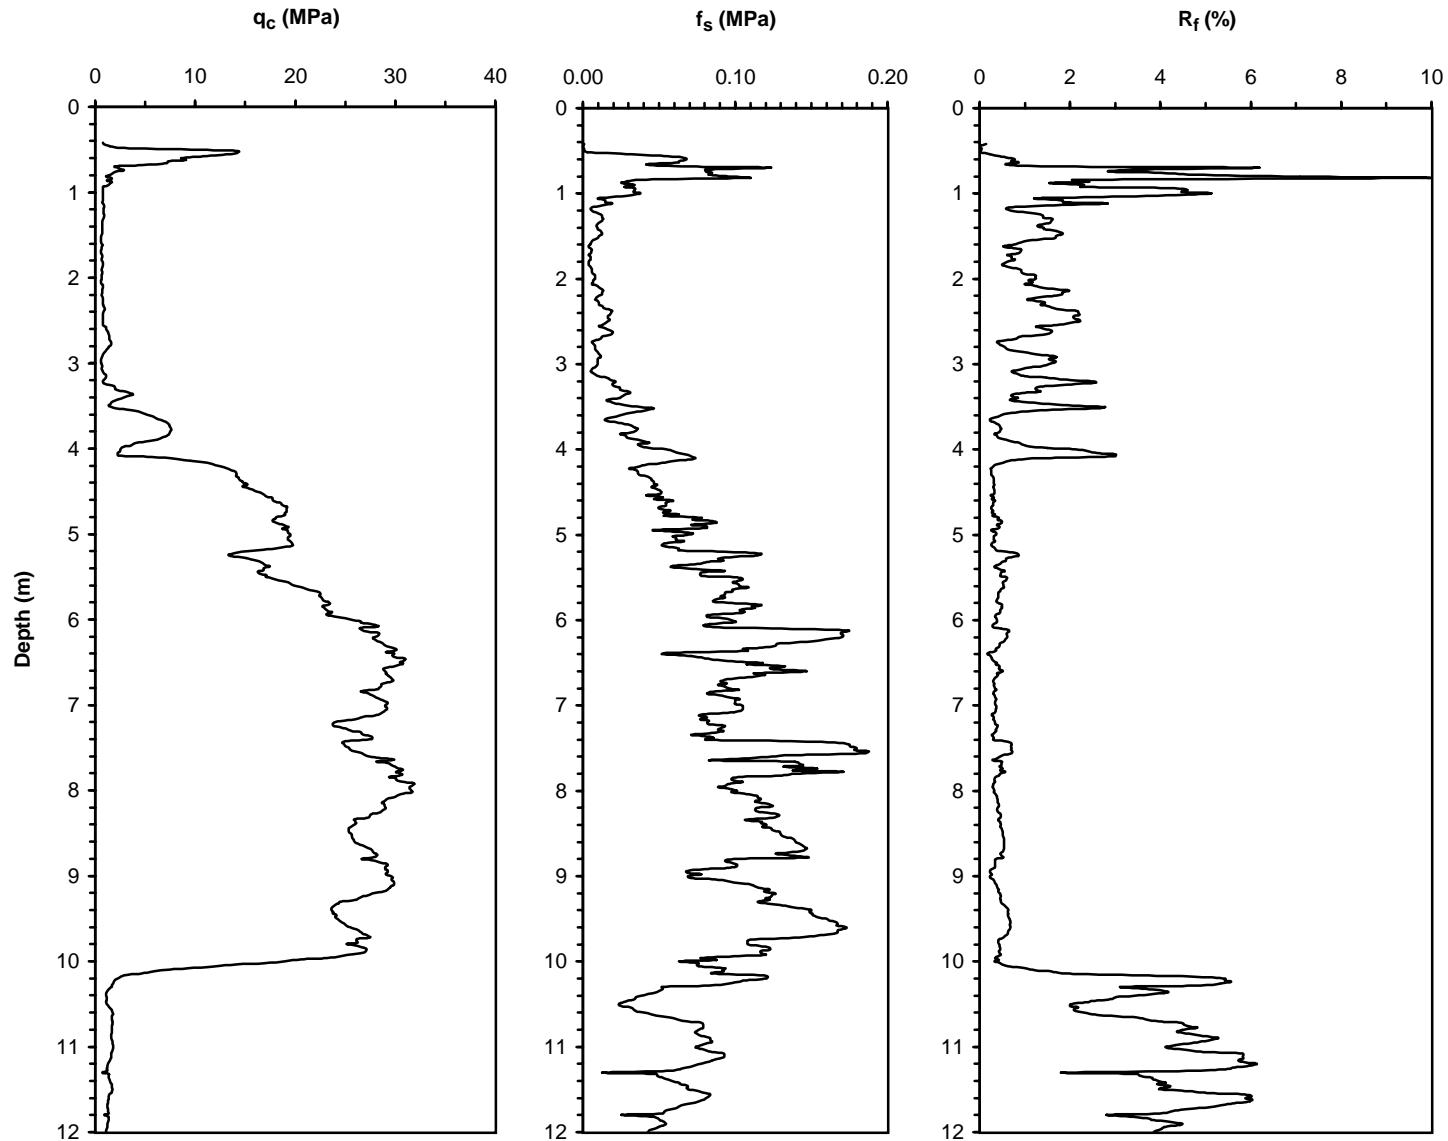
**Page:** 1 of 2

**Elevation:** -20 cm with respect to CPT-B3

**Water Table Elevation:** Not measured

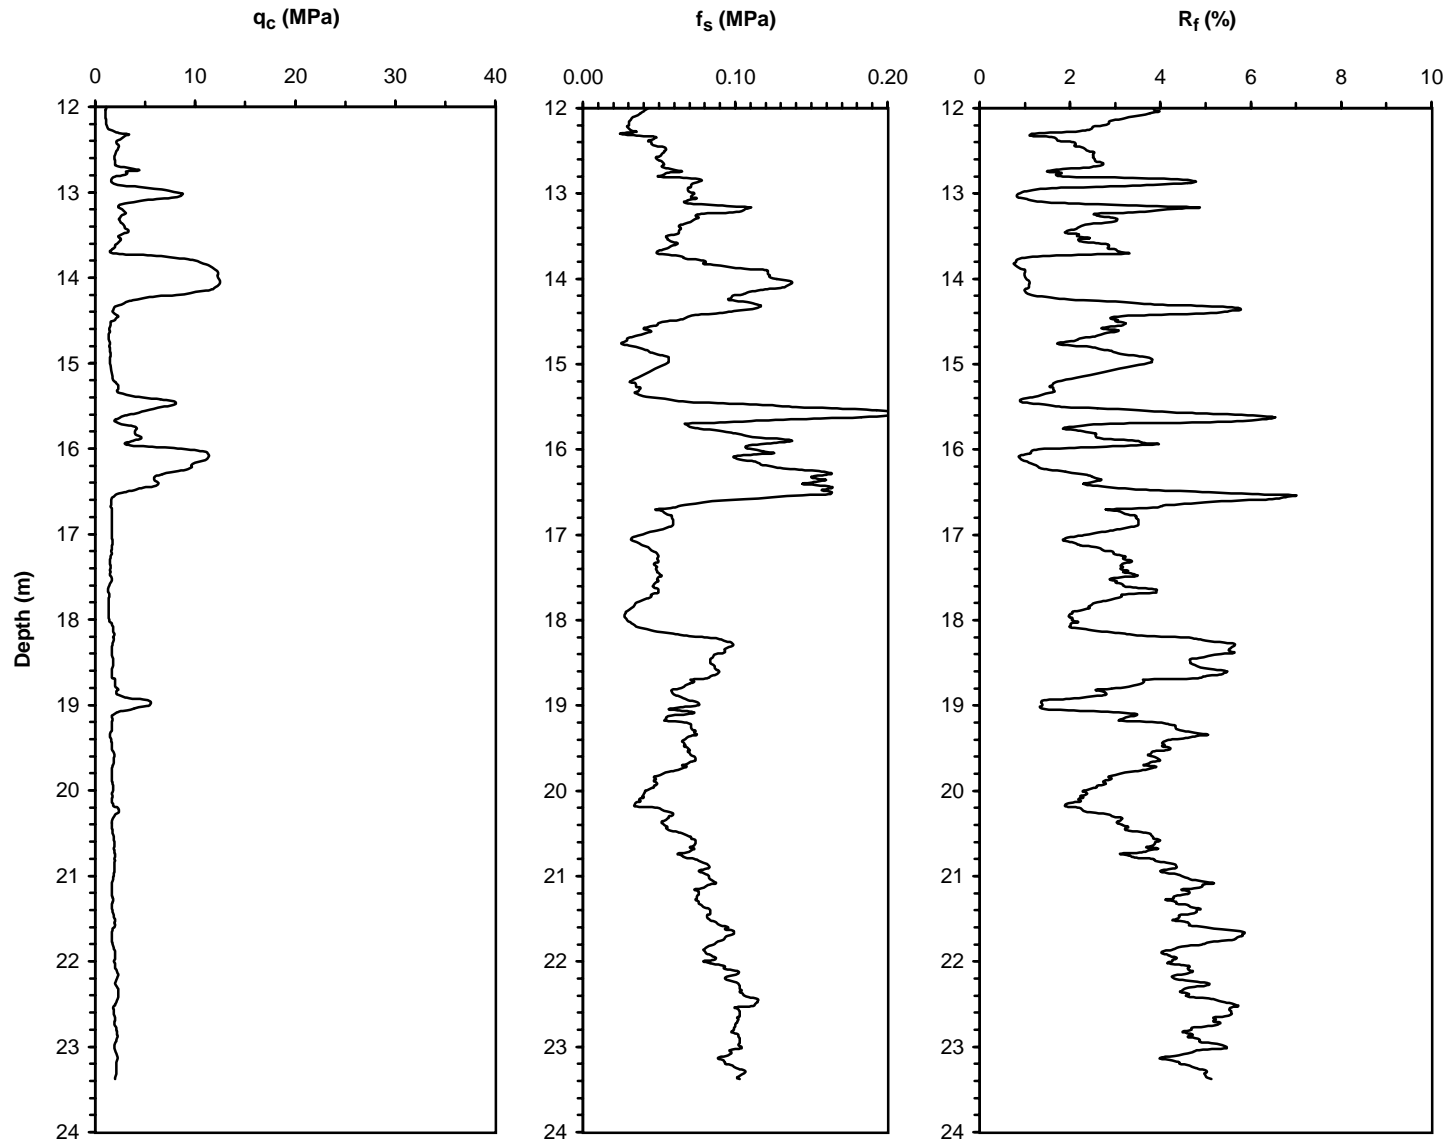
Page: 2 of 2

**Project Name:** Ground Failure and Building Performance in Adapazari, Turkey  
**Location:** Site B - Kuyudibi Av. and Yaprak Street, Karaosman District, Adapazari  
**GPS Coordinates:** 40.78513°N - 30.40024°E  
**Test Number:** CPT-B1  
**Type of Cone:** ELC10 CF (a.p. v.d. Berg)

**Elevation:** -20 cm with respect to CPT-B3

**Water Table Elevation:** Not measured
