UCB-BYU-UCLA  
ZETAŞ-SAU  
Joint Research

**Project Name:** Ground Failure and Building Performance in Adapazari, Turkey  
**Location:** Site B - Kuyudibi Av. and Yaprak Street, Karaosman District, Adapazari  
**GPS Coordinates:** 40.78513°N 30.40024°E  
**Test Number:** CPT-B2  
**Type of Cone:** ELC10 CF No. 991232 (a.p. v.d. Berg)

**Elevation:** -31 cm with respect to CPT-B3

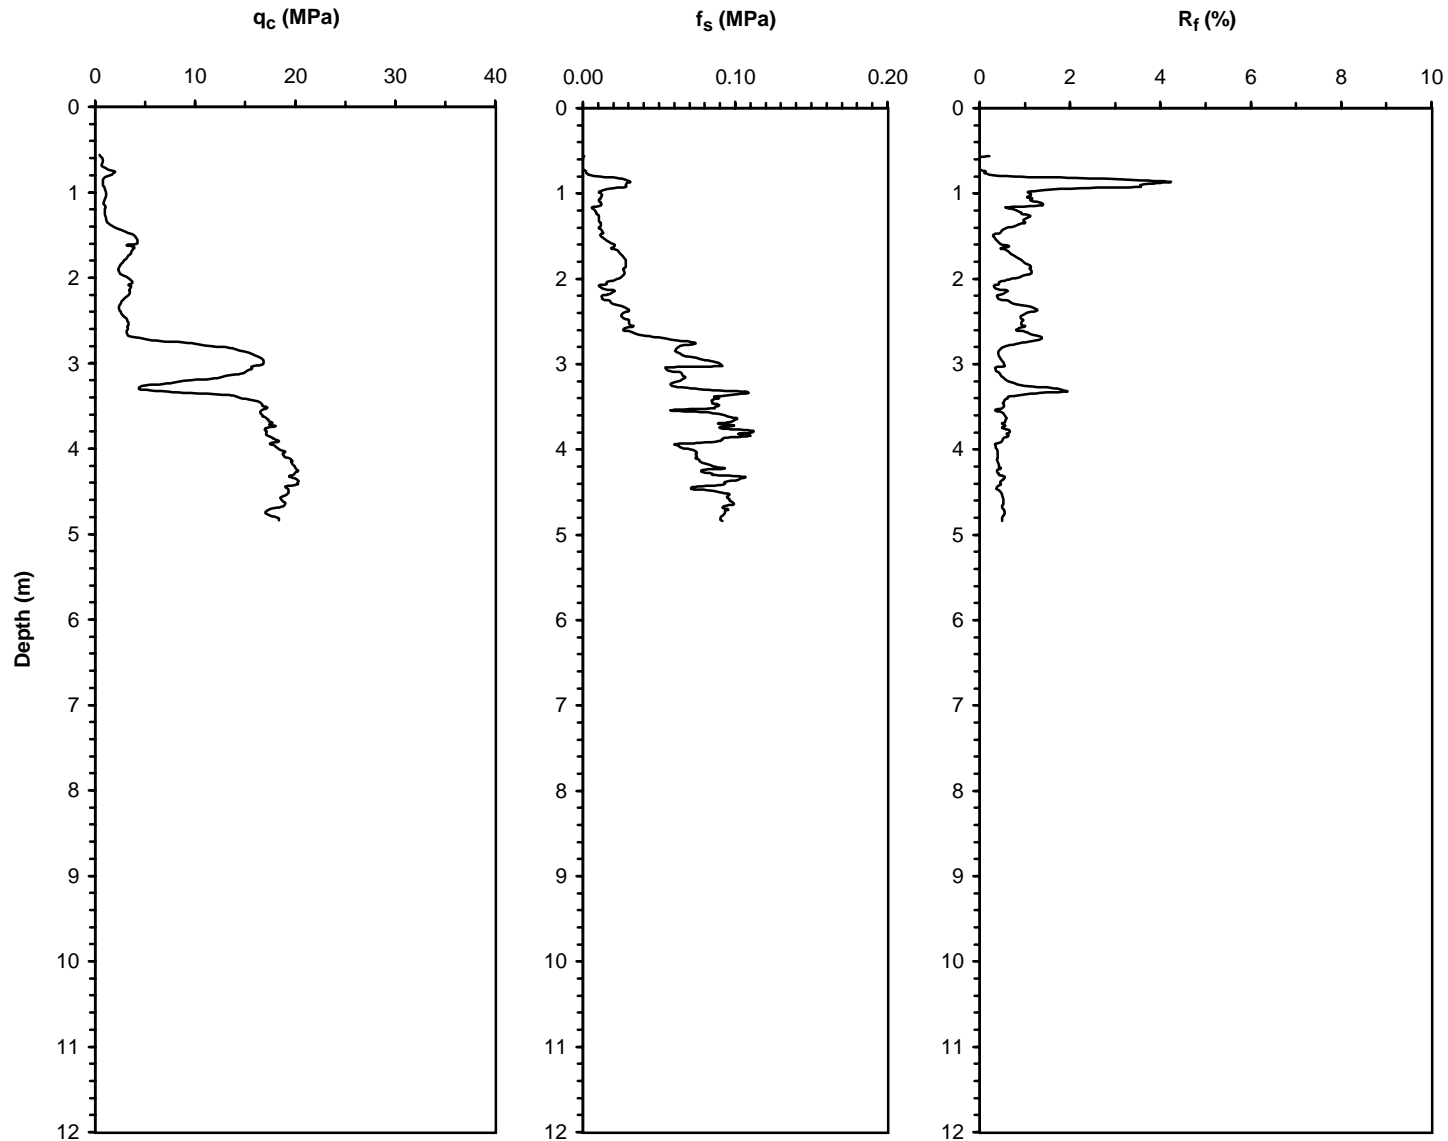
**Notes:** Electronics failed at 4.84 m of penetration
