UCB-BYU-UCLA
ZETAŞ-SAU
Joint Research

Project Name: Ground Failure and Building Performance in Adapazari, Turkey
Location: Site B - Kuyudibi Av. and Yaprak Street, Karaosman District, Adapazari
GPS Coordinates: 40.78513°N 30.40024°E
Test Number: CPT-B4
Type of Cone: ELC10 CFPS No. 991232 (a.p. v.d. Berg)

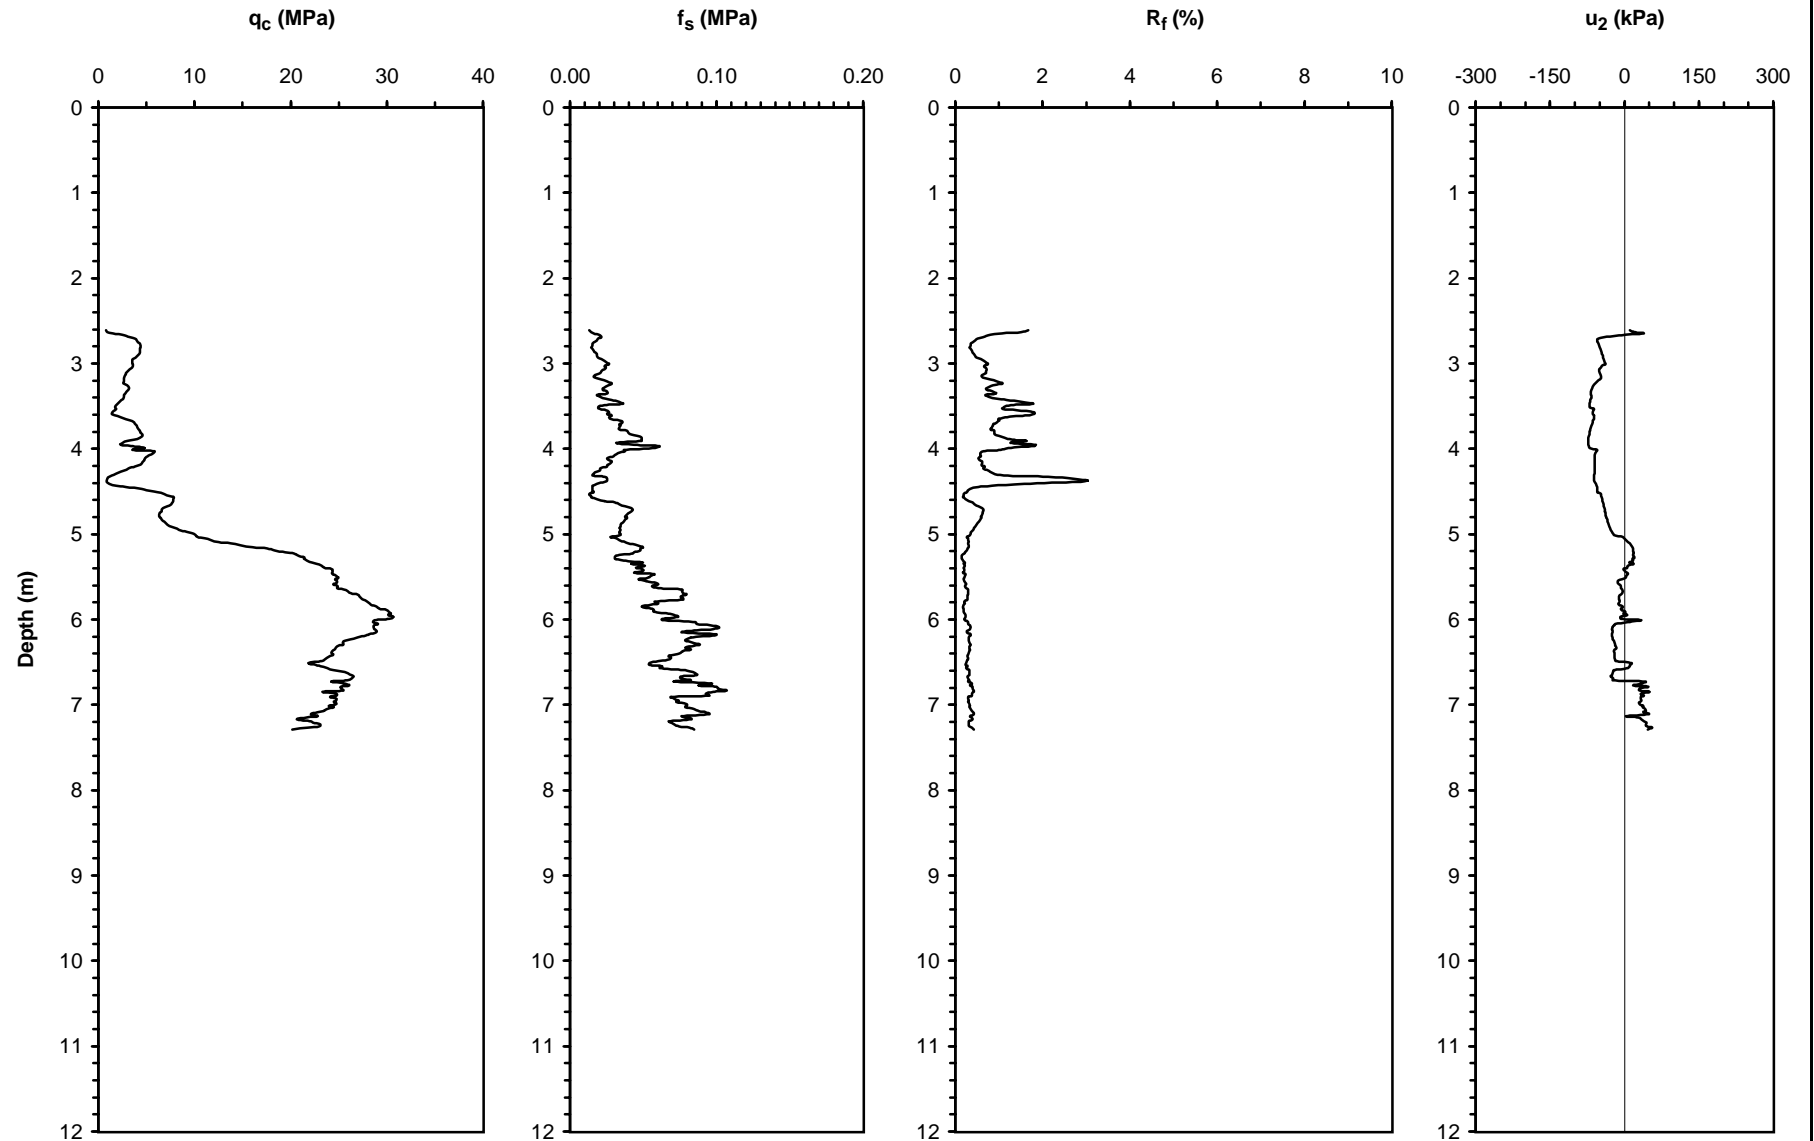
Notes: Pre-drilled with auger 2.6 m. At 1.04 m the rods dropped 10 cm due to loose fill in predrilled hole.
