UCB-BYU-UCLA
ZETAŞ-SAU
Joint Research

Project Name: Ground Failure and Building Performance in Adapazari, Turkey
Location: Site C - Bölük Street, İstiklal District, Adapazari
GPS Coordinates: 40.78370°N 30.39221°E
Test Number: CPT-C3
Type of Cone: ELC10 CF No. 990617 (a.p. v.d. Berg)

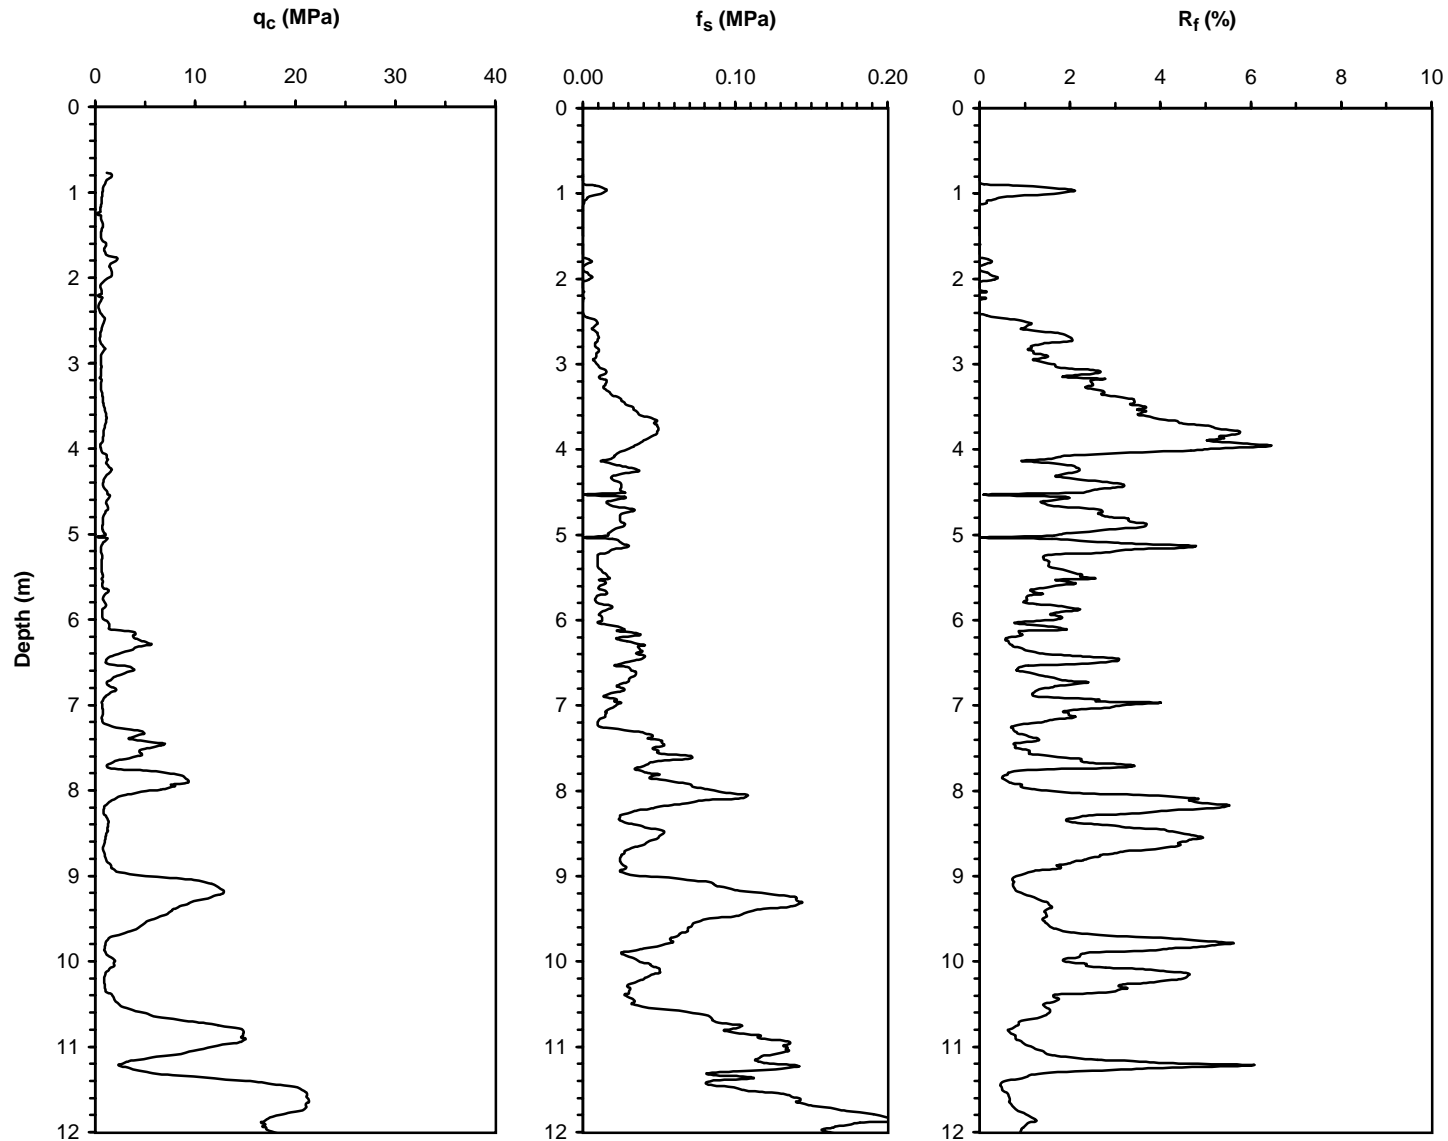
Page: 1 of 2

Elevation: -9 cm with respect to CPT-C4

Water Table Elevation: Not measured

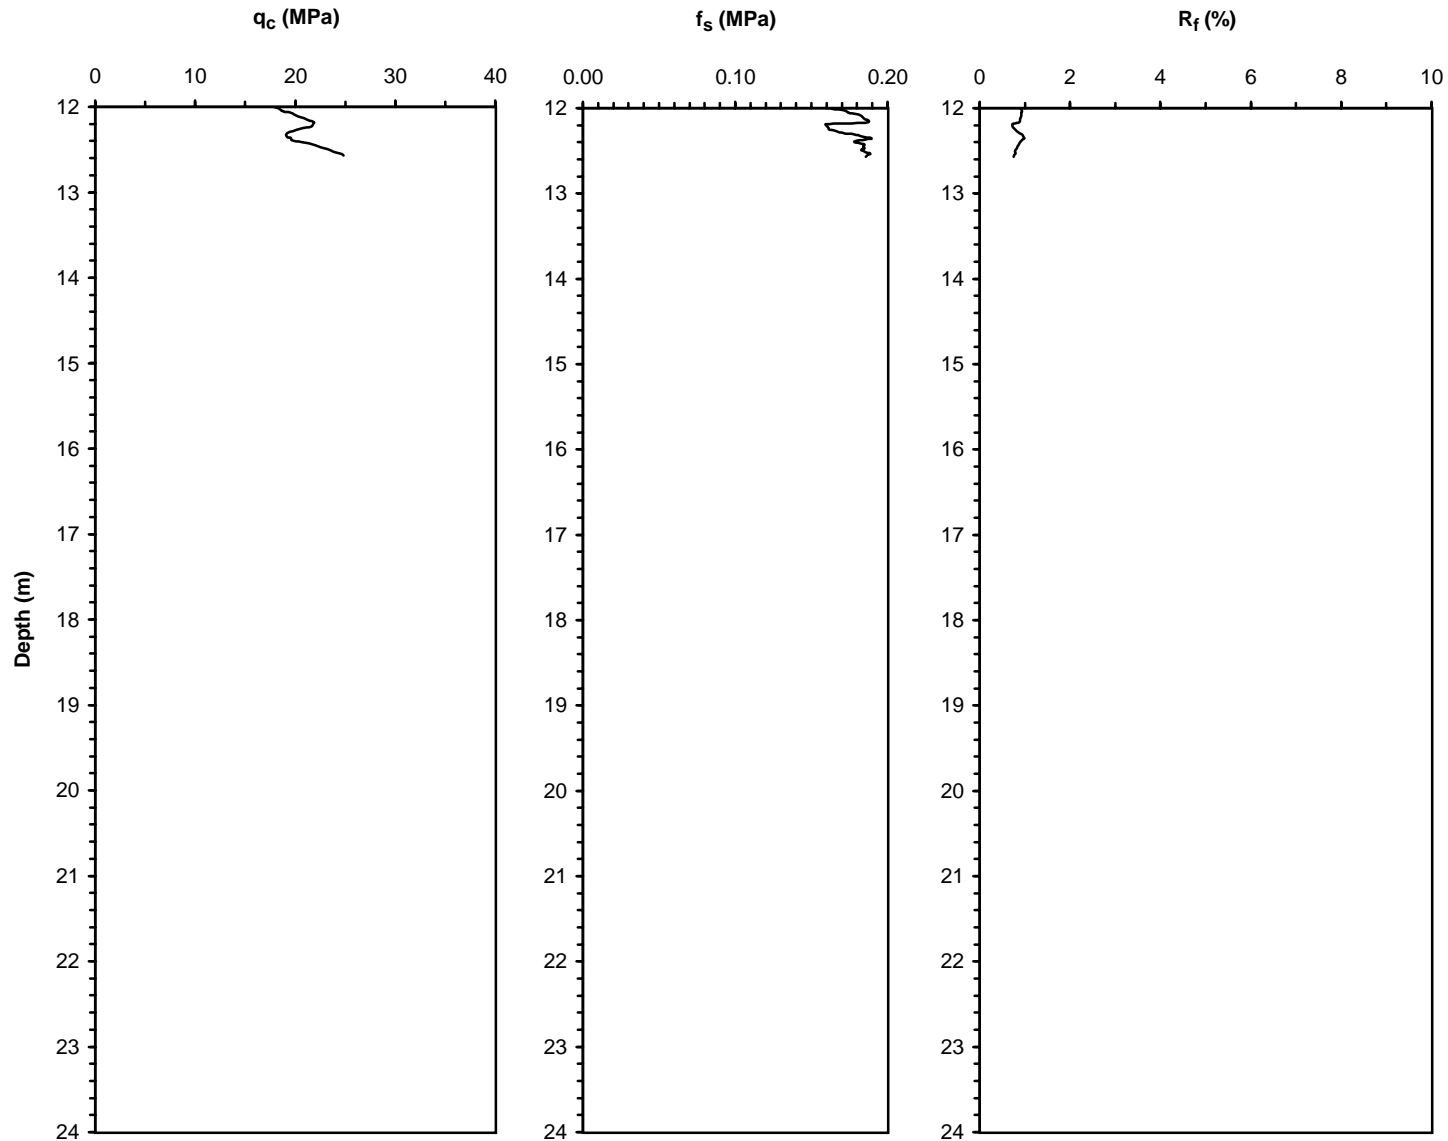
Page: 2 of 2

Project Name: Ground Failure and Building Performance in Adapazari, Turkey
Location: Site C - Bölük Street, İstiklal District, Adapazari
GPS Coordinates: 40.78370°N 30.39221°E
Test Number: CPT-C3
Type of Cone: ELC10 CF No. 990617 (a.p. v.d. Berg)

Elevation: -9 cm with respect to CPT-C4

Water Table Elevation: Not measured
