UCB-BYU-UCLA
ZETAŞ-SAU
Joint Research

Project Name: Ground Failure and Building Performance in Adapazari, Turkey
Location: Site C - Bölük Street, İstiklal District, Adapazari
GPS Coordinates: 40.78370°N 30.39221°E
Test Number: CPT-C5
Type of Cone: ELC10 CF No. 990617 (a.p. v.d. Berg)

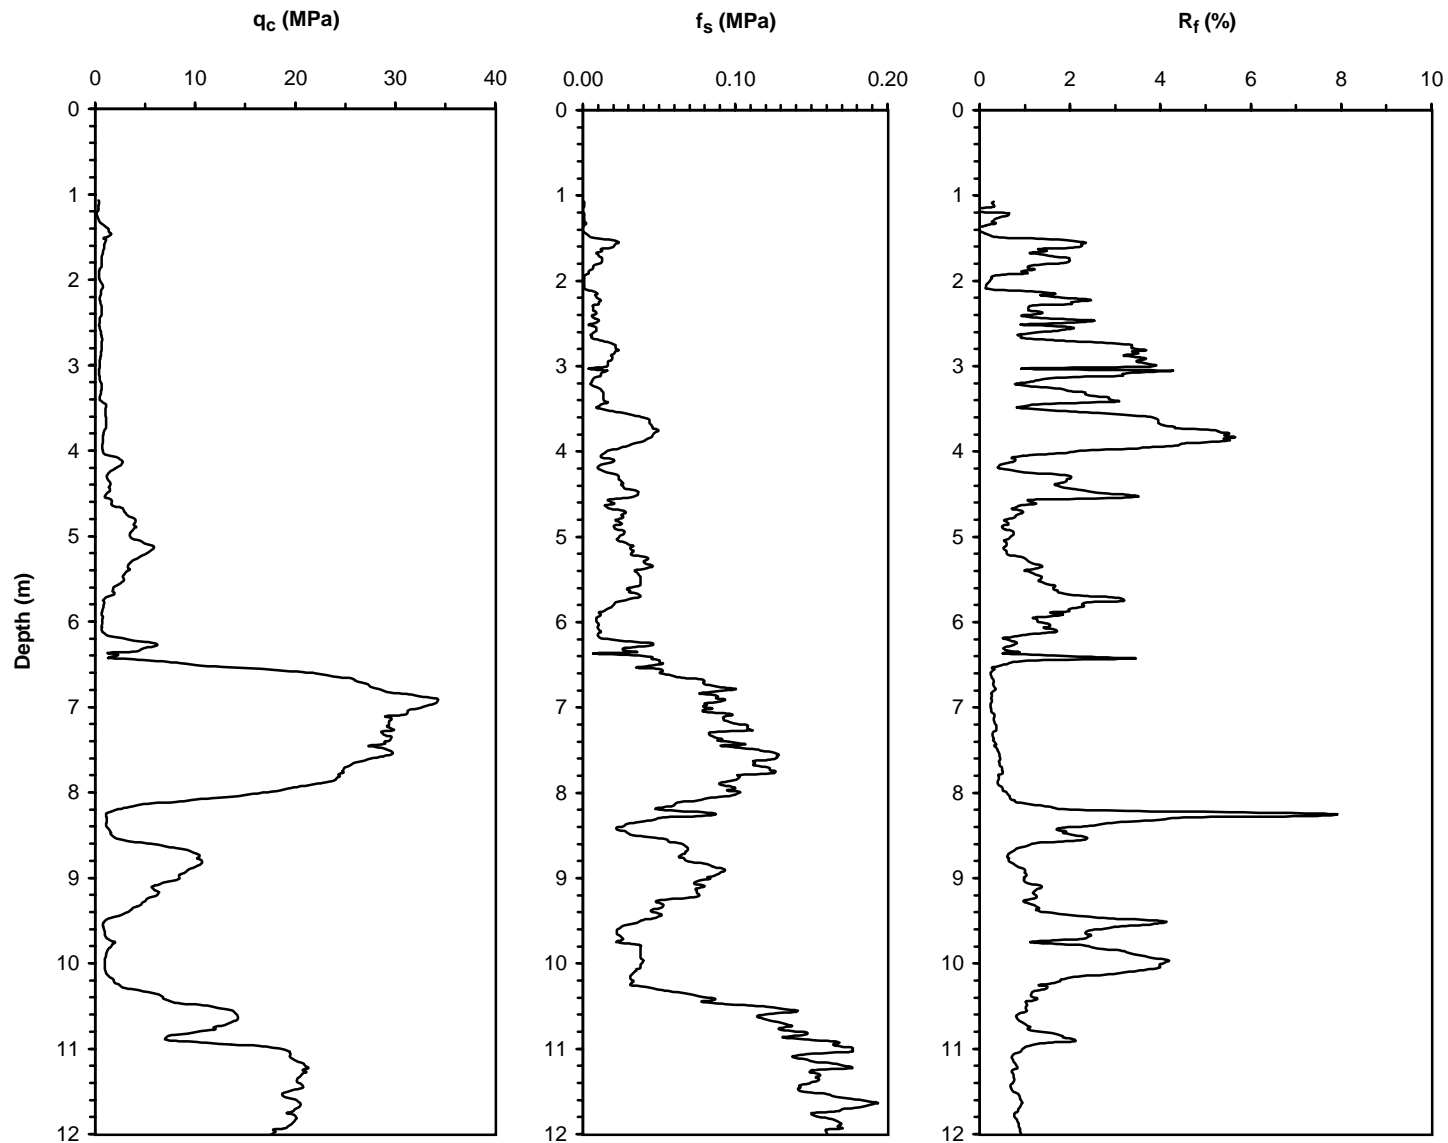
Page: 1 of 2

Elevation: -22 cm with respect to CPT-C4

Water Table Elevation: Not measured

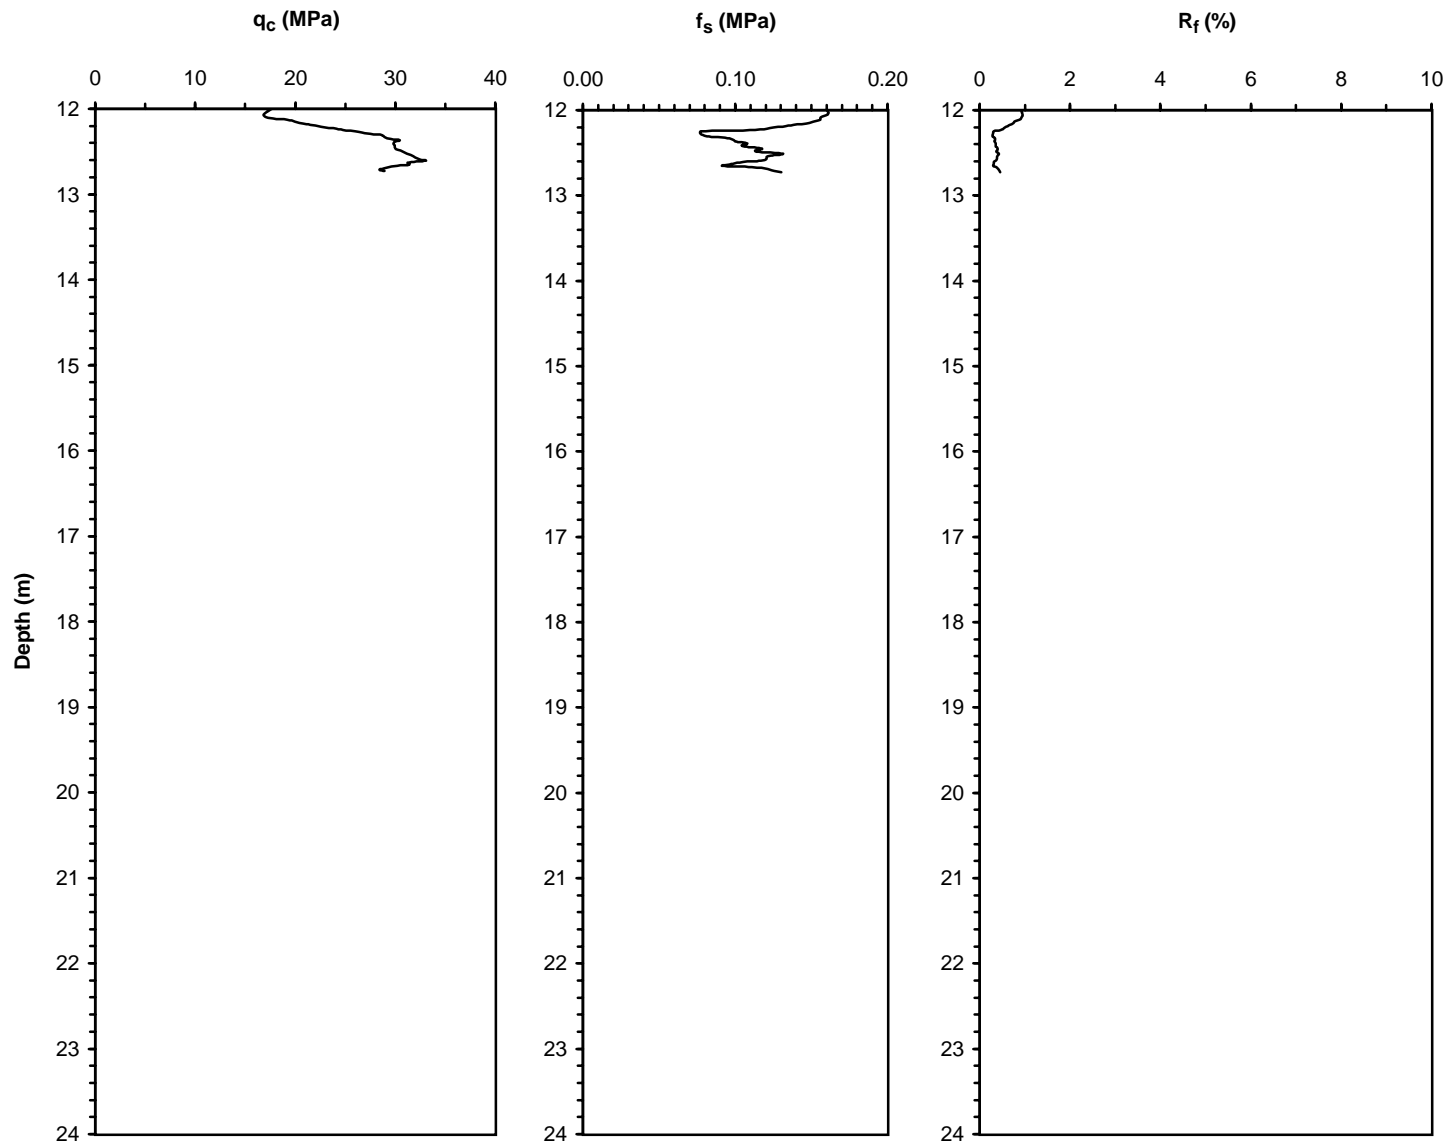
Page: 2 of 2

Project Name: Ground Failure and Building Performance in Adapazari, Turkey
Location: Site C - Bölük Street, İstiklal District, Adapazari
GPS Coordinates: 40.78370°N 30.39221°E
Test Number: CPT-C5
Type of Cone: ELC10 CF No. 990617 (a.p. v.d. Berg)

Elevation: -22 cm with respect to CPT-C4

Water Table Elevation: Not measured
