UCB-BYU-UCLA
ZETAŞ-SAU
Joint Research

Project Name: Ground Failure and Building Performance in Adapazari, Turkey
Location: Site D - Meydan Street, Çukurahmediye District, Adapazari
GPS Coordinates: 40.76929°N 30.40828°E
Test Number: CPT-D2
Type of Cone: ELC10 CFPS No. 991232 (a.p. v.d. Berg)

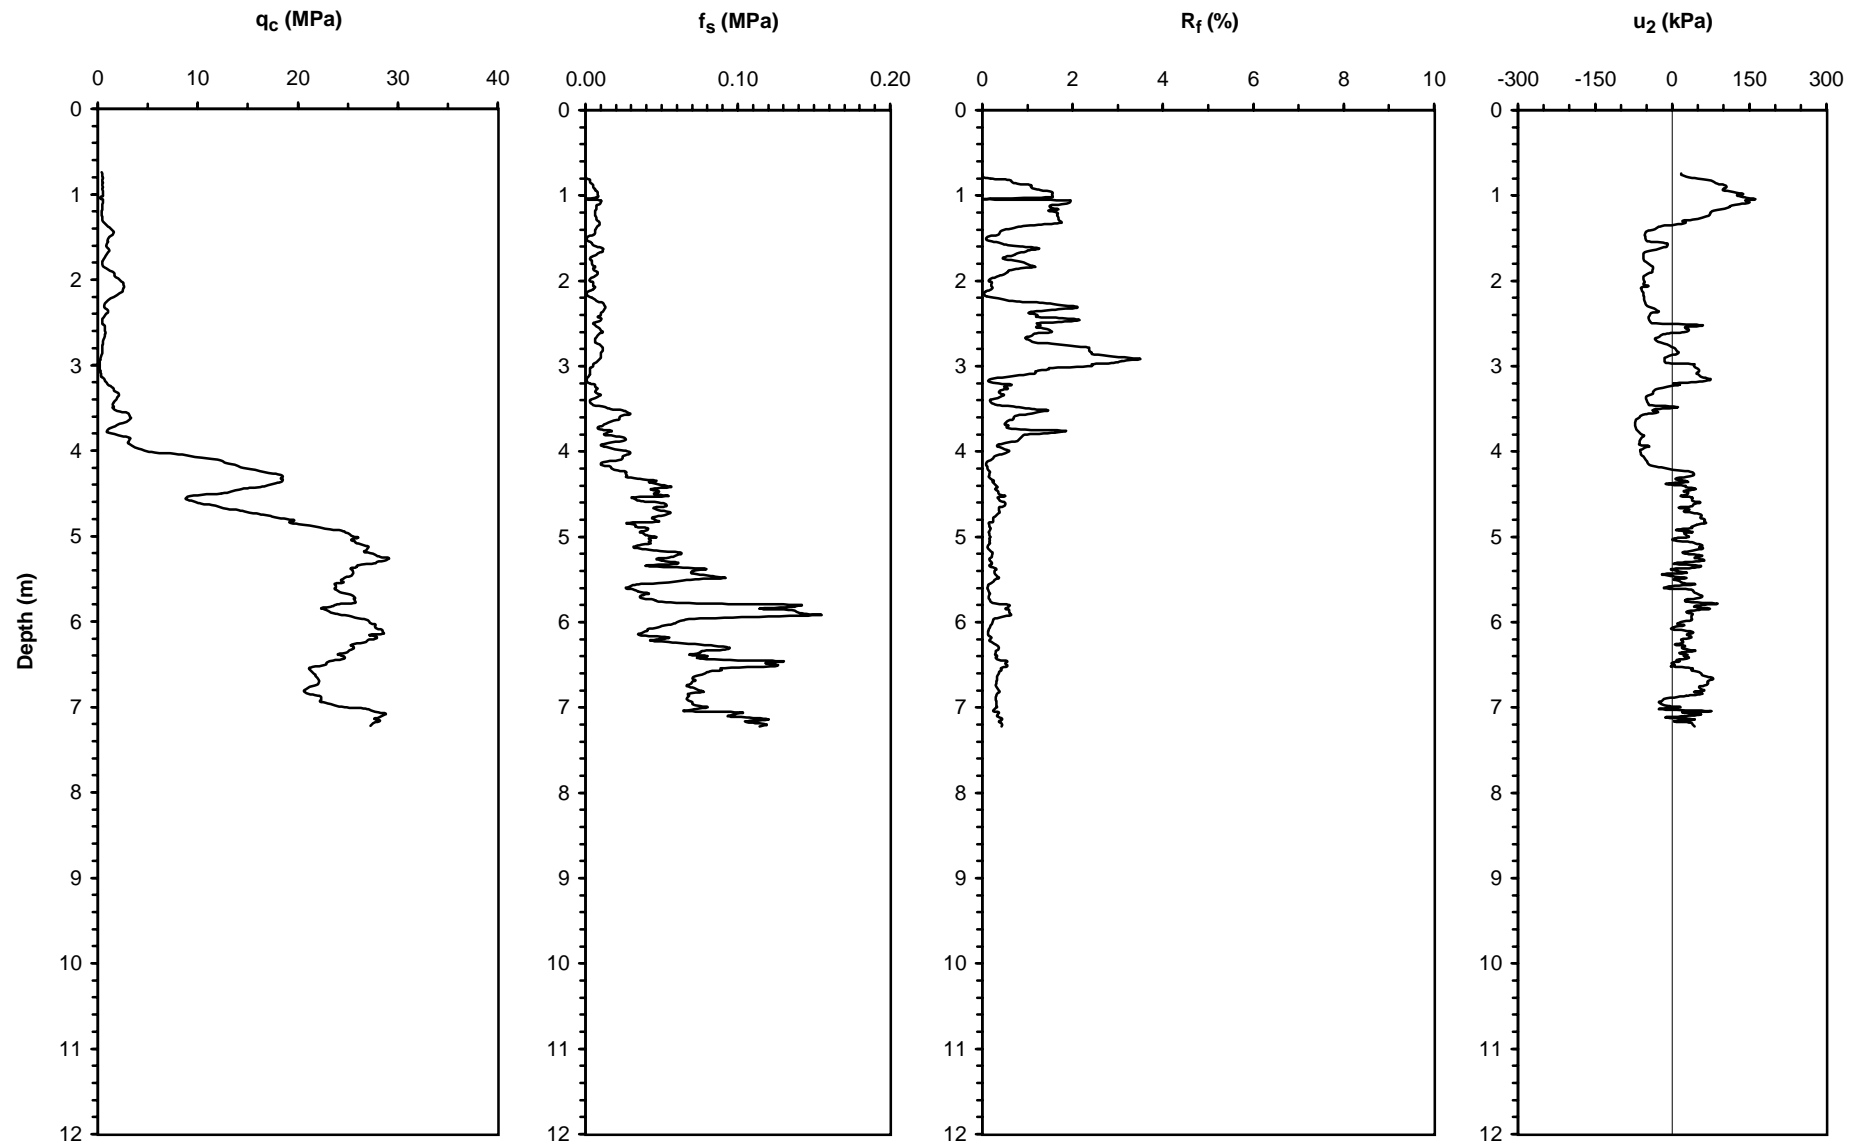
Elevation: -10 cm with respect to CPT-D1
