UCB-BYU-UCLA
ZETAŞ-SAU
Joint Research

Project Name: Ground Failure and Building Performance in Adapazari, Turkey
Location: Site F - Sönmez Street, Yenigün District, Adapazari
GPS Coordinates: 40.77148°N 30.40795°E
Test Number: CPT-F1
Type of Cone: ELC10 CFPS No. 991232 (a.p. v.d. Berg)

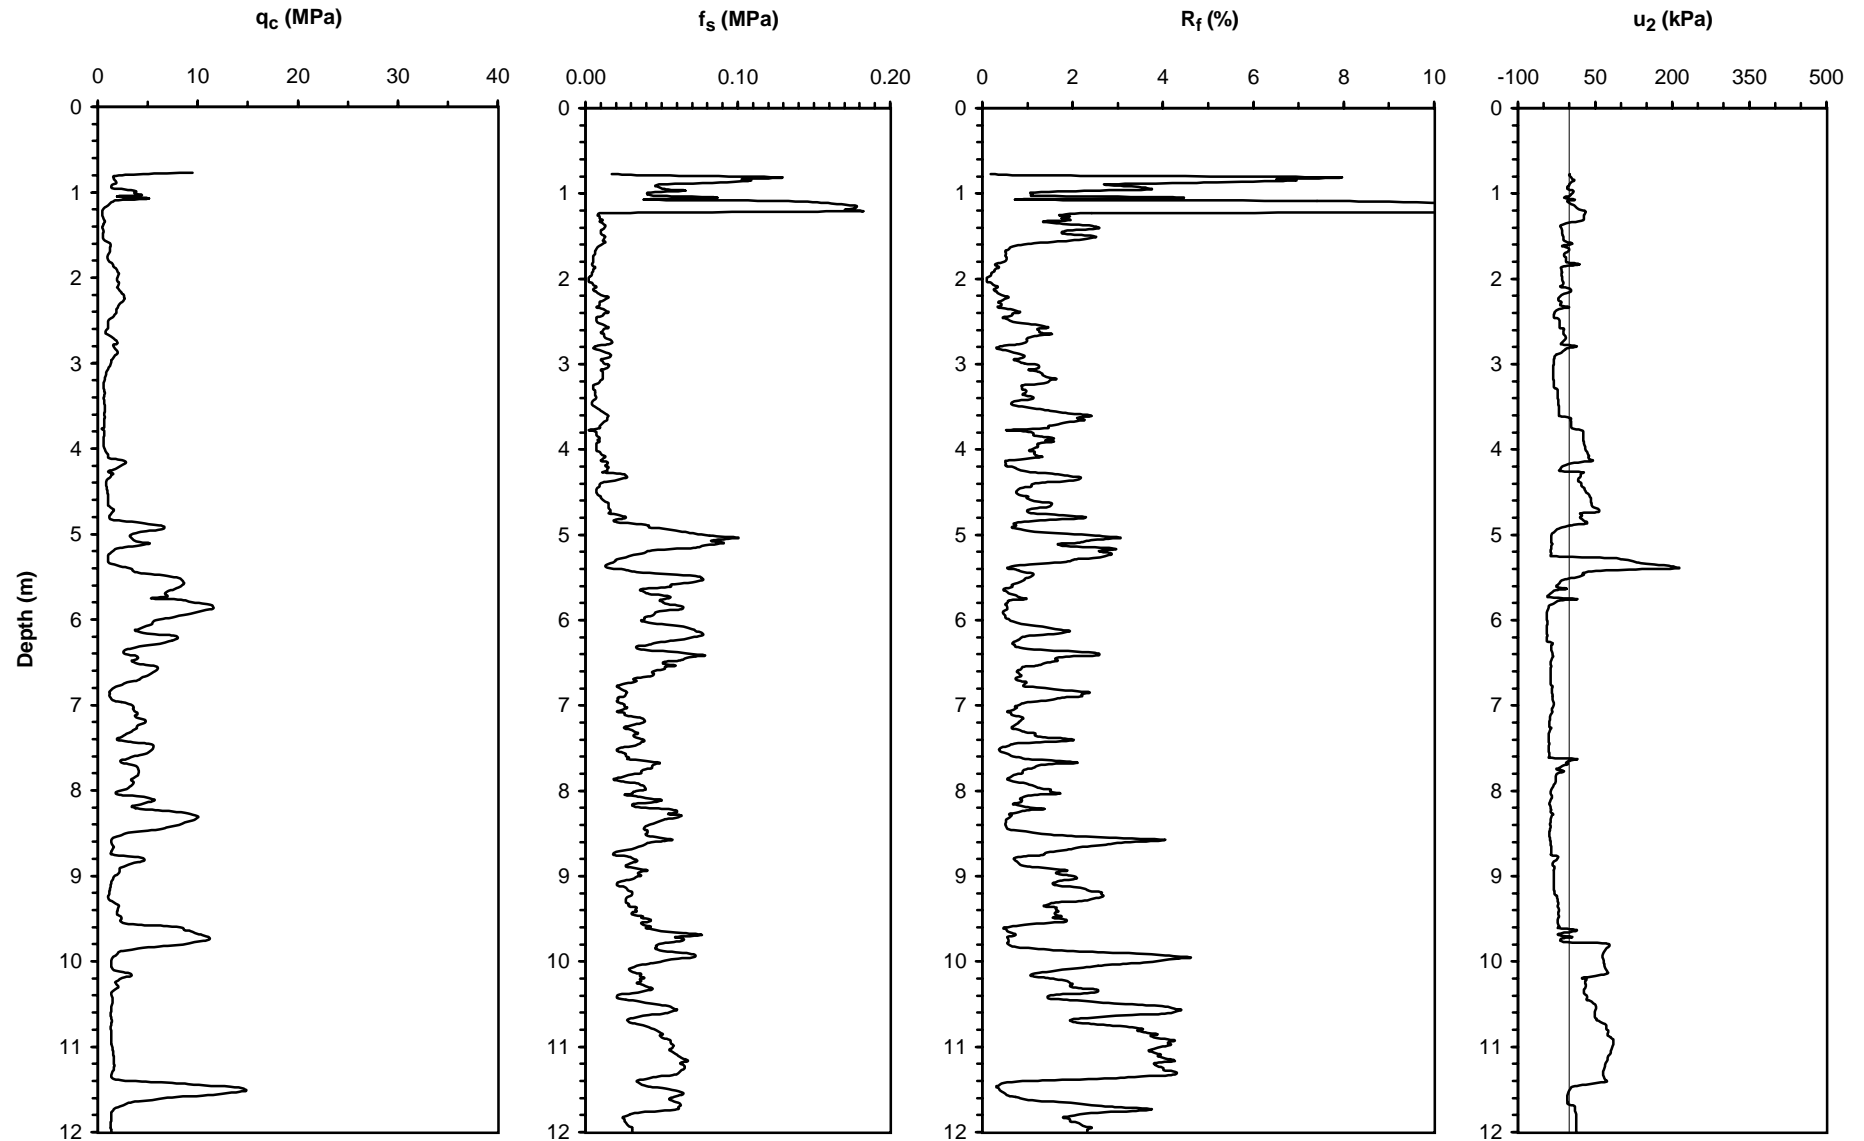
Page: 1 of 3

Notes: Probed with percussion hammer 75 cm to check for utilities

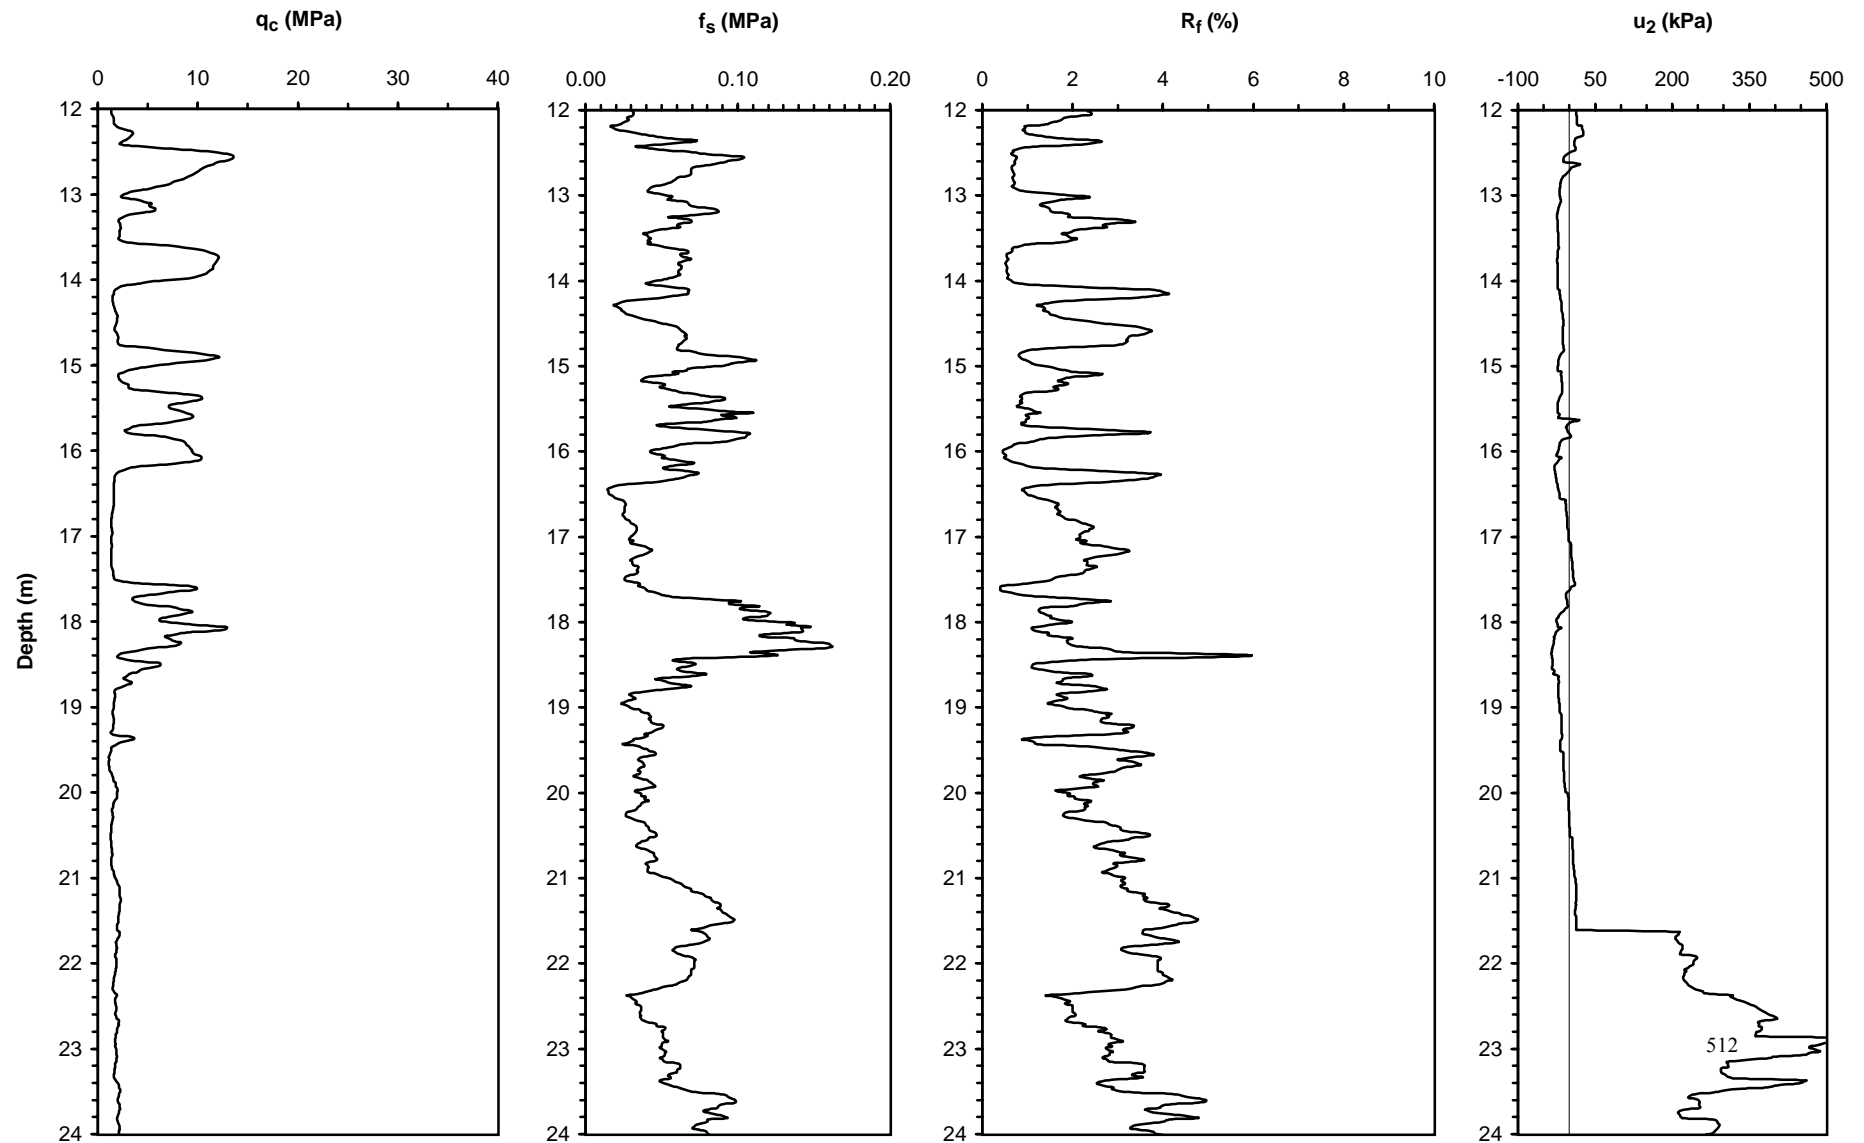
Page: 2 of 3

Project Name: Ground Failure and Building Performance in Adapazari, Turkey
Location: Site F - Sönmez Street, Yenigün District, Adapazari
GPS Coordinates: 40.77148°N 30.40795°E
Test Number: CPT-F1
Type of Cone: ELC10 CFPS No. 991232 (a.p. v.d. Berg)

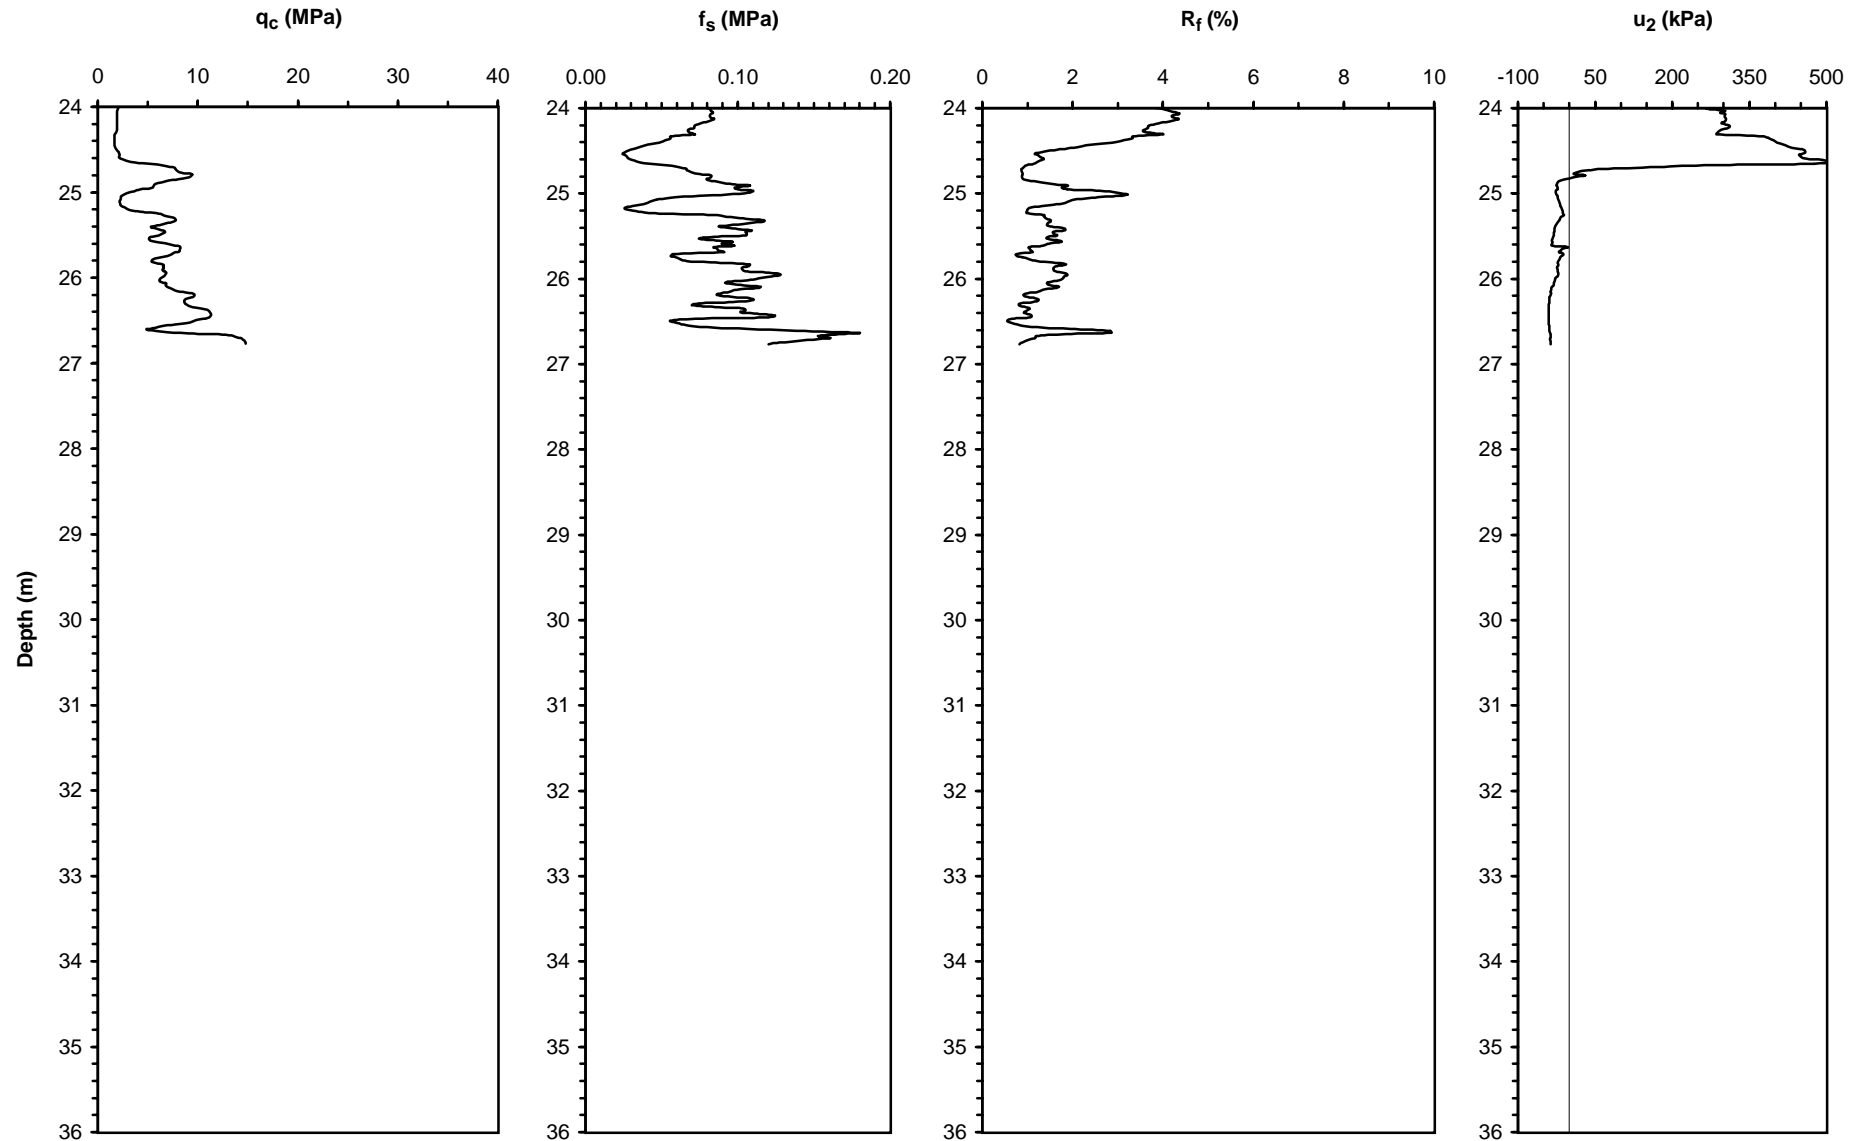
Page: 3 of 3

Project Name: Ground Failure and Building Performance in Adapazari, Turkey
Location: Site F - Sönmez Street, Yenigün District, Adapazari
GPS Coordinates: 40.77148°N 30.40795°E
Test Number: CPT-F1
Type of Cone: ELC10 CFPS No. 991232 (a.p. v.d. Berg)
