UCB-BYU-UCLA
ZETAŞ-SAU
Joint Research

Project Name: Ground Failure and Building Performance in Adapazari, Turkey
Location: Site G - Hasircilar Street, Yenigun District, Adapazari
GPS Coordinates: 40.77450°N 30.40896°E
Test Number: CPT-G1
Type of Cone: ELC10 CFPS No. 991232 (a.p. v.d. Berg)

Date: June 21, 2000

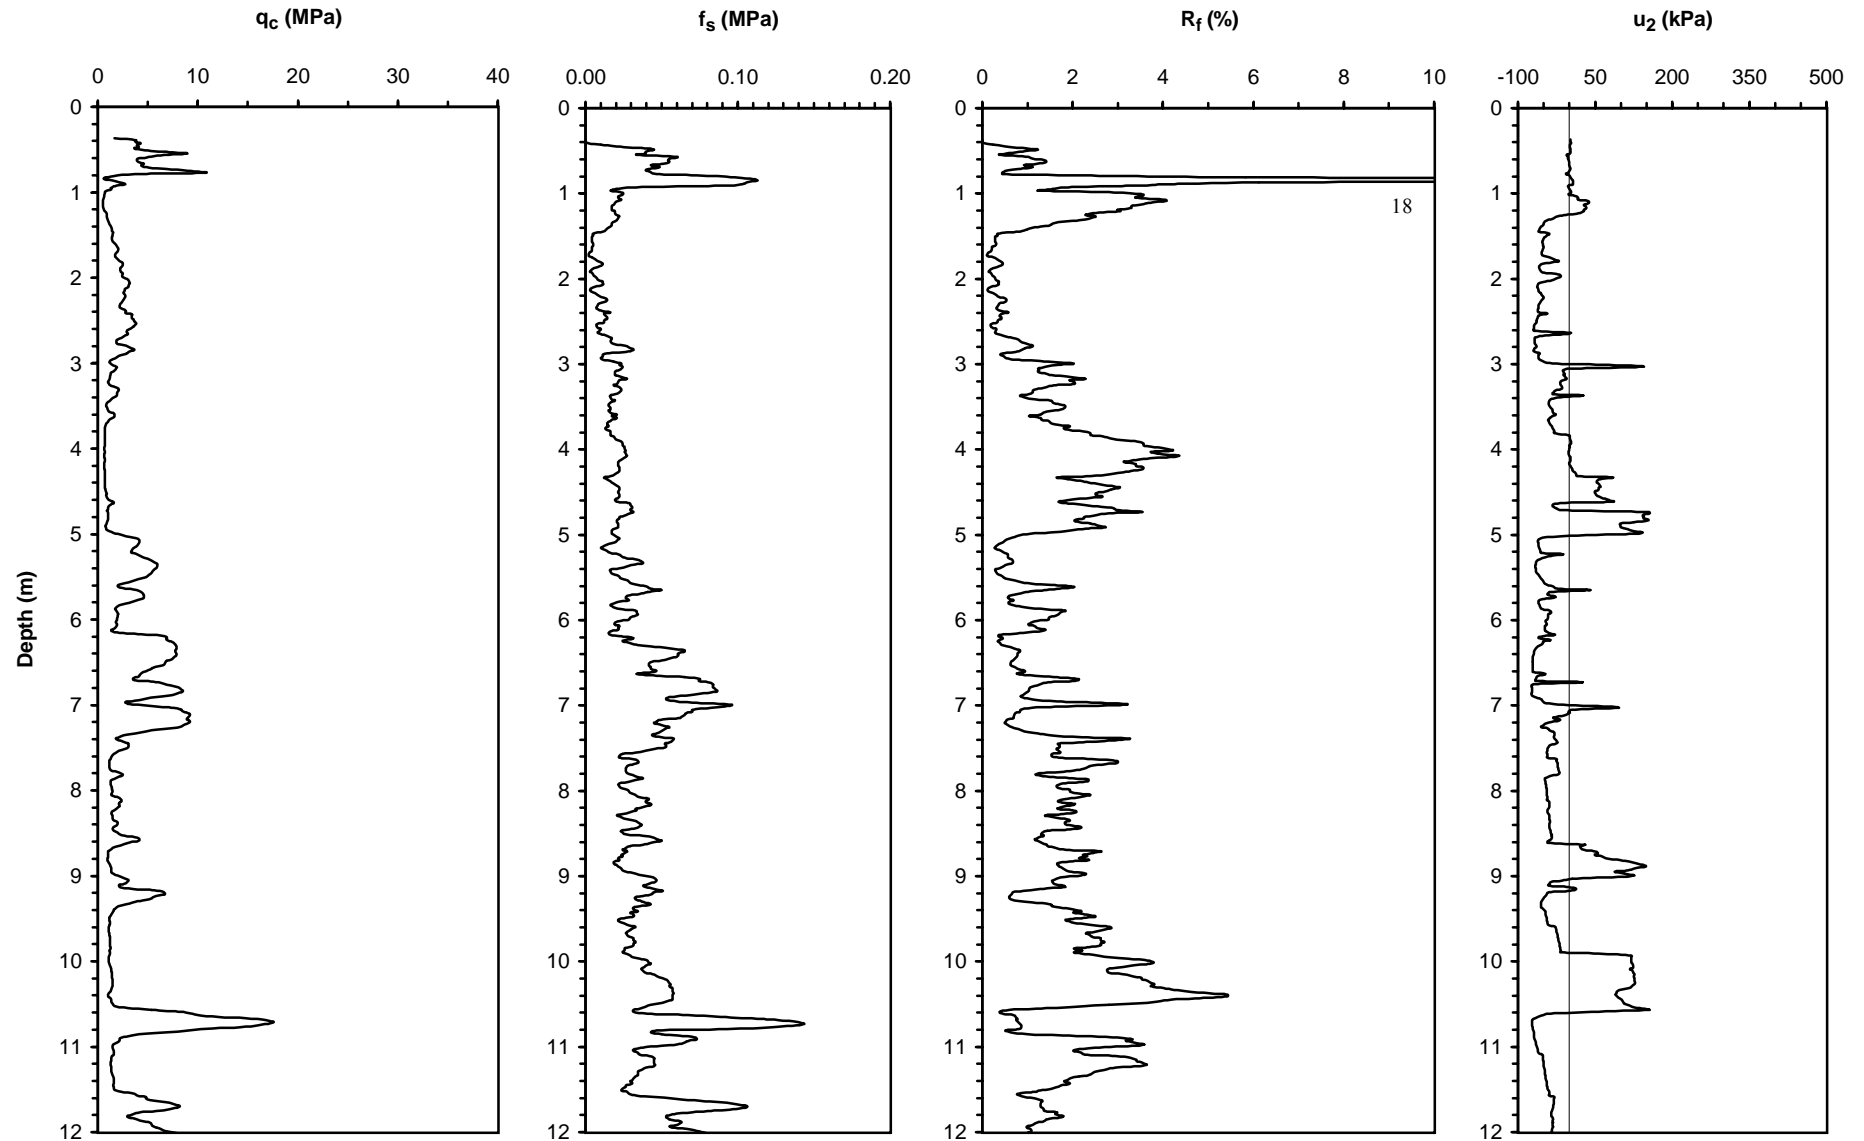
Page: 1 of 3

Elevation: 0 cm with respect to CPT-G1

Water Table Elevation: Not measured

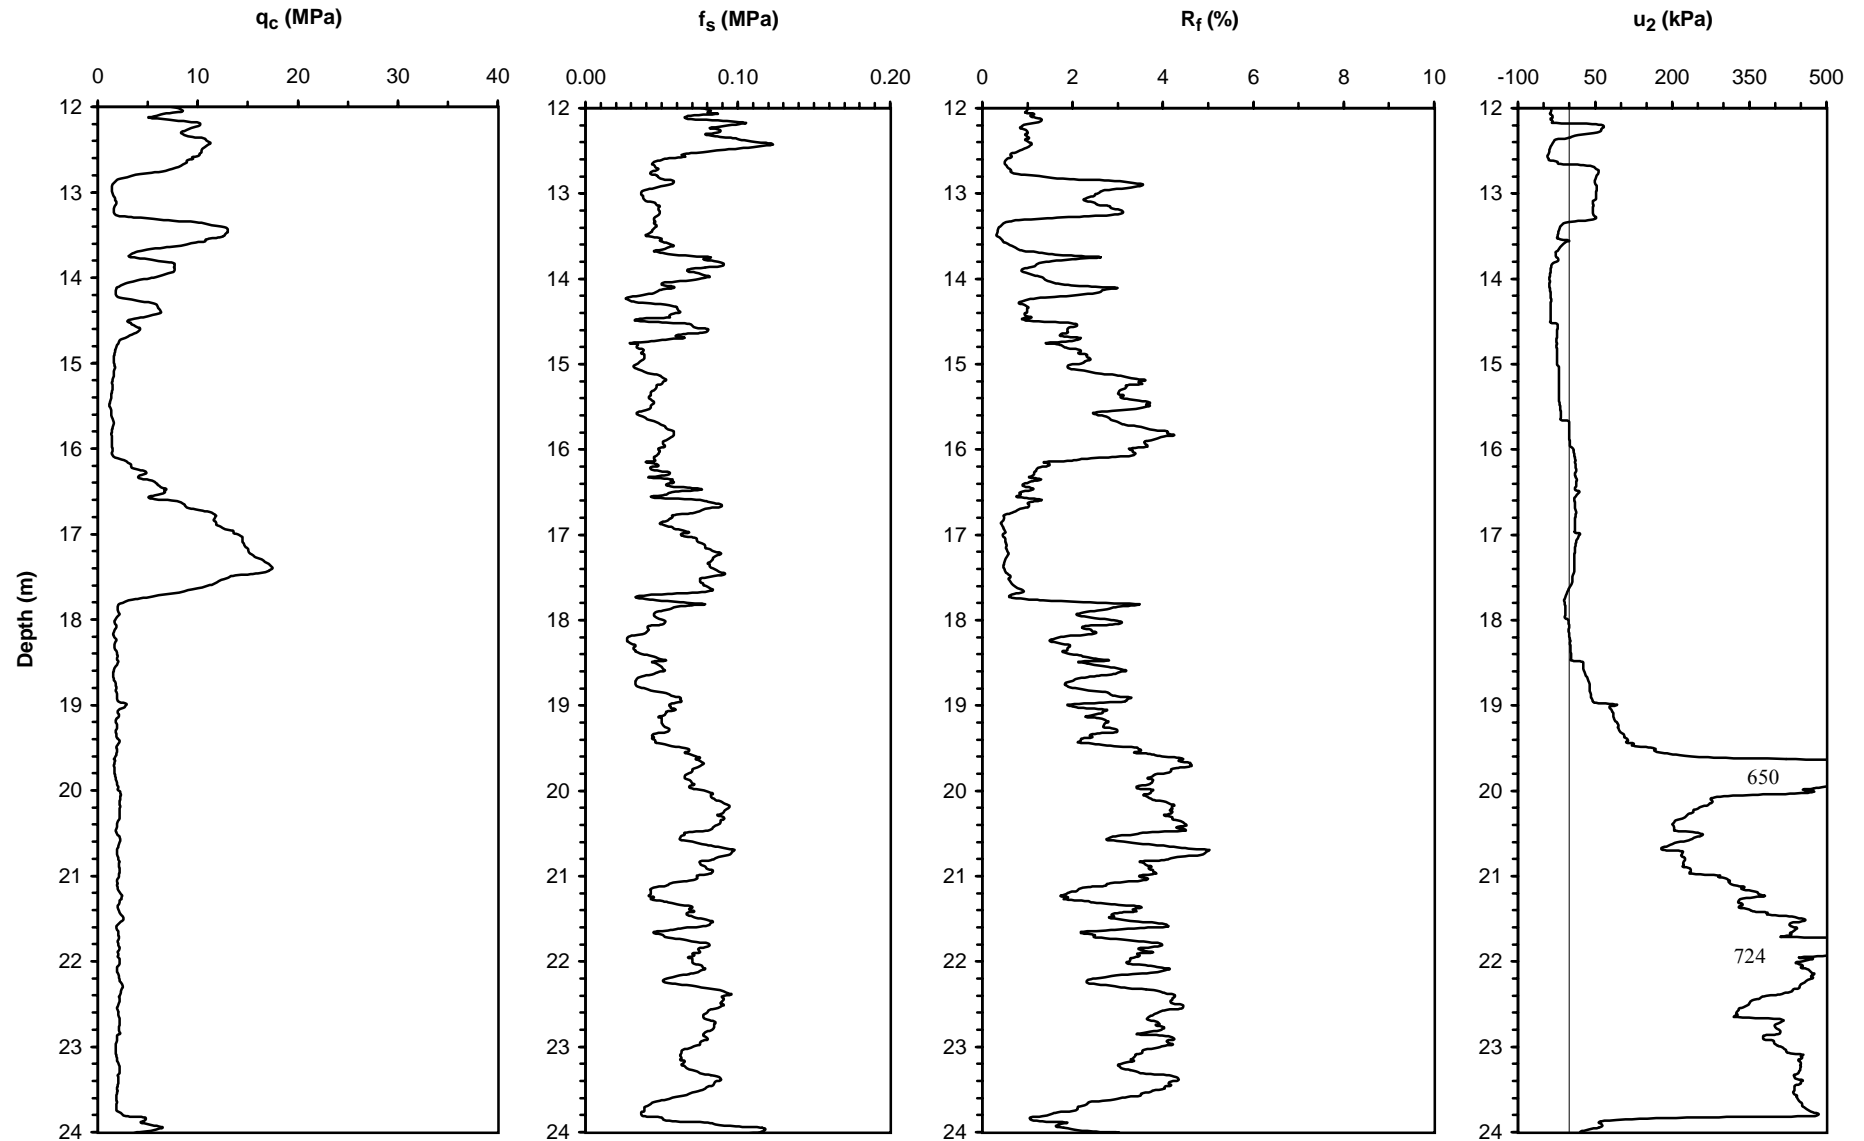
Page: 2 of 3

Project Name: Ground Failure and Building Performance in Adapazari, Turkey
Location: Site G - Hasircilar Street, Yenigun District, Adapazari
GPS Coordinates: 40.77450°N 30.40896°E
Test Number: CPT-G1
Type of Cone: ELC10 CFPS No. 991232 (a.p. v.d. Berg)

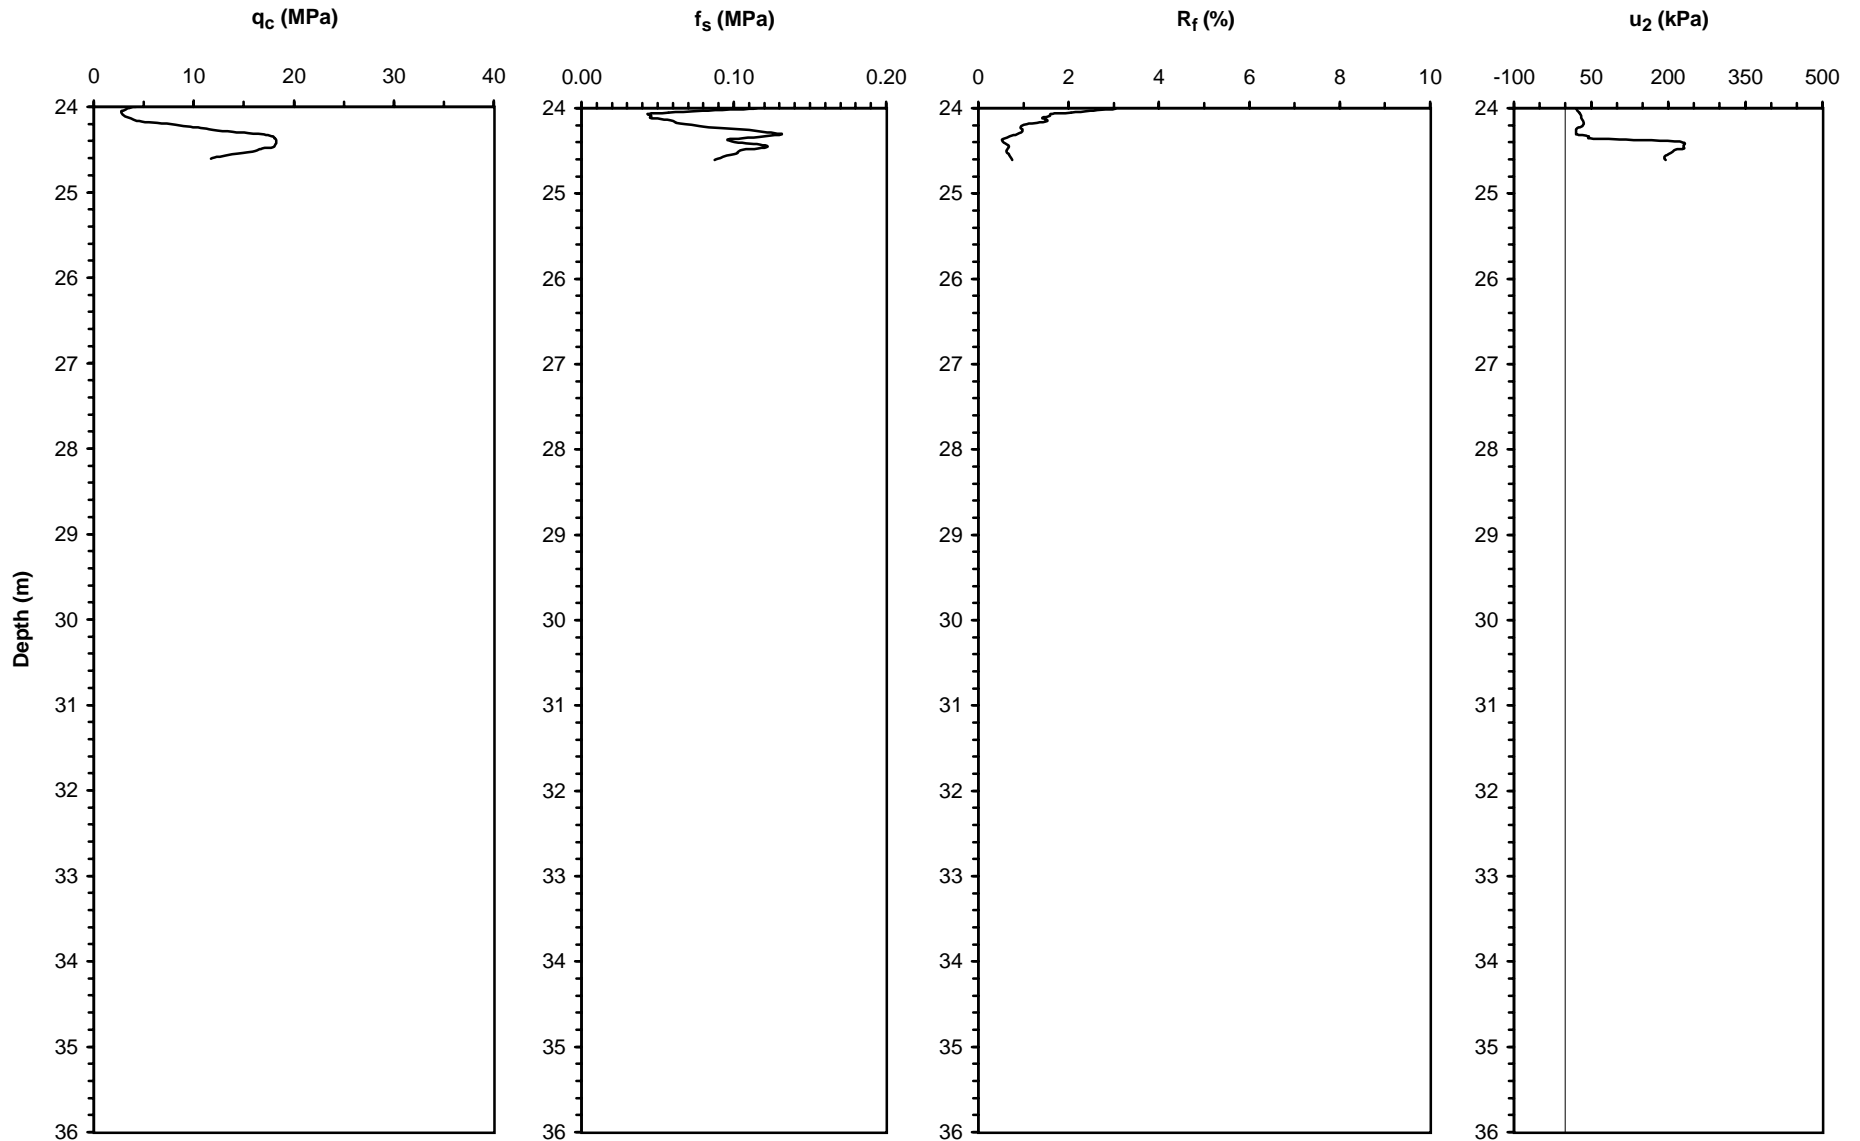
Page: 3 of 3

Project Name: Ground Failure and Building Performance in Adapazari, Turkey
Location: Site G - Hasircilar Street, Yenigun District, Adapazari
GPS Coordinates: 40.77450°N 30.40896°E
Test Number: CPT-G1
Type of Cone: ELC10 CFPS No. 991232 (a.p. v.d. Berg)
