UCB-BYU-UCLA  
ZETAŞ-SAU  
Joint Research

**Project Name:** Ground Failure and Building Performance in Adapazari, Turkey  
**Location:** Site H - Kınalı Street, Yağcılar District, Adapazari  
**GPS Coordinates:** 40.78419°N 30.41295°E  
**Test Number:** CPT-H3  
**Type of Cone:** ELC10 CFP No. 000606 (a.p. v.d. Berg)

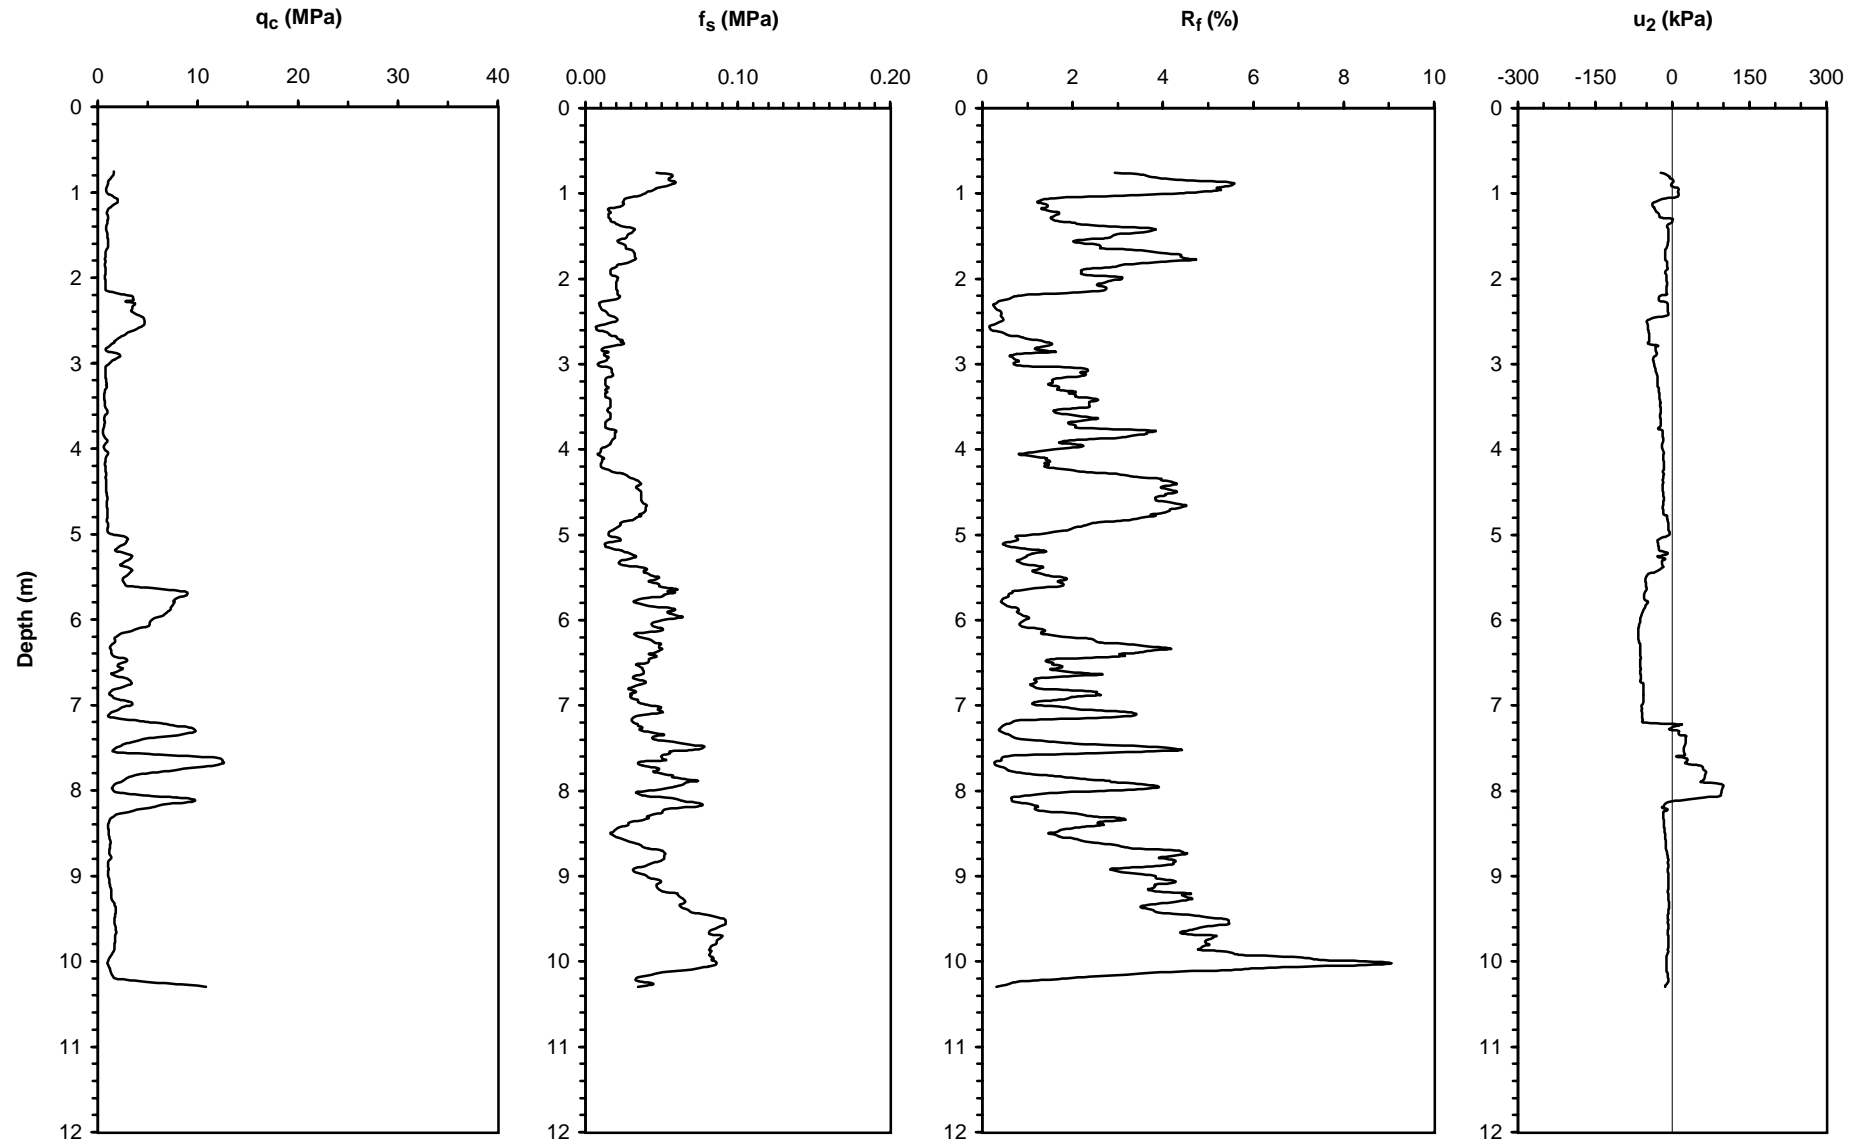
**Notes:** Probed with percussion hammer 75 cm to check for utilities
