UCB-BYU-UCLA
ZETAŞ-SAU
Joint Research

Project Name: Ground Failure and Building Performance in Adapazari, Turkey
Location: Site I - Çark Avenue, Semerciler District, Adapazari
GPS Coordinates: 40.77681°N 30.39223°E
Test Number: CPT-II
Type of Cone: ELC10 CF No. 990618 (a.p. v.d. Berg)

Date: August 18, 2000 12:03

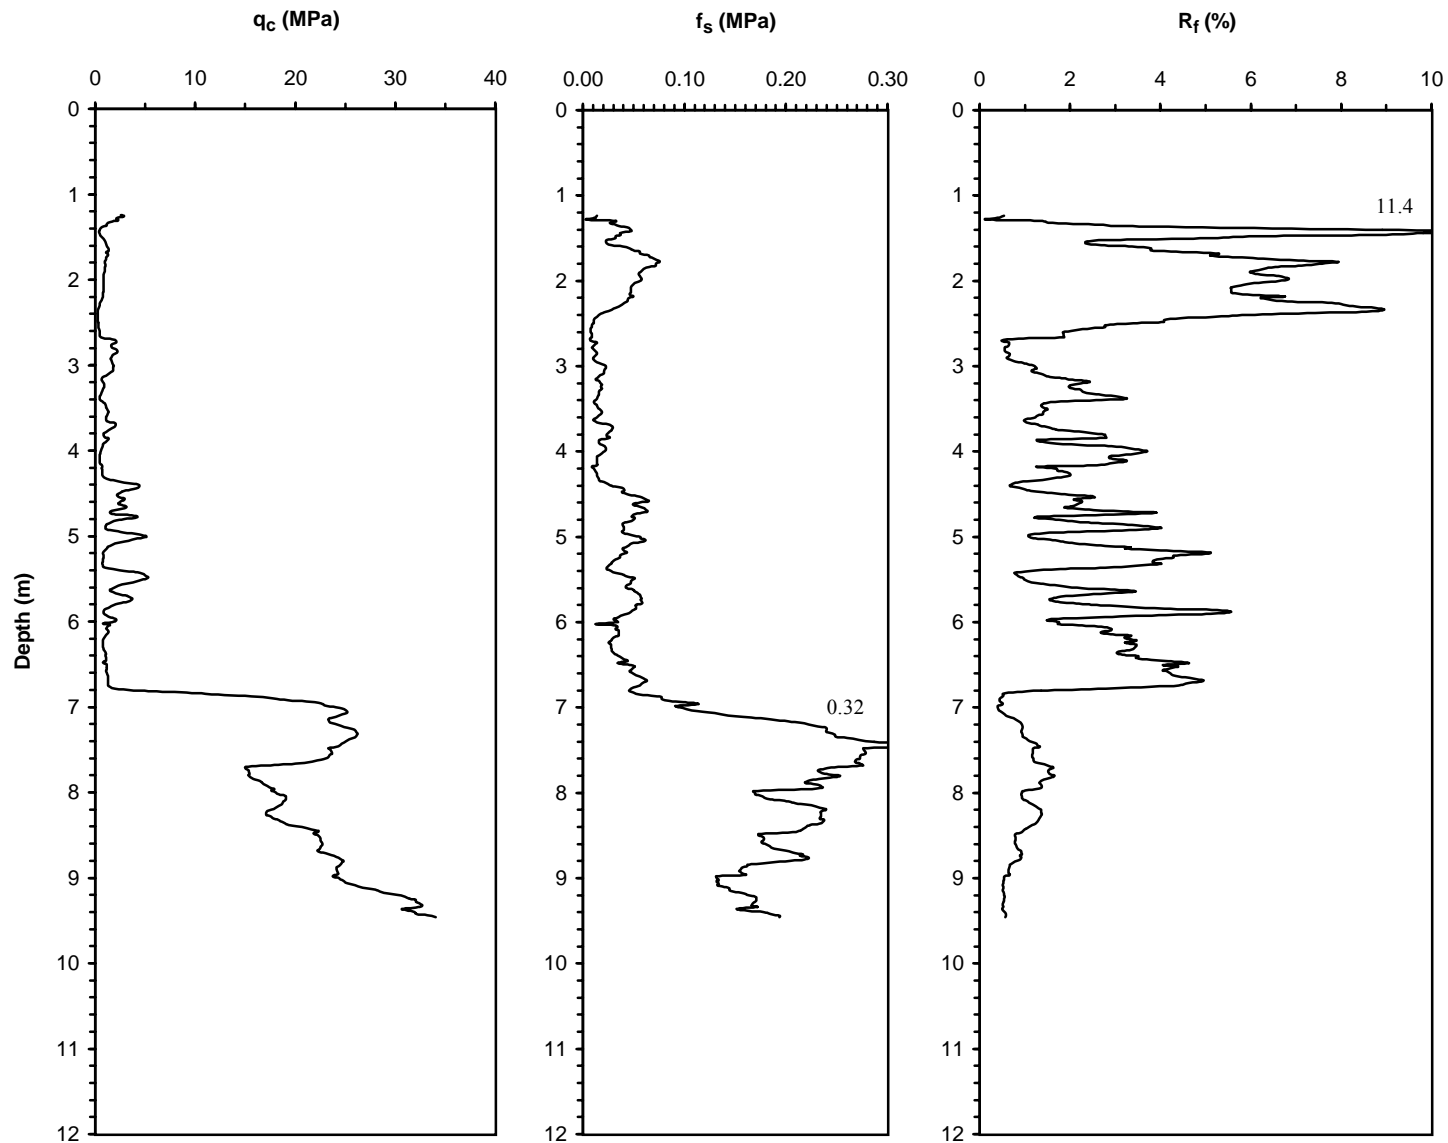
Notes: A 122 cm hole was pre-excavated in search for utilities. The soil was then replaced.

Water Table Elevation: Not measured
