UCB-BYU-UCLA
ZETAŞ-SAU
Joint Research

Project Name: Ground Failure and Building Performance in Adapazari, Turkey
Location: Site I - Çark Avenue, Semerciler District, Adapazari
GPS Coordinates: 40.77681°N 30.39223°E
Test Number: CPT-I2 (CPT-1-32)
Type of Cone: ELC10 CFPS No. 991232 (a.p. v.d. Berg)

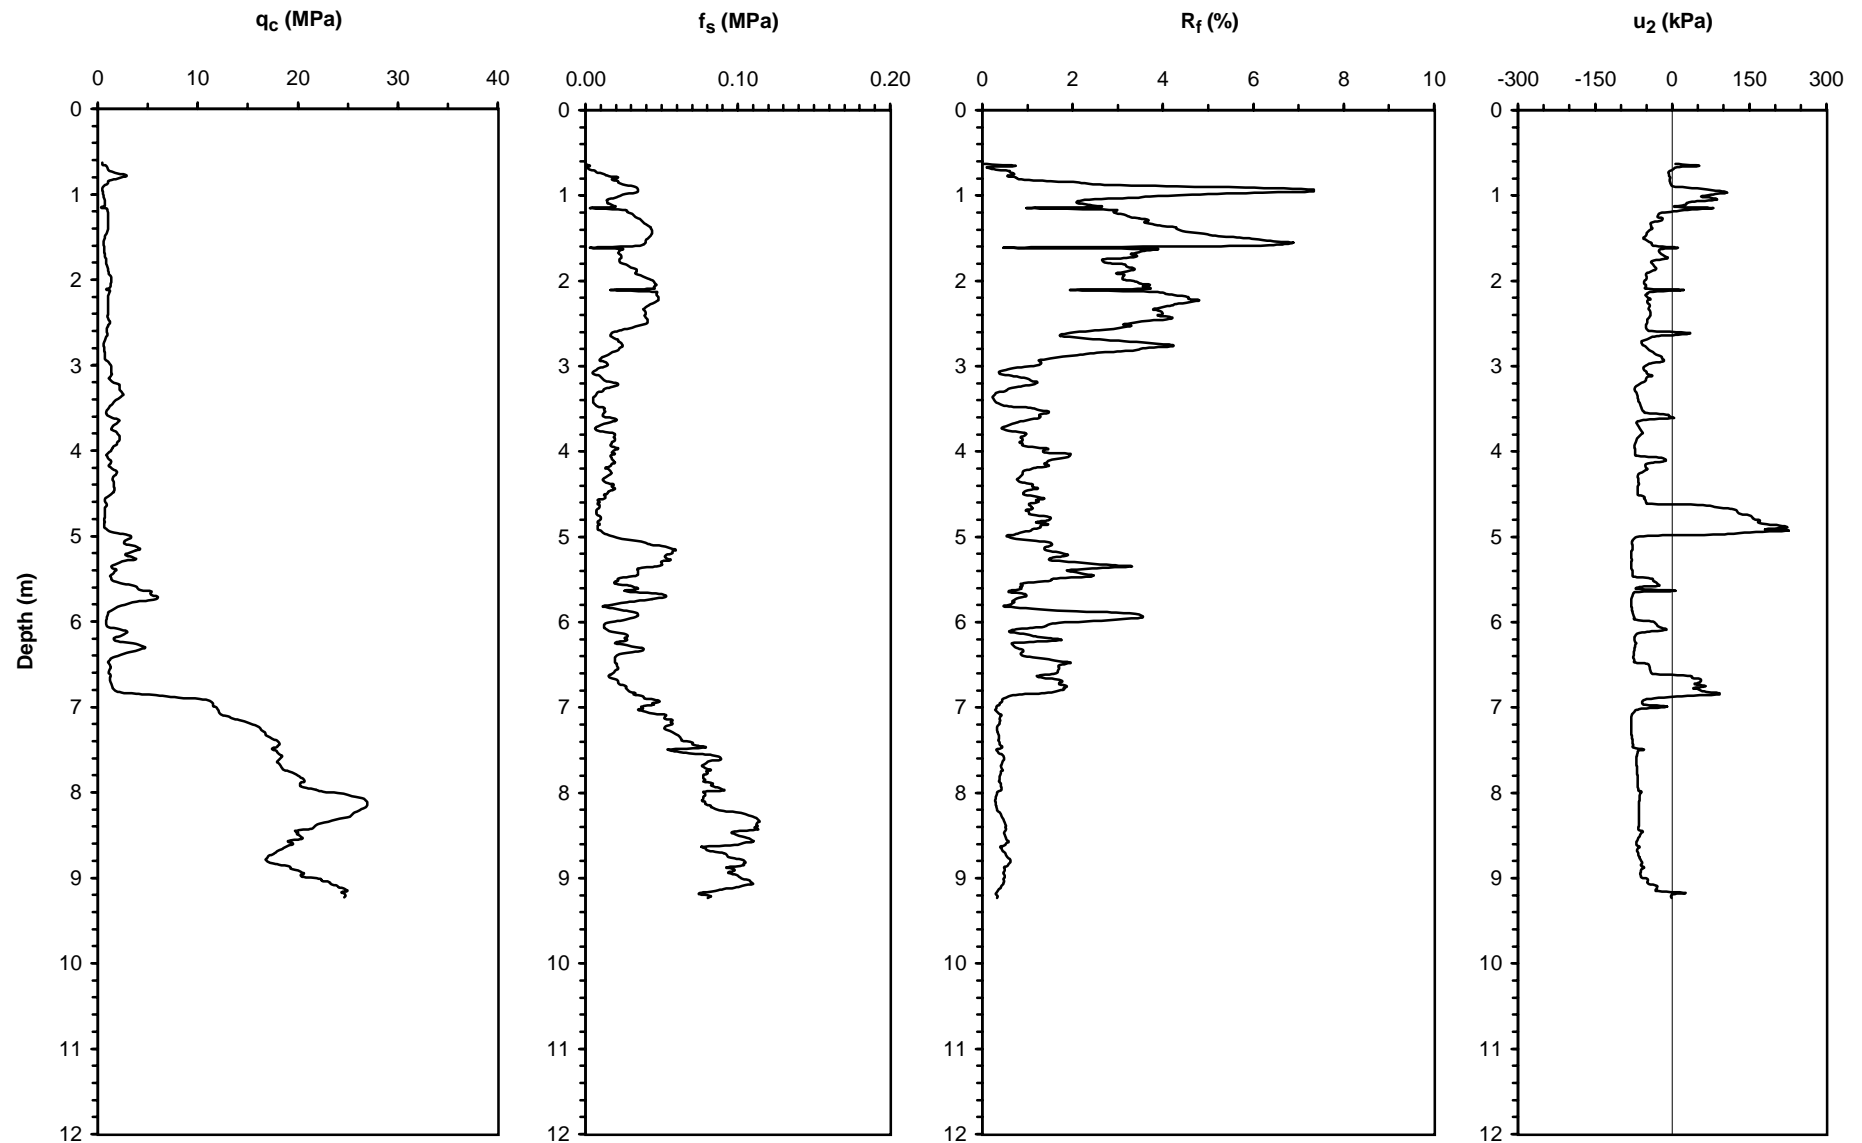
Elevation: -10 cm with respect to CPT-I1

Water Table Elevation: Not measured
