UCB-BYU-UCLA
ZETAŞ-SAU
Joint Research

Project Name: Ground Failure and Building Performance in Adapazari, Turkey
Location: Site L - Ankara Avenue, Orta District, Adapazari
GPS Coordinates: 40.77855°N 30.40272°E
Test Number: CPT-L1
Type of Cone: ELC10 CF No.990618 (a.p. v.d. Berg)

Page: 1 of 1

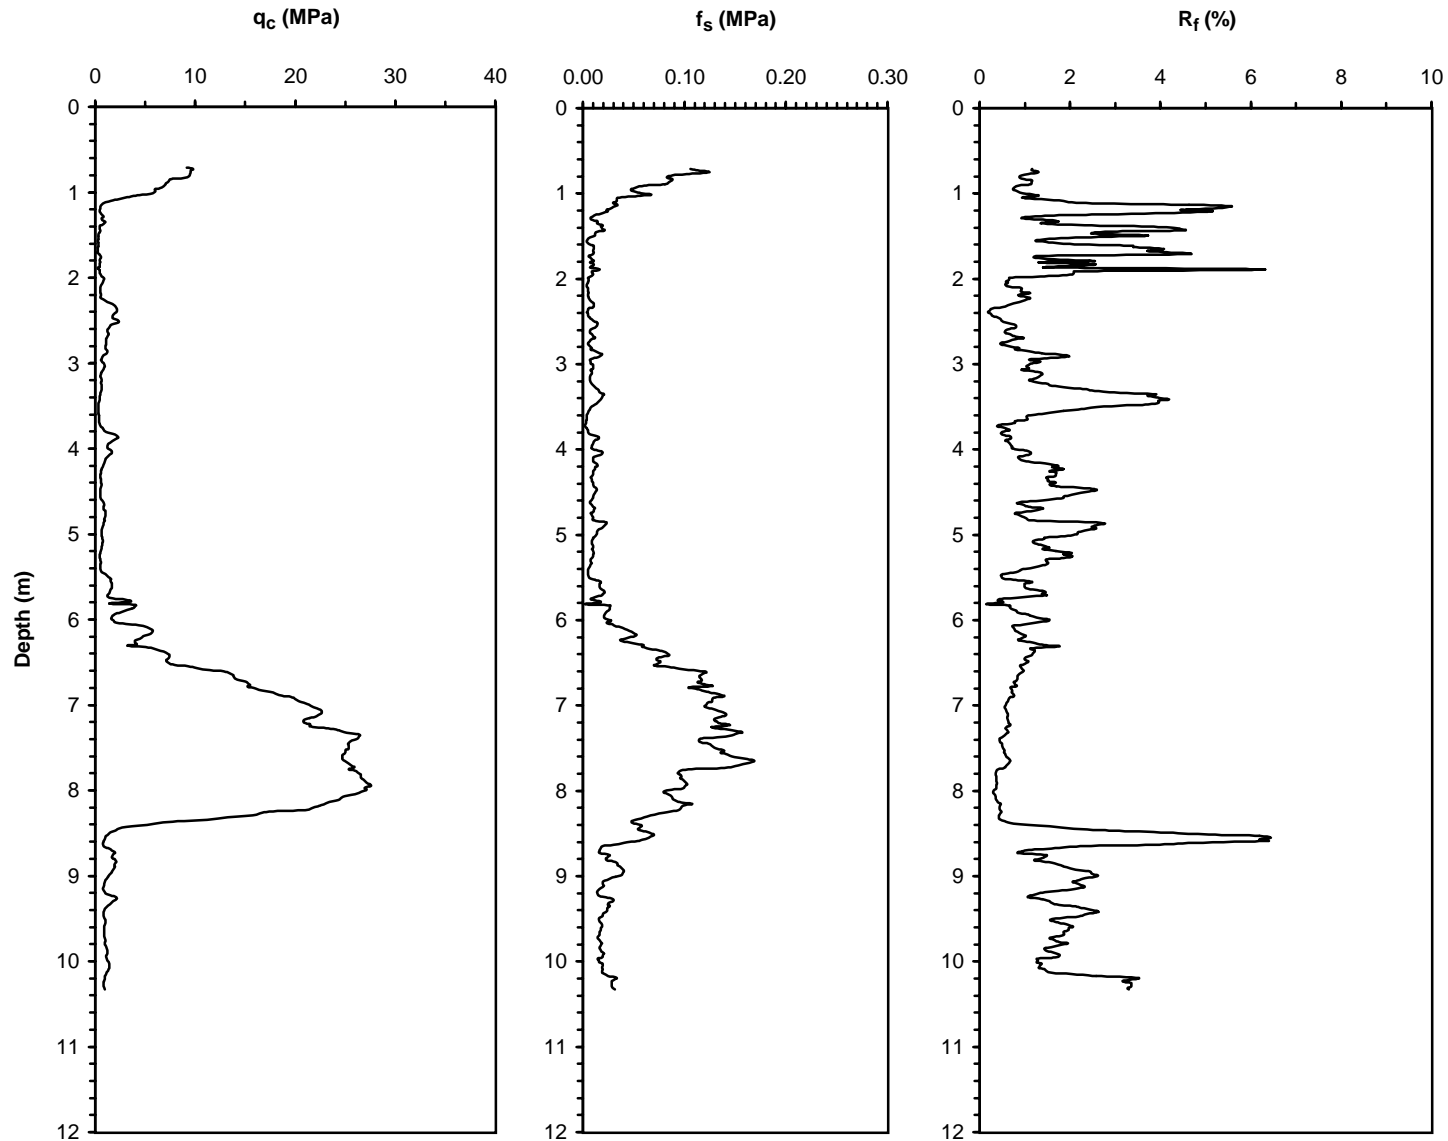
Notes: Probed with percussion hammer 70 cm to check for utilities
