UCB-BYU-UCLA
ZETAŞ-SAU
Joint Research

Project Name: Ground Failure and Building Performance in Adapazari, Turkey
Location: Site L - Ankara Avenue, Orta District, Adapazari
GPS Coordinates: 40.77855°N 30.40272°E
Test Number: CPT-L2 (CPT-1-39)
Type of Cone: ELC10 CF No.990618 (a.p. v.d. Berg)

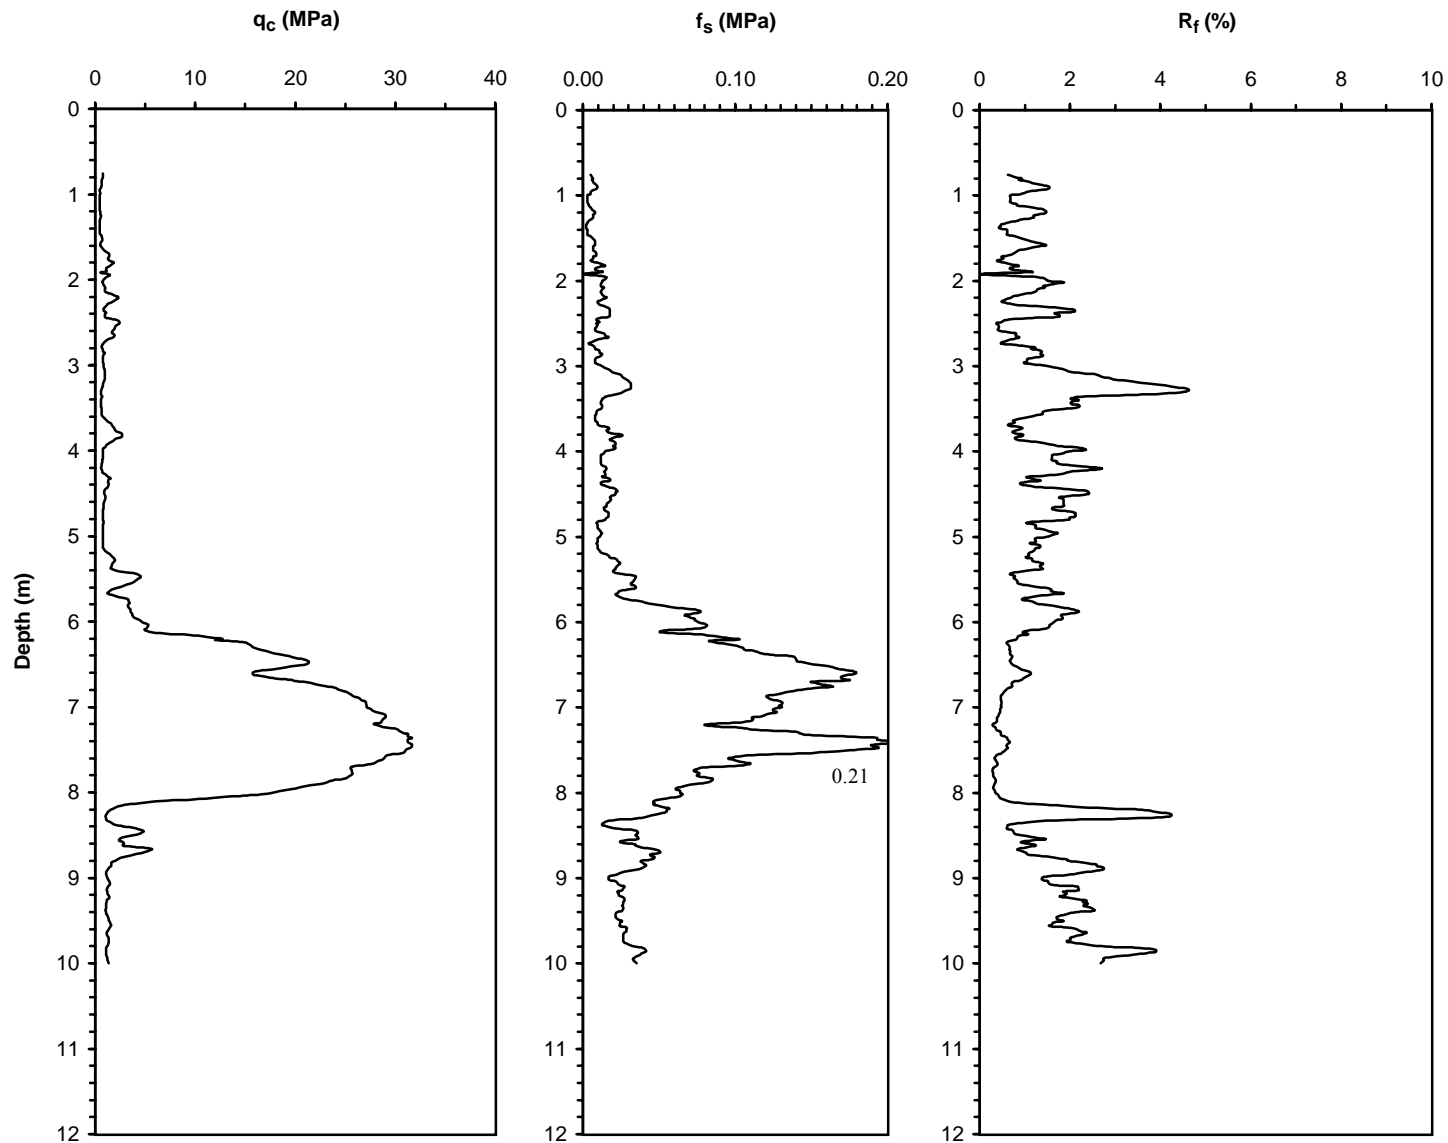
Elevation: -3 cm with respect to CPT-L1

Notes: Probed with percussion hammer 75 cm to check for utilities

Water Table Elevation: Not measured
