Unreinforced Masonry and Selected Modern Buildings and Port Facilities

in the Darfield, NZ Earthquake 9-4-2010

Fred Turner, SE

CA Seismic Safety Commission

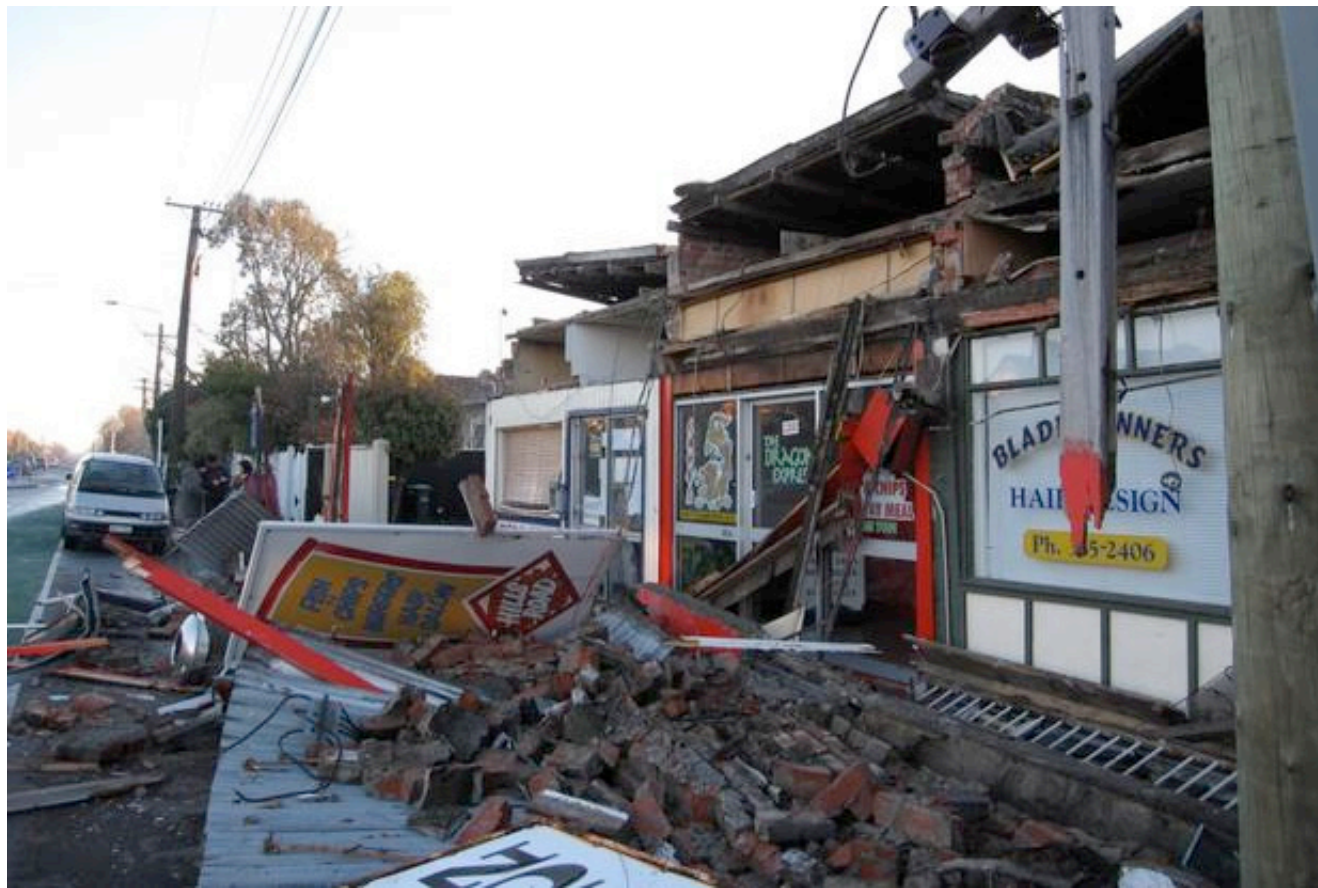
URM Parapet & Upper Wall Collapses

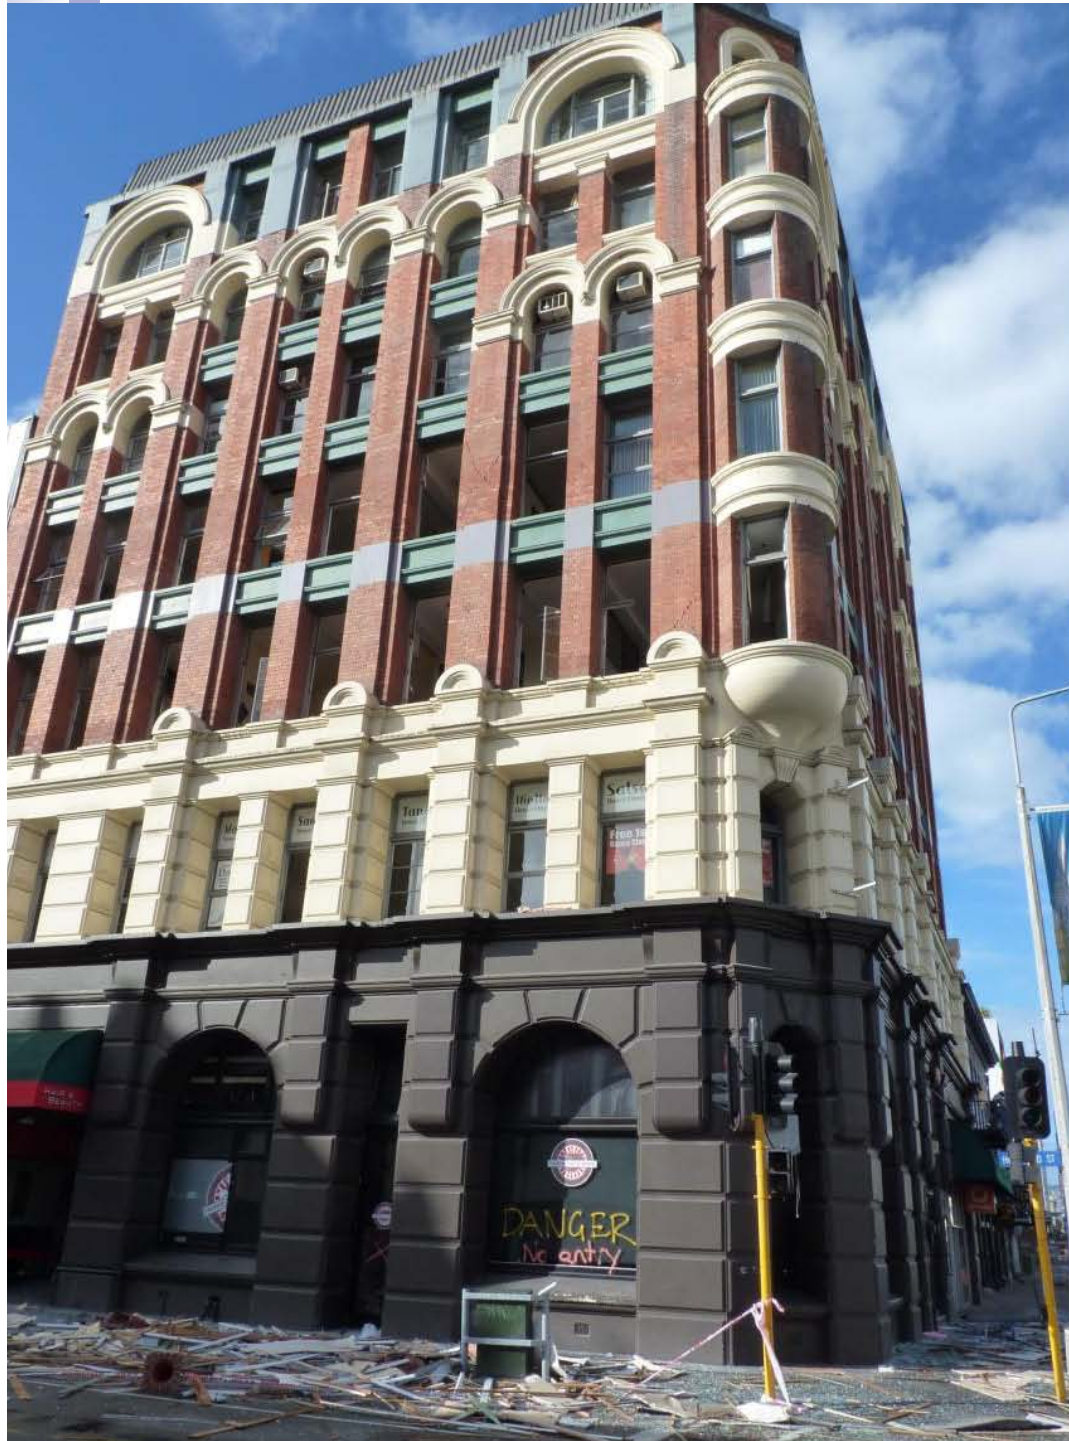
Taller URM Buildings

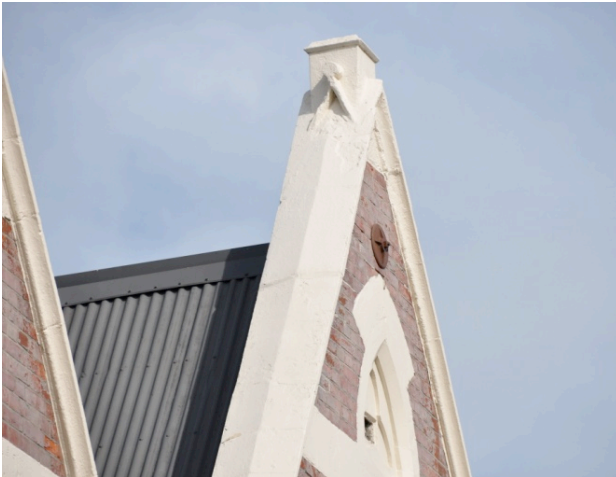
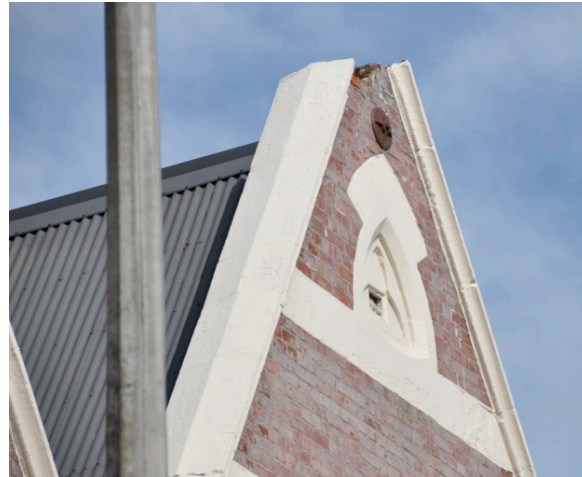
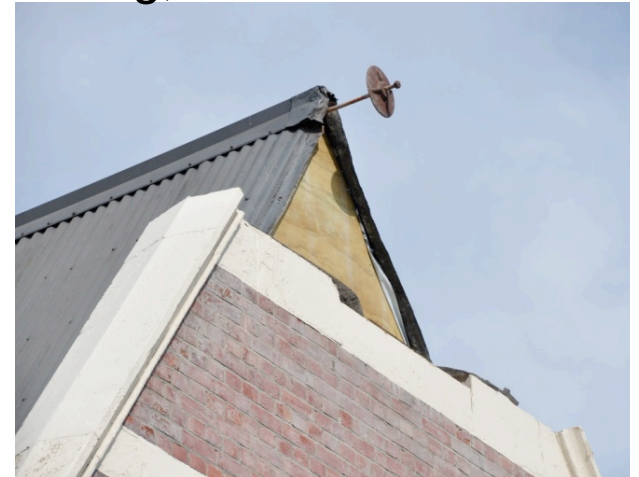
URM Gable Walls

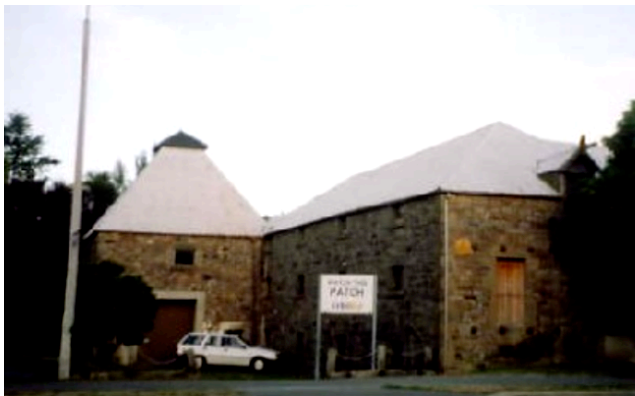
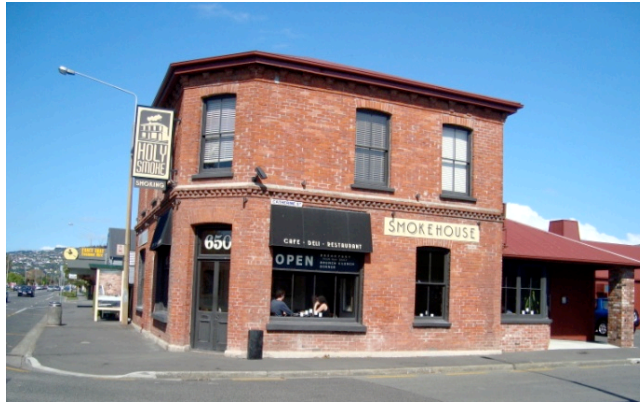
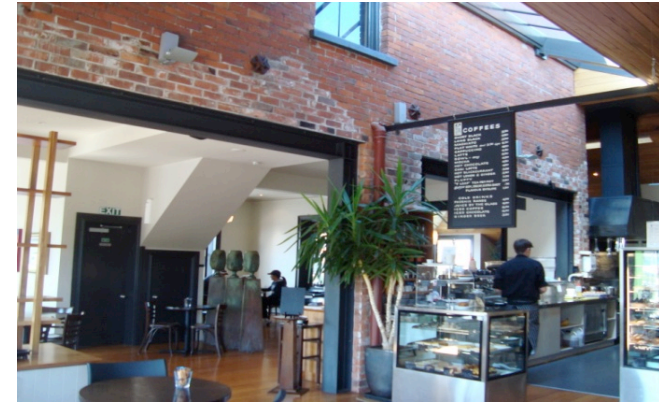
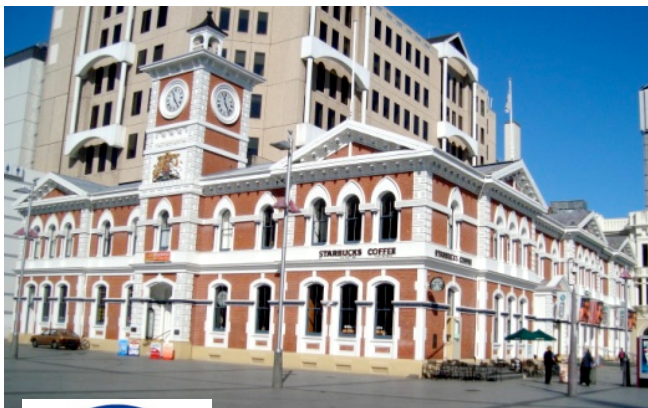
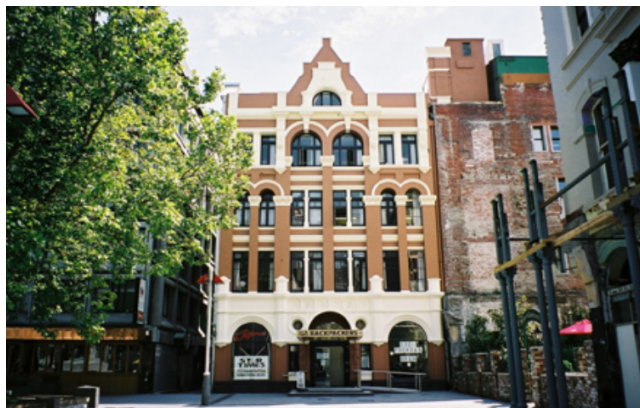
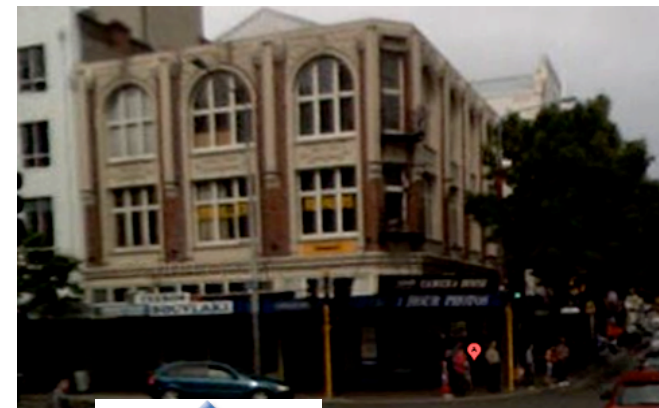
Systematically Retrofitted Commercial URM Buildings

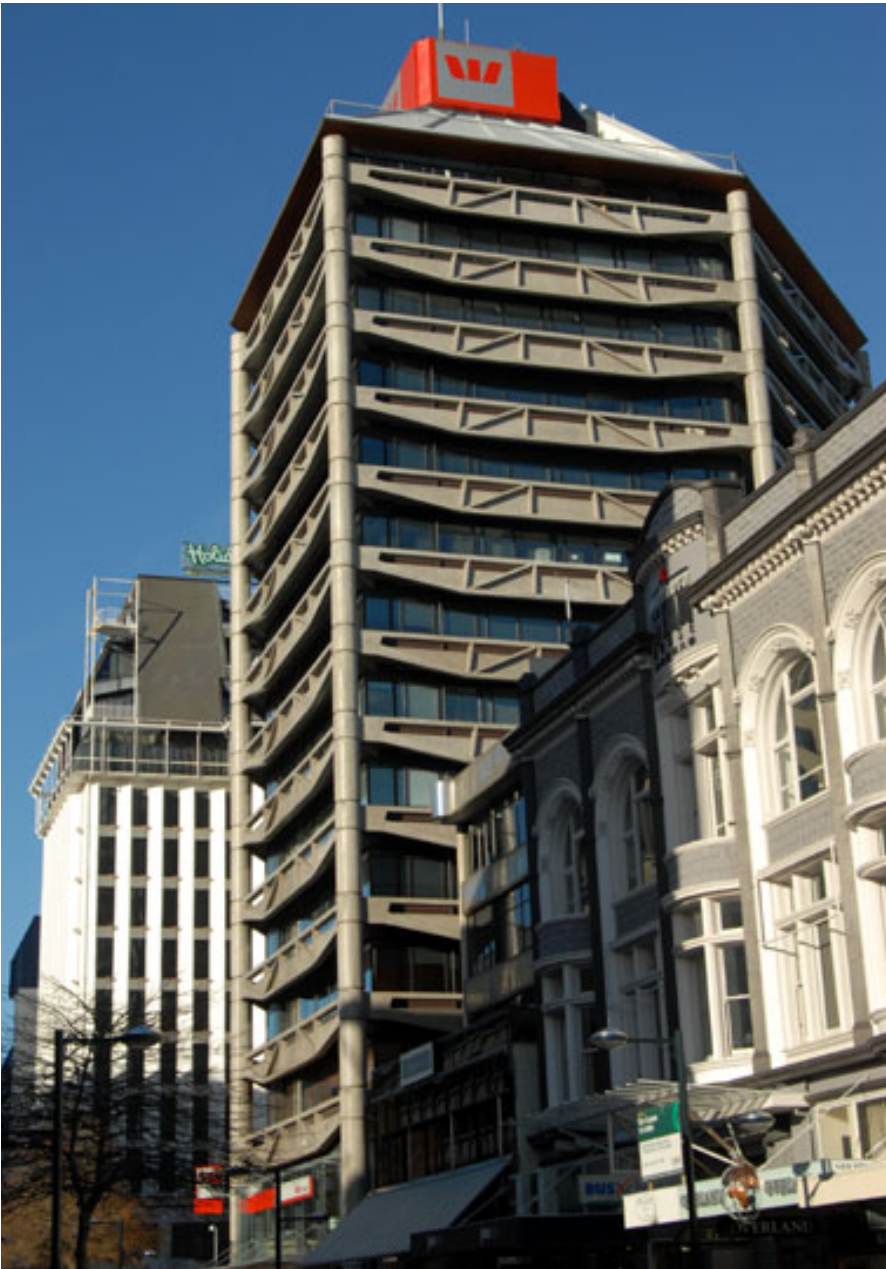
Westpac Bldg

Before

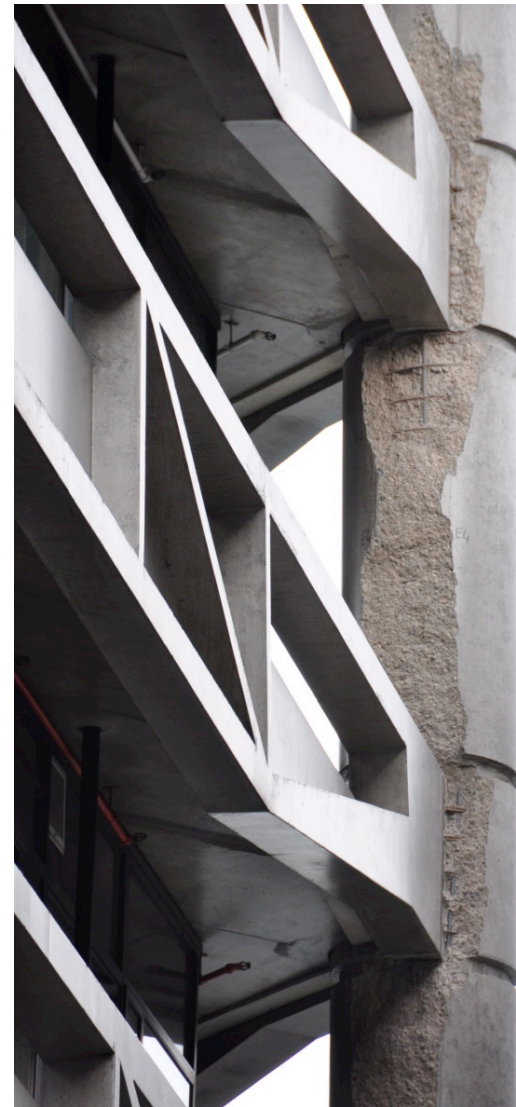
After

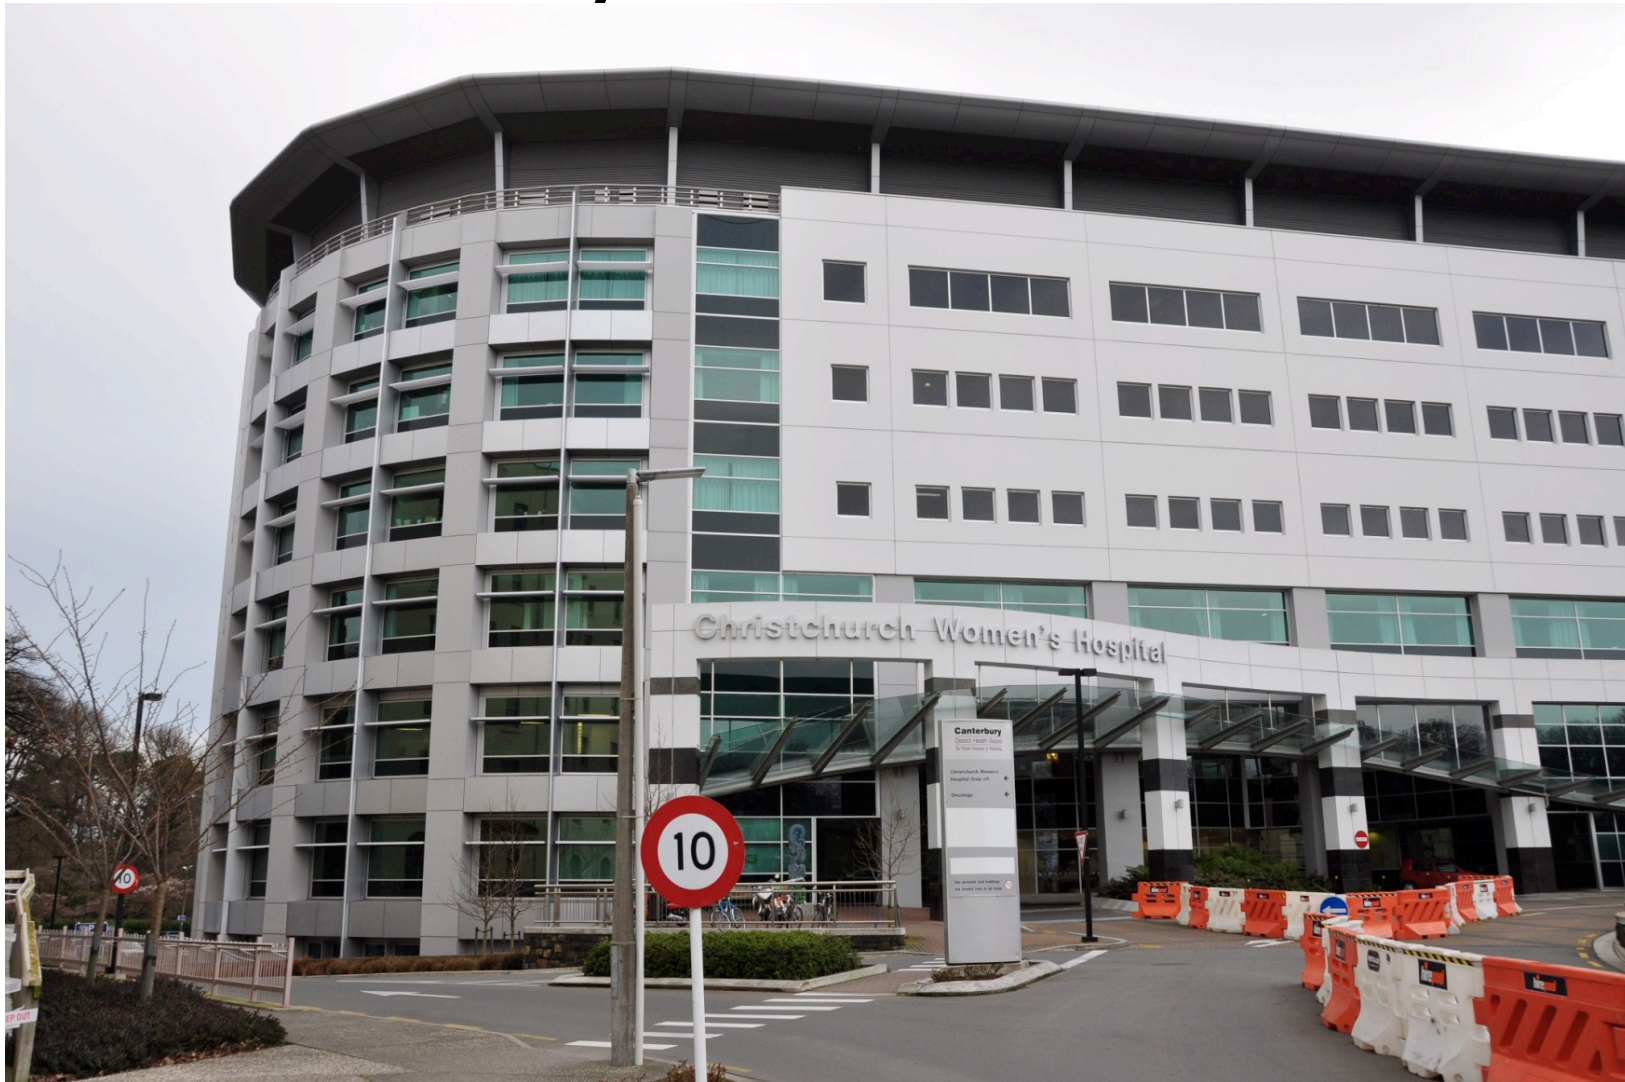
Women's Hospital Seismically Isolated

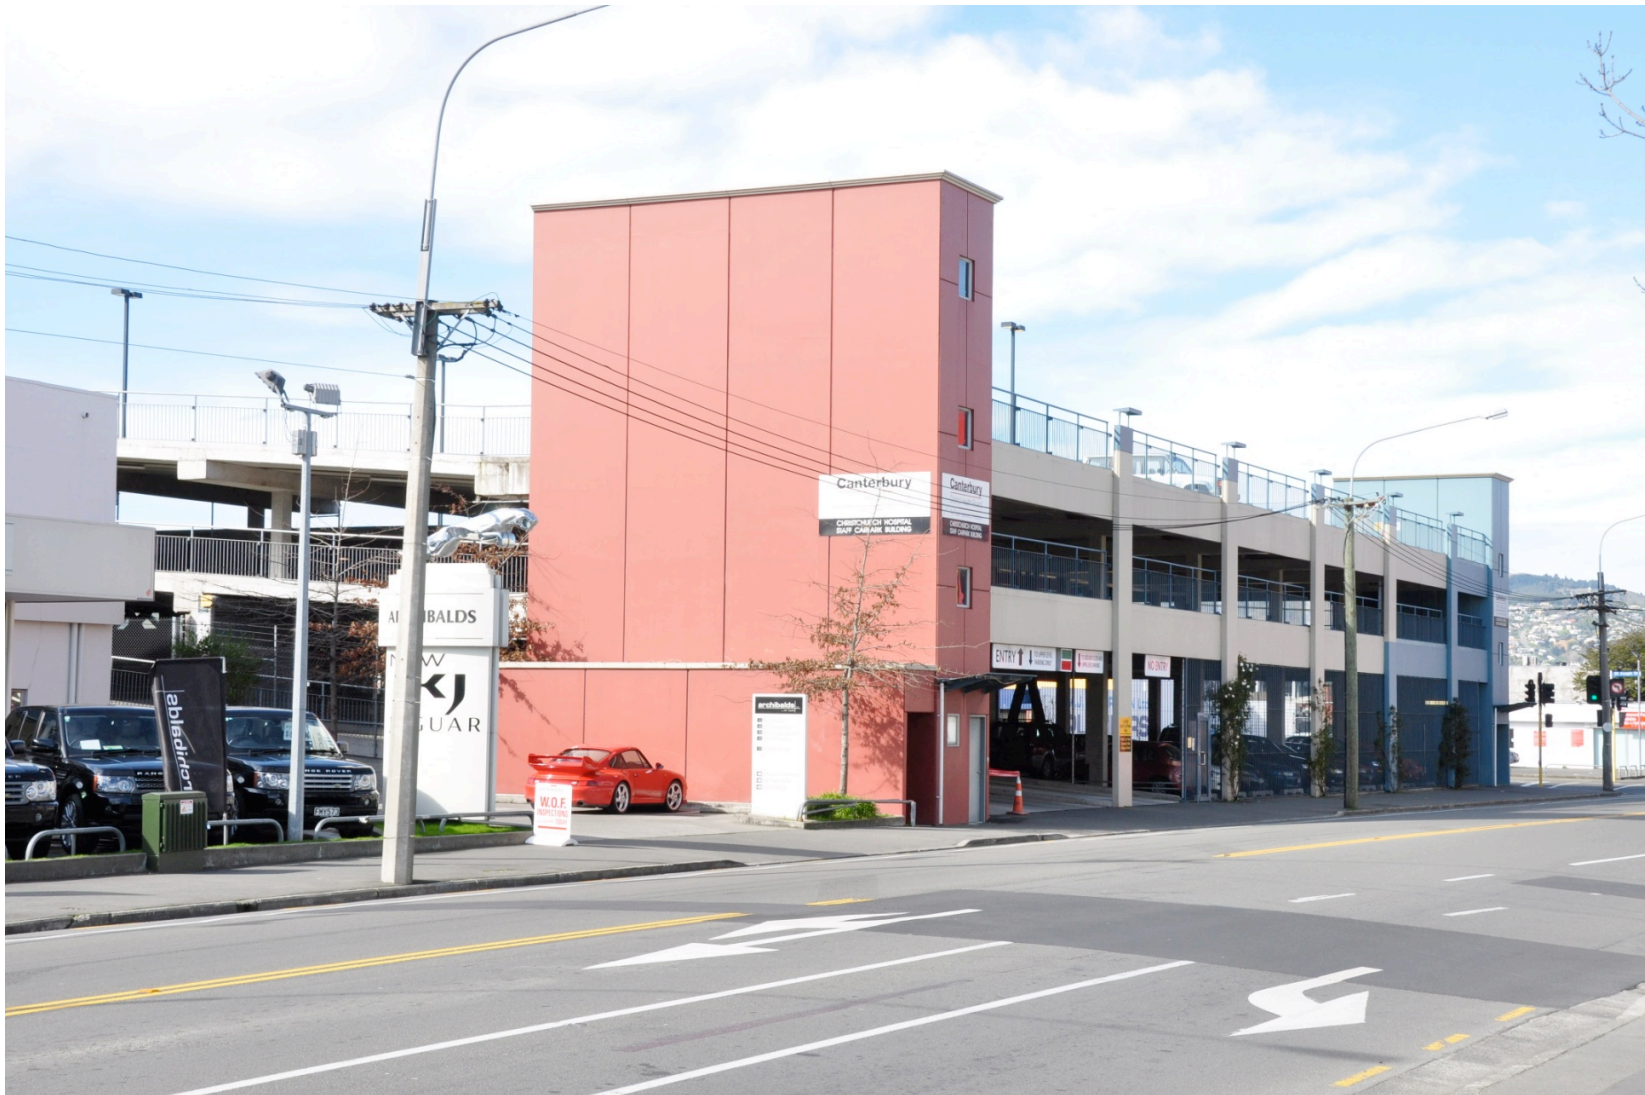
Parking Garage with EB Frame

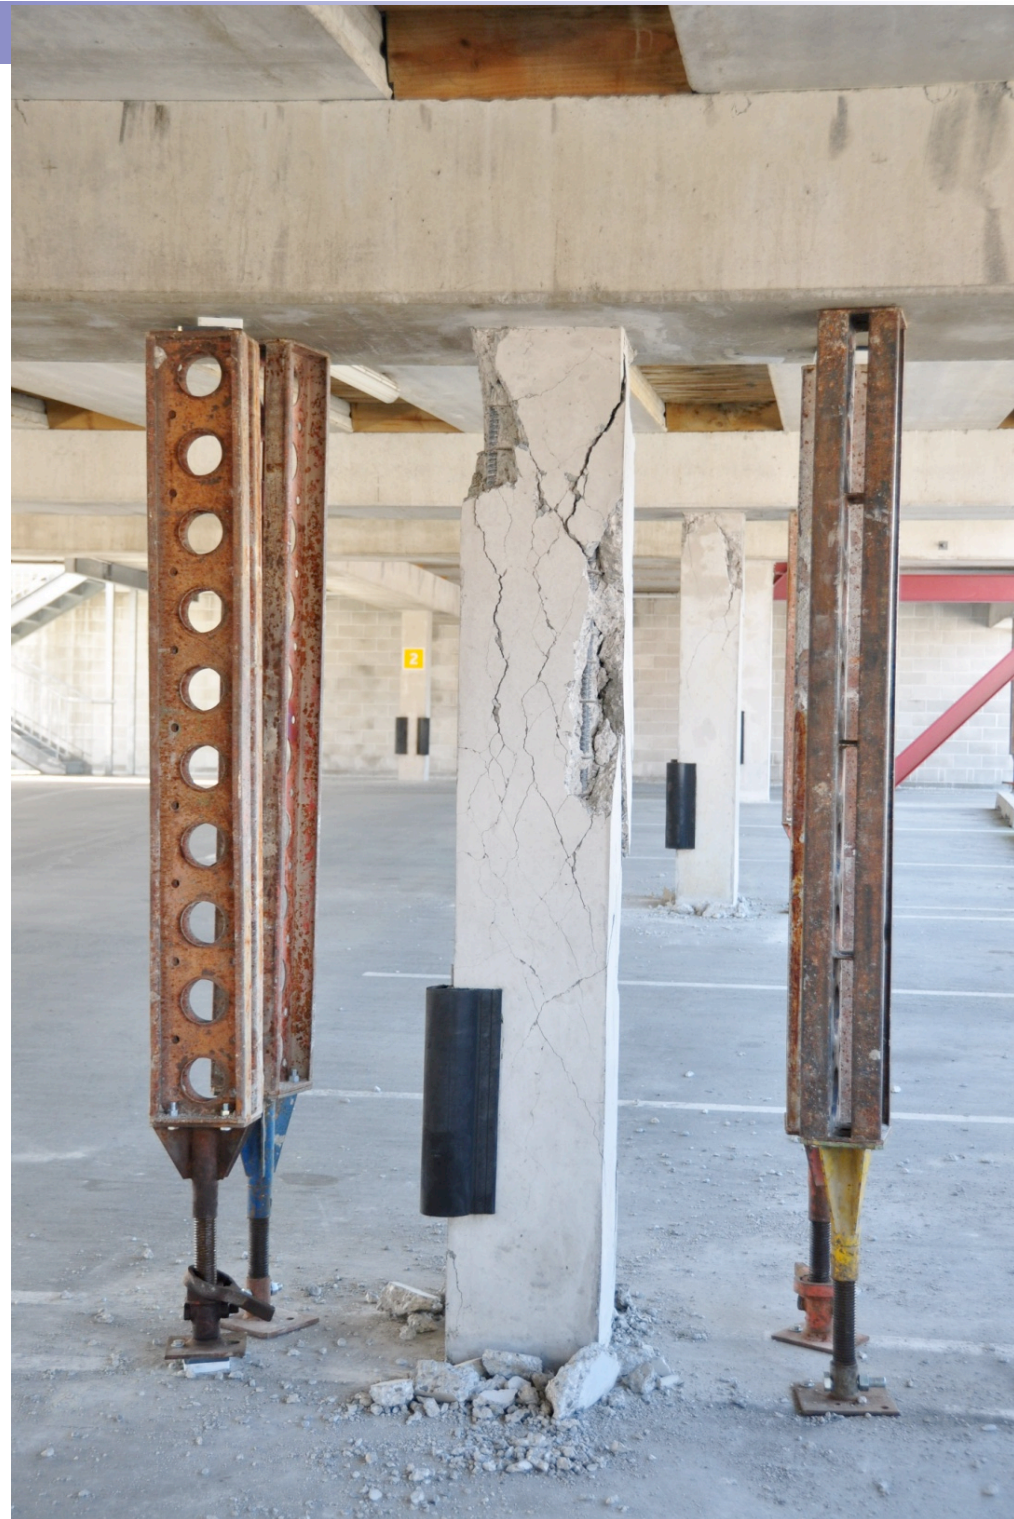
Parking Garage with Precast Concrete Columns & Steel Eccentric Braced Frames

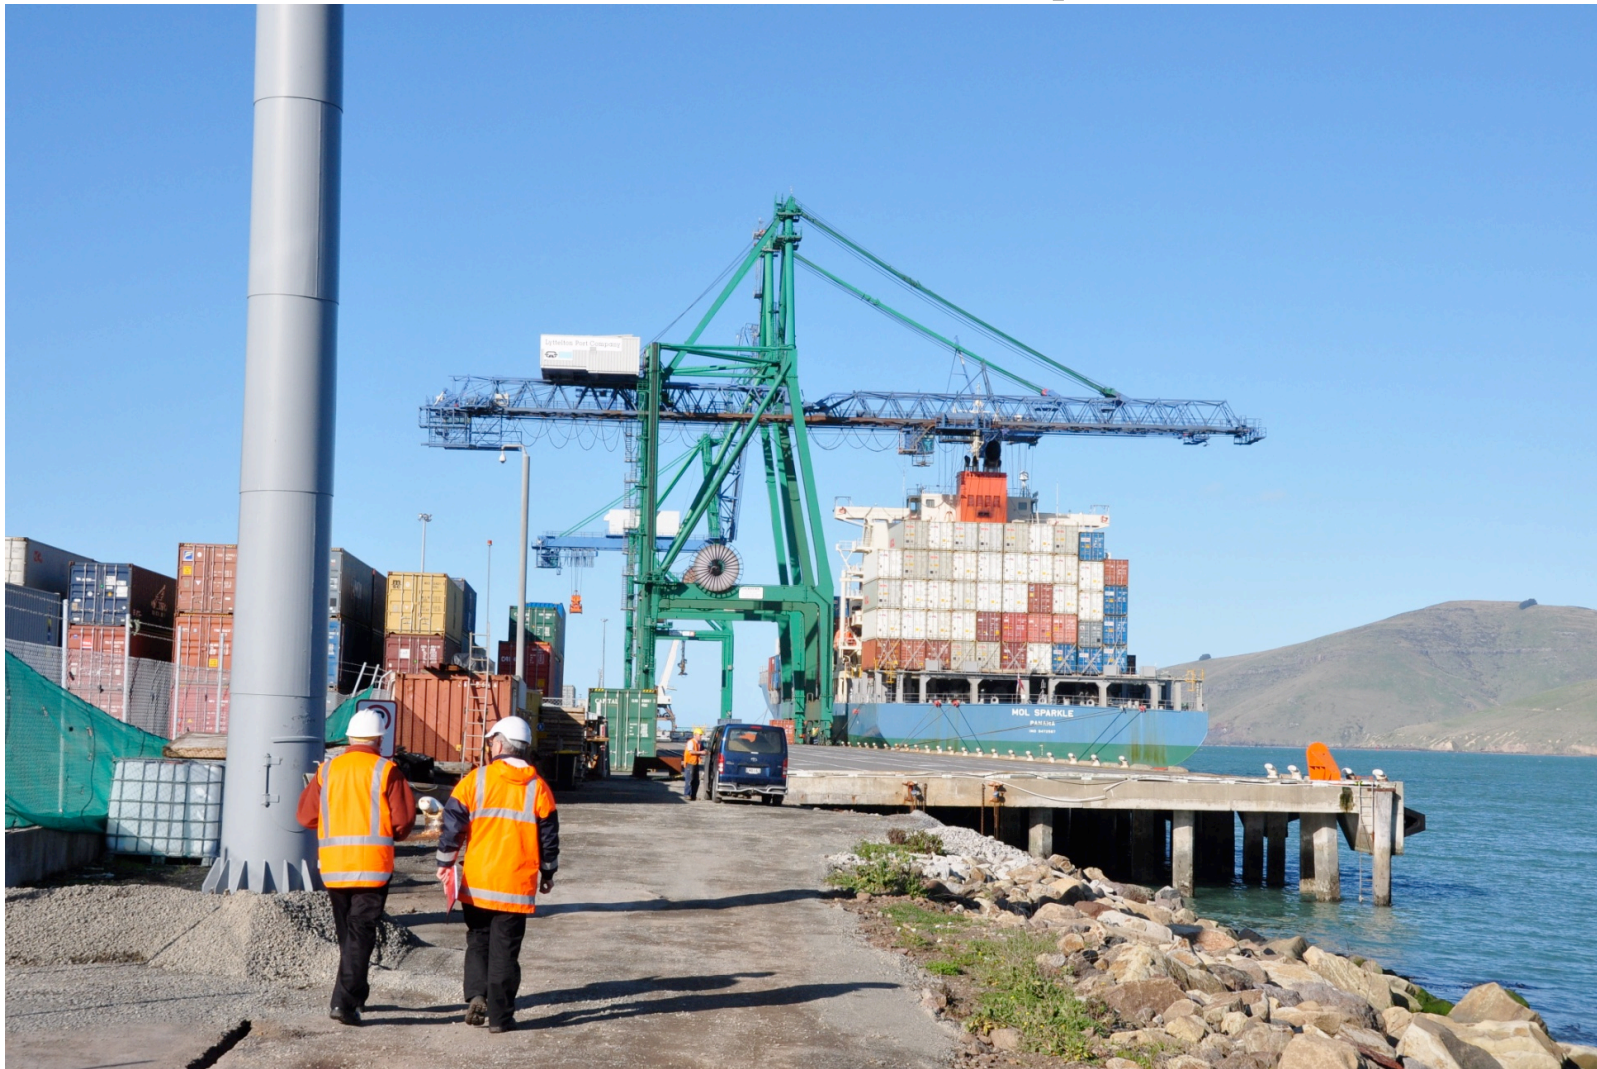
Port Cranes Still Operable
