# Performance of Nonstructural Components in Critical Facilities

*2012 PEER Annual Meeting*

**Gilberto Mosqueda**

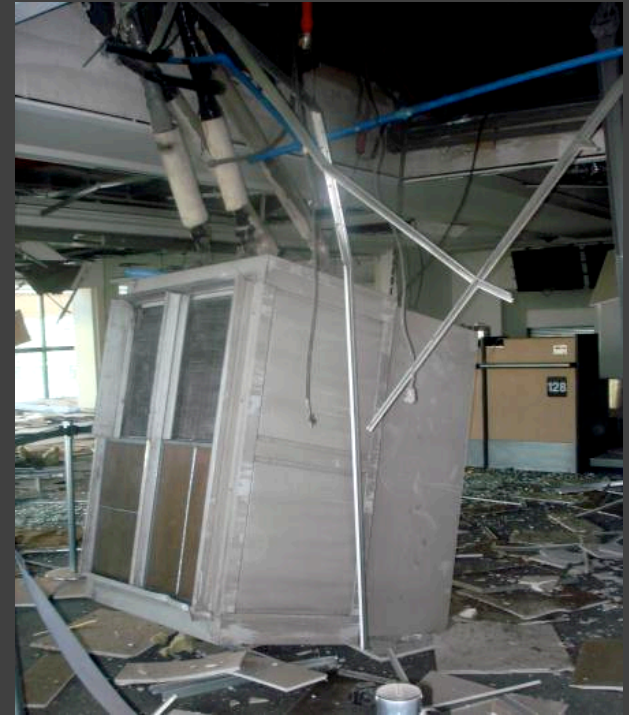
Many suspended air handling units like this fell to the ground

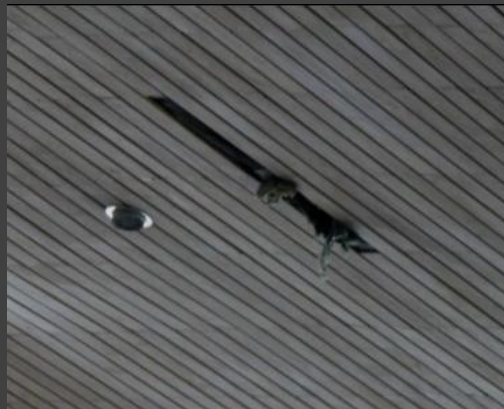
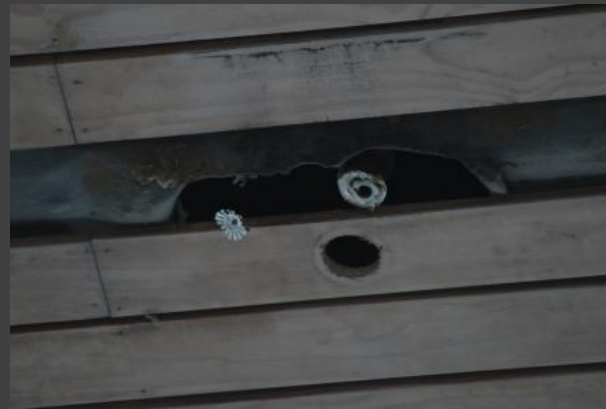
Closeup view of some sprinkler heads sheared off

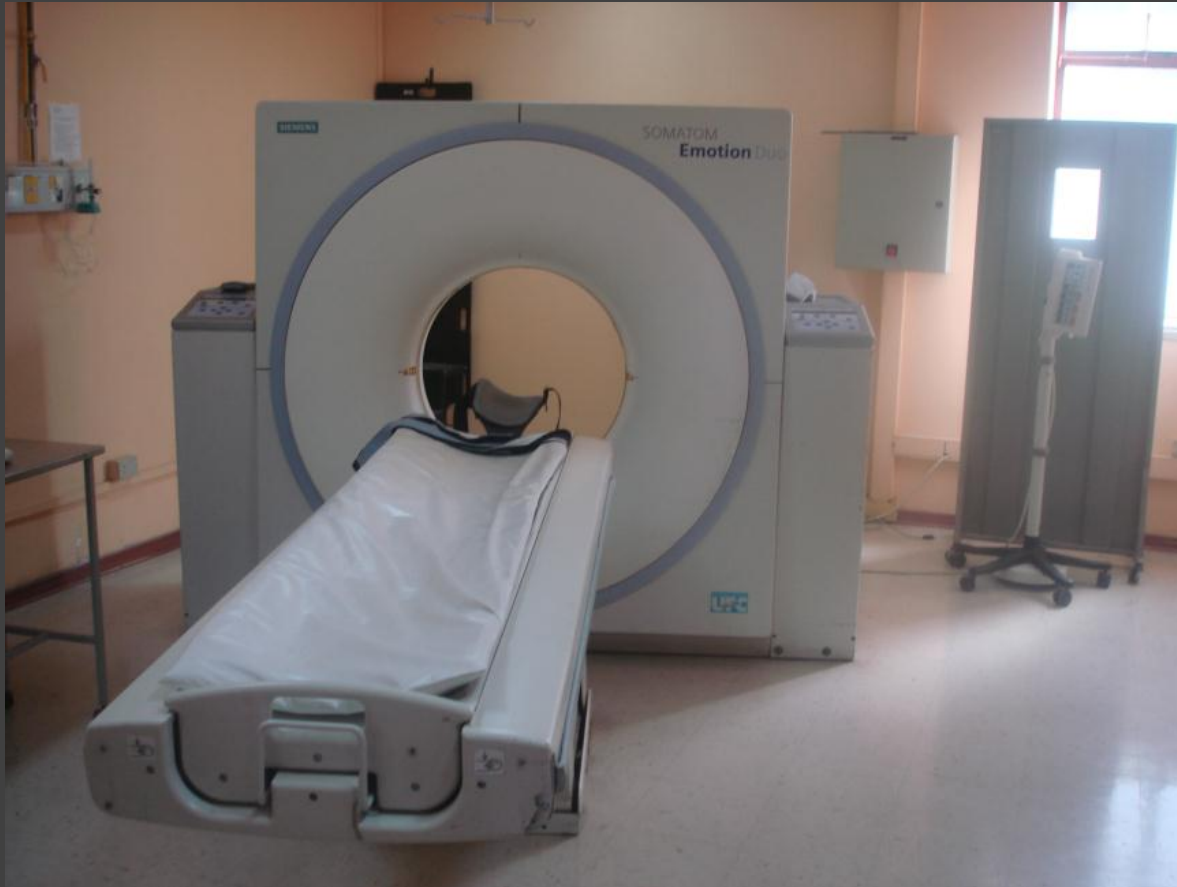
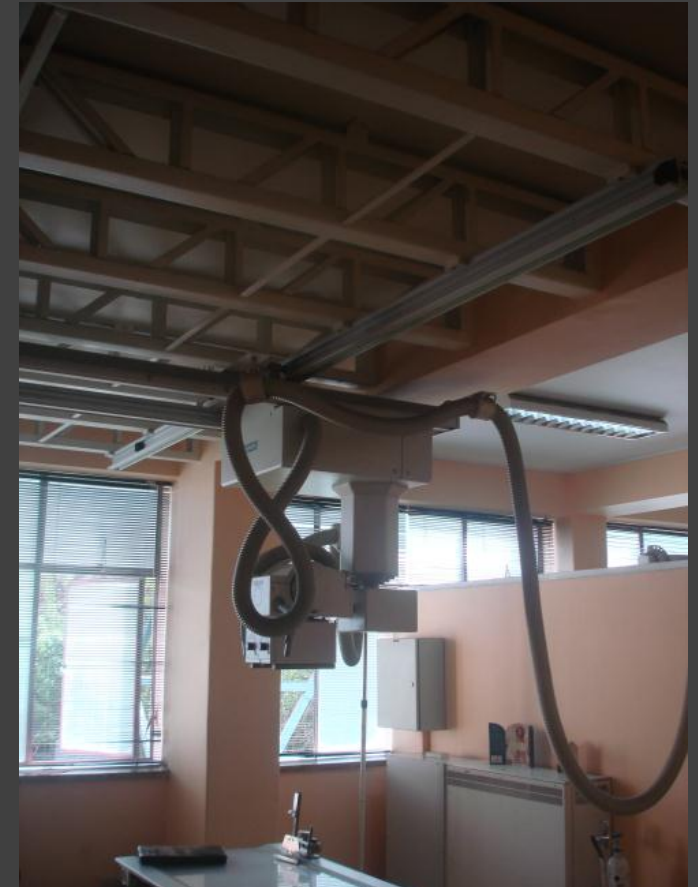
Examples of well anchored hospital equipment that performed well  
at Santiago General Hospital

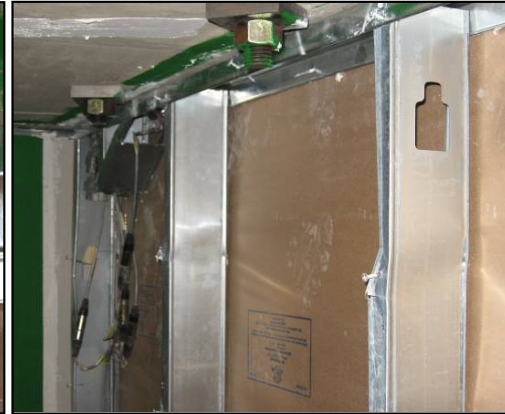
Hinges forming in studs (commercial construction)

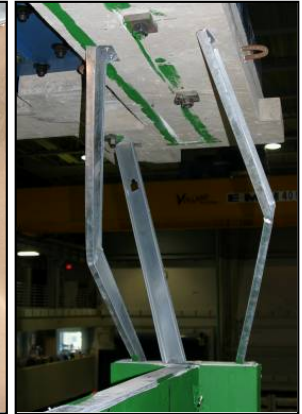
Buckling of diagonal braces

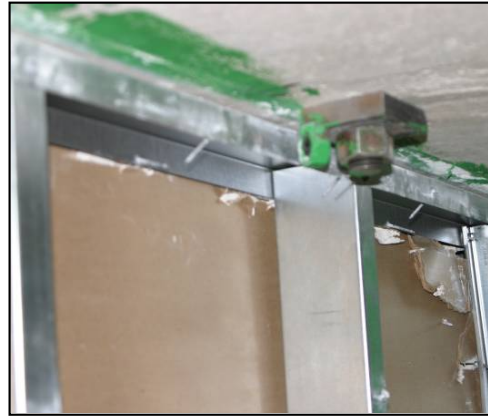
Crushing and shearing of gypsum around screws in connection to top track
