Geotechnical Aspects of the M = 8.8 February 27, 2010 Chile Earthquake

*Jonathan Bray, UC Berkeley; David Frost, Georgia Tech;
Ramon Verdugo, Universidad de Chile; Christian Ledezma, Pontificia
Universidad Catolica de Chile; & Terry Eldridge, Golder Assoc.*

NSF-Sponsored GEER Reconnaissance

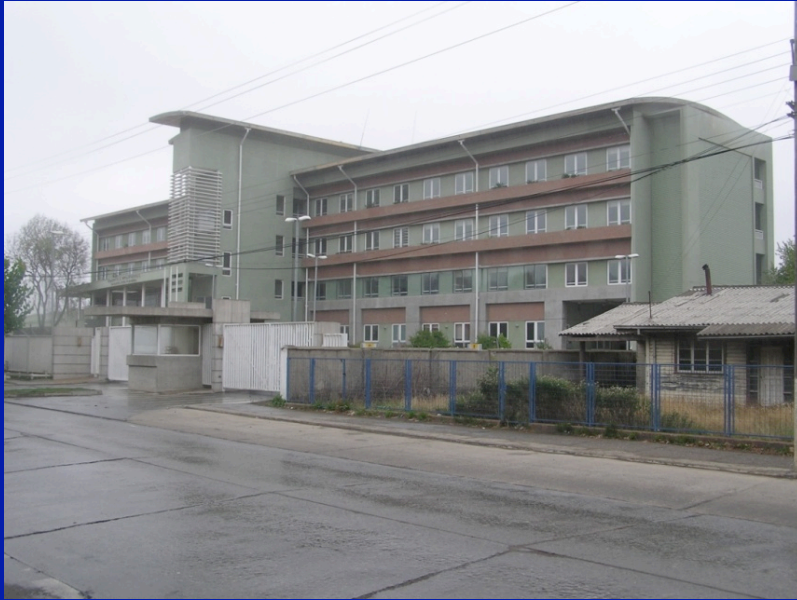
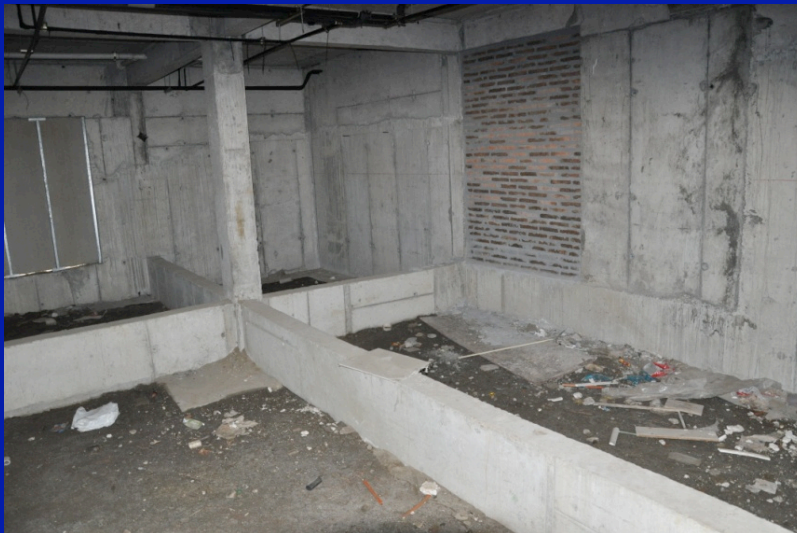
Hospital in Curanilahue

Effects of Ground Failure on Buildings

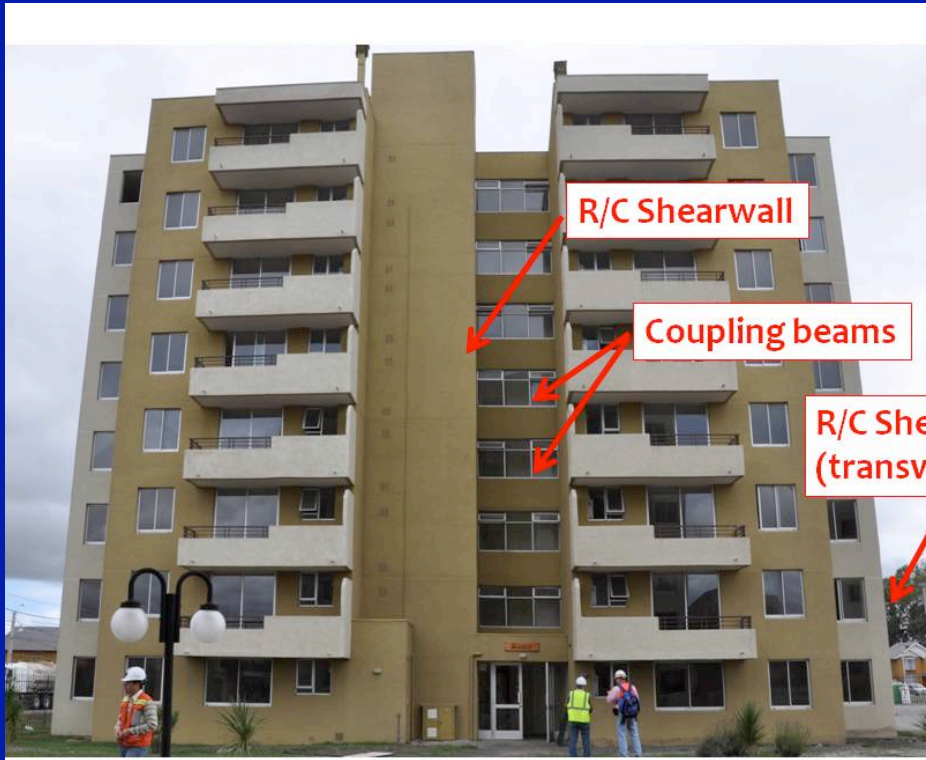
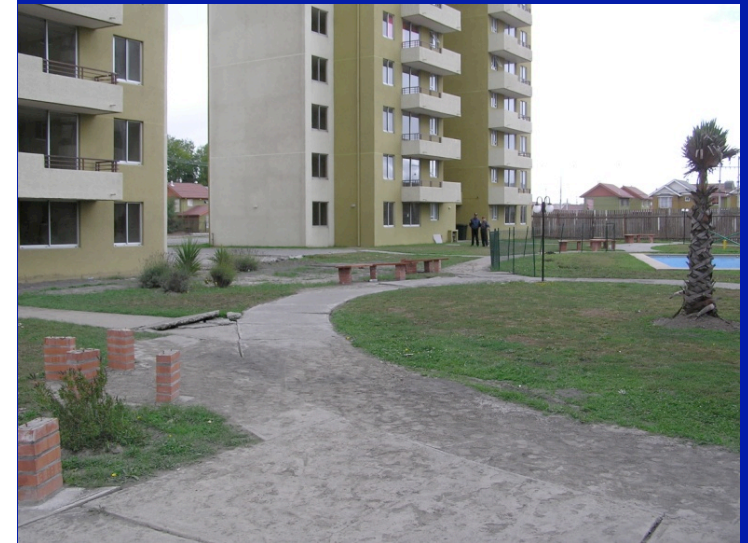
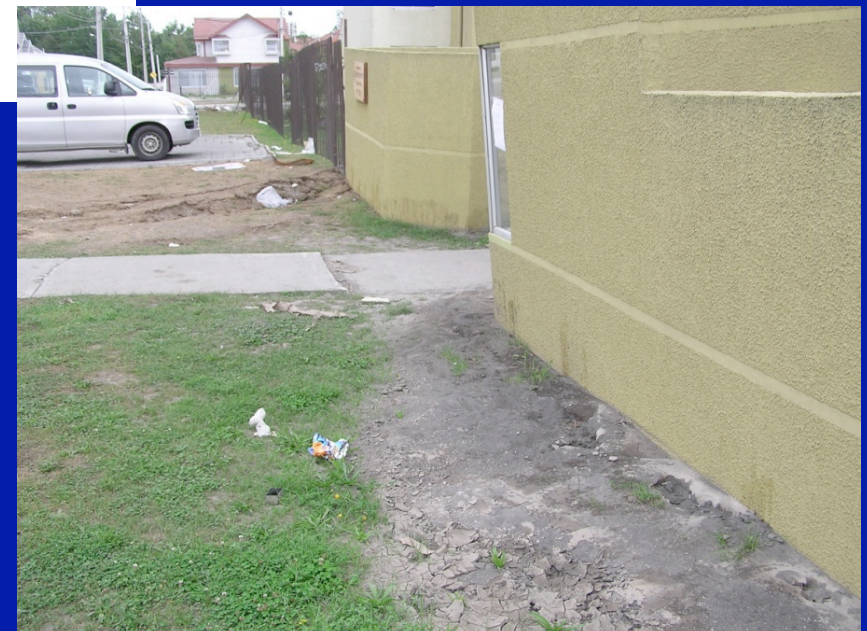
Four 8-Story Condominiums, Concepción

Effects of Ground Failure on Buildings

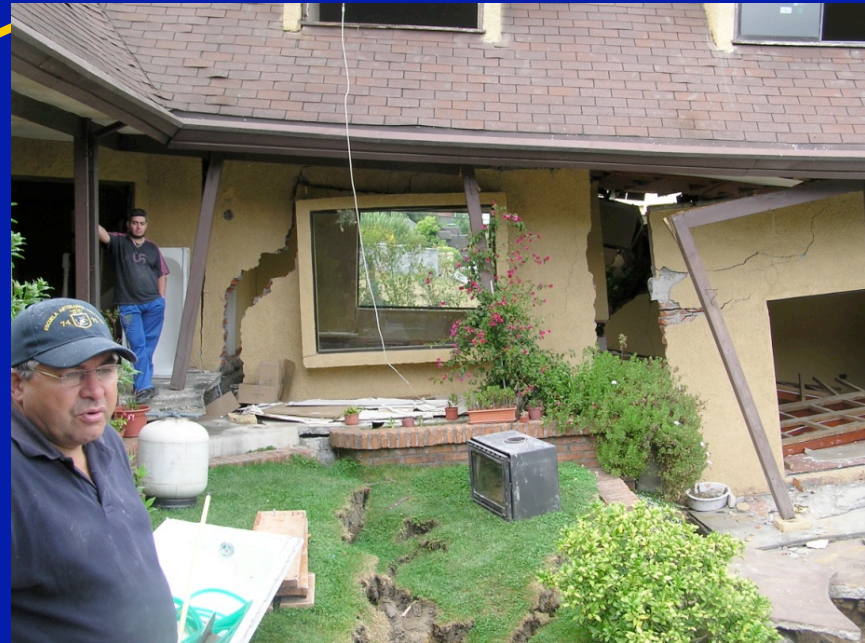
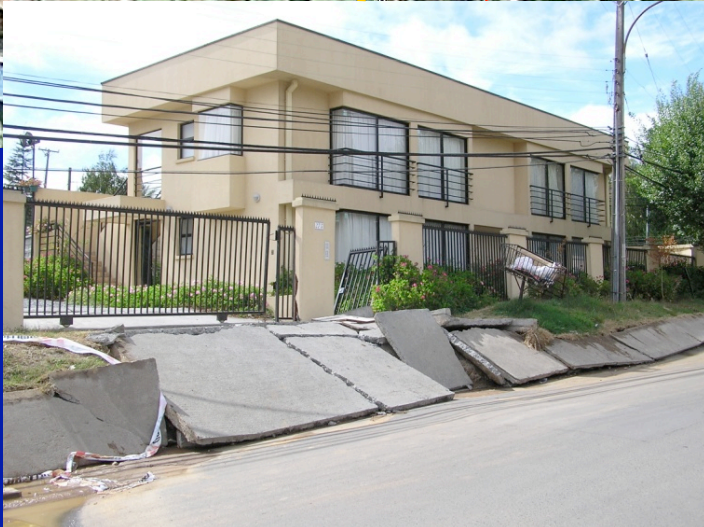
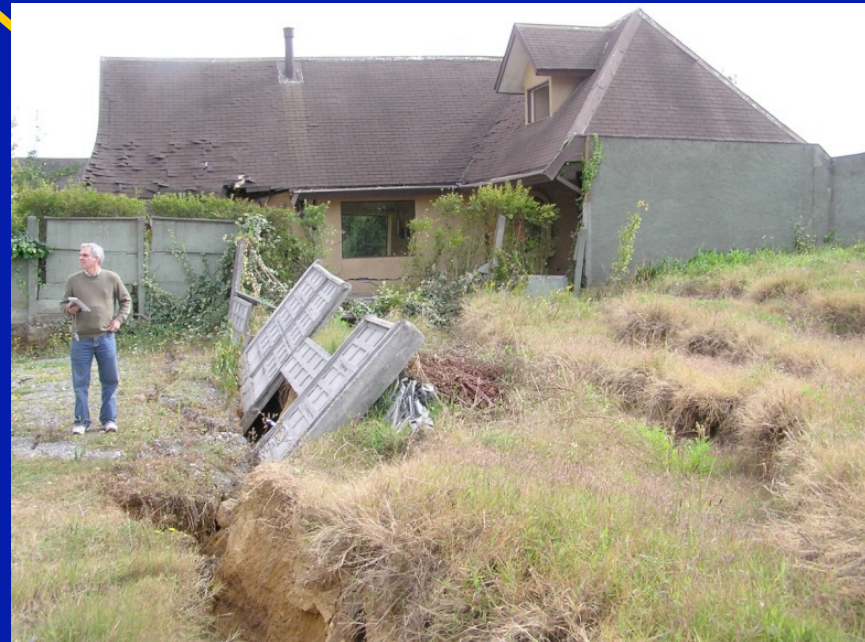
Slide Damages Homes But Not Apartments

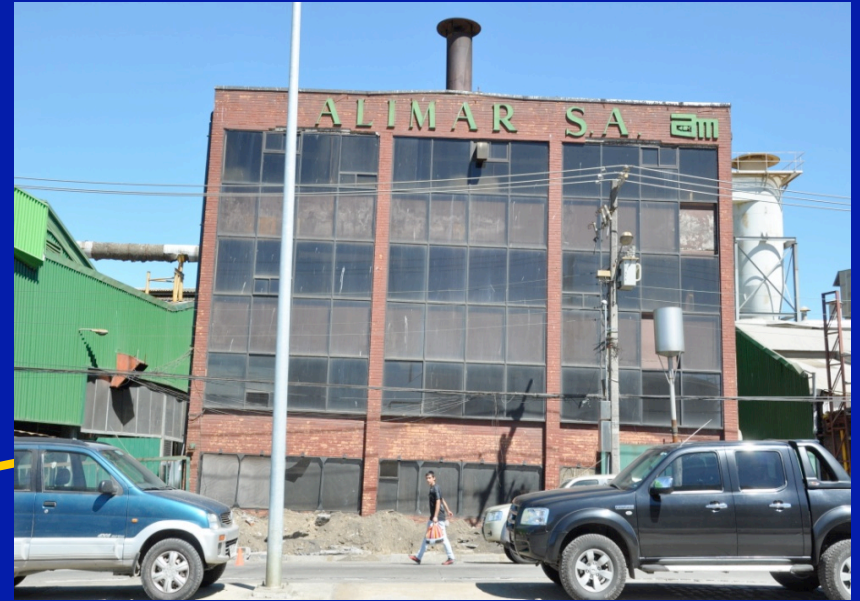
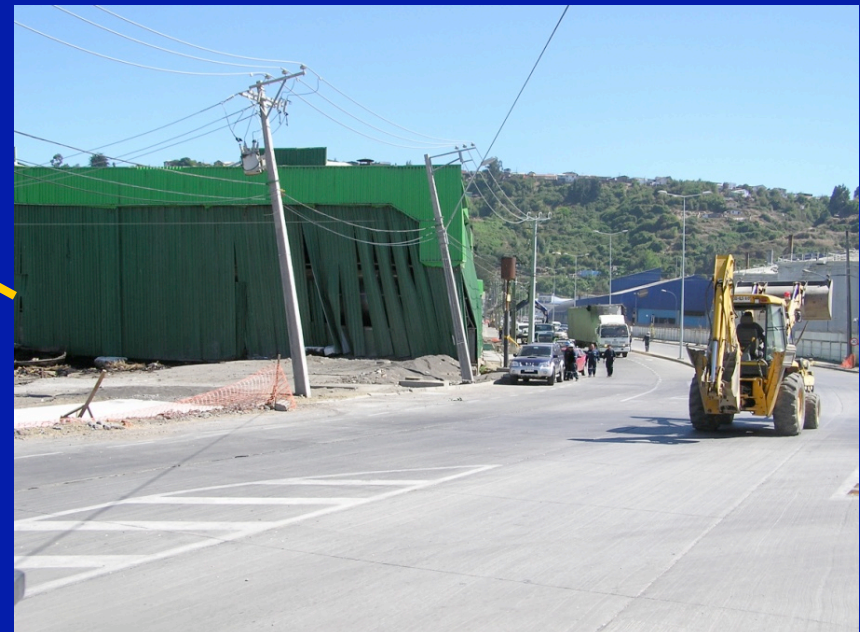
Fish Packing Facility, San Vicente

Lateral Spreading Effects on Industrial Facilities

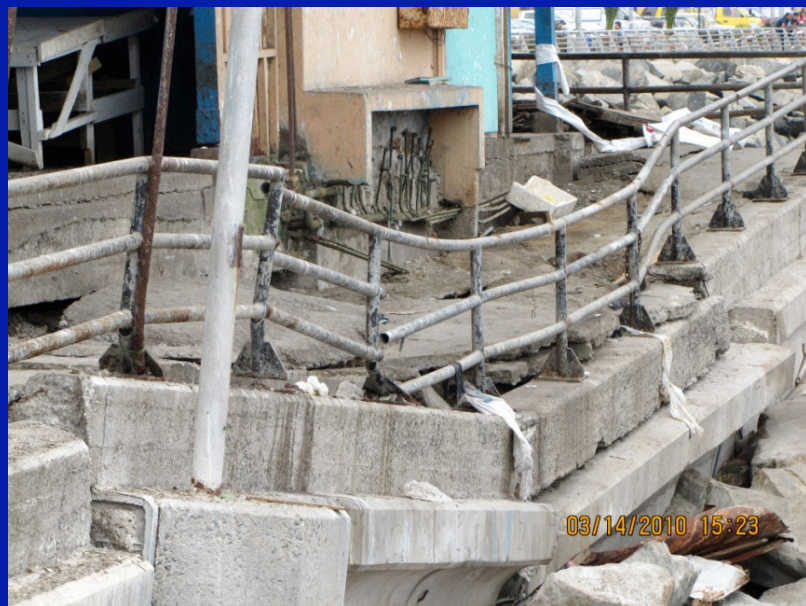
San Antonio

Effects of Ground Failure on Port Facilities

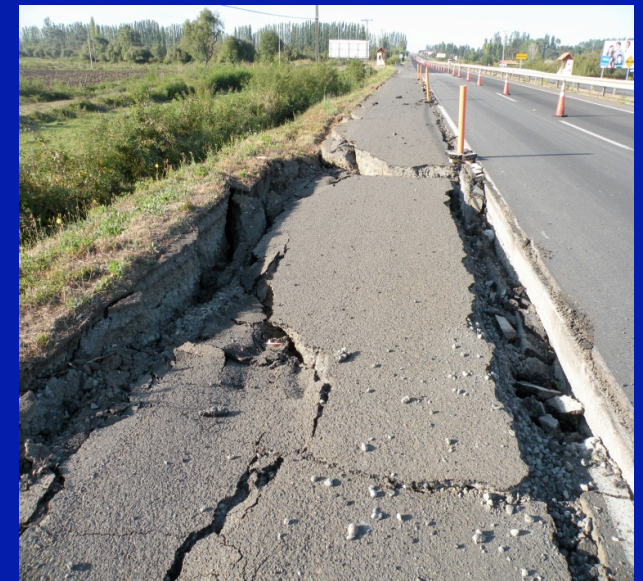
Possible liquefaction of thin seams in foundation soils led to translational failures of highway embankments

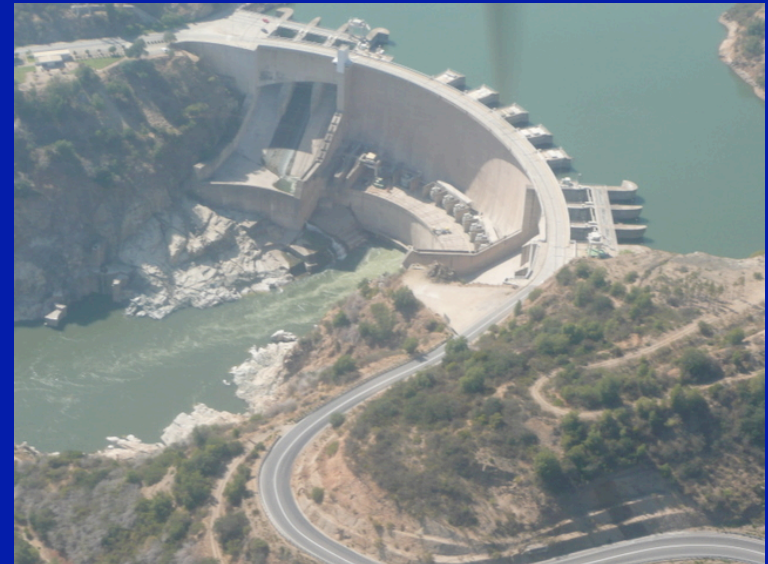
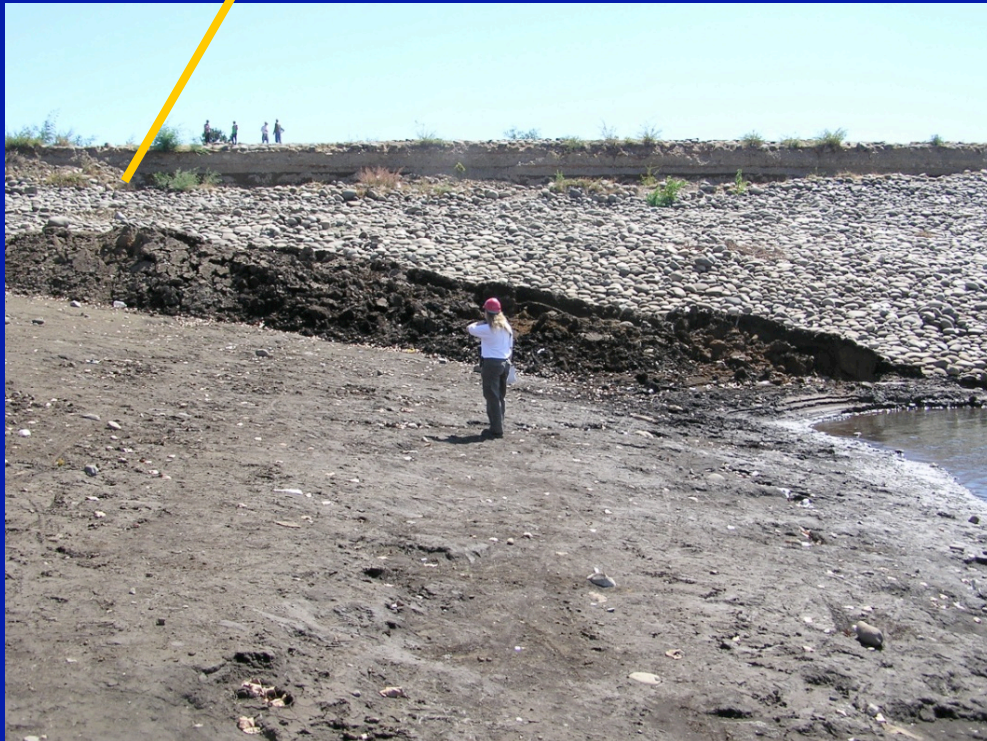
Rapel Concrete Dam

(most dams performed well)
